Project No.  
**3586.002.020**

Subject: Henry Ranch  
San Ramon, California

**GEOLOGIC HAZARD ABATEMENT DISTRICT  
MONITORING – FALL 2020**

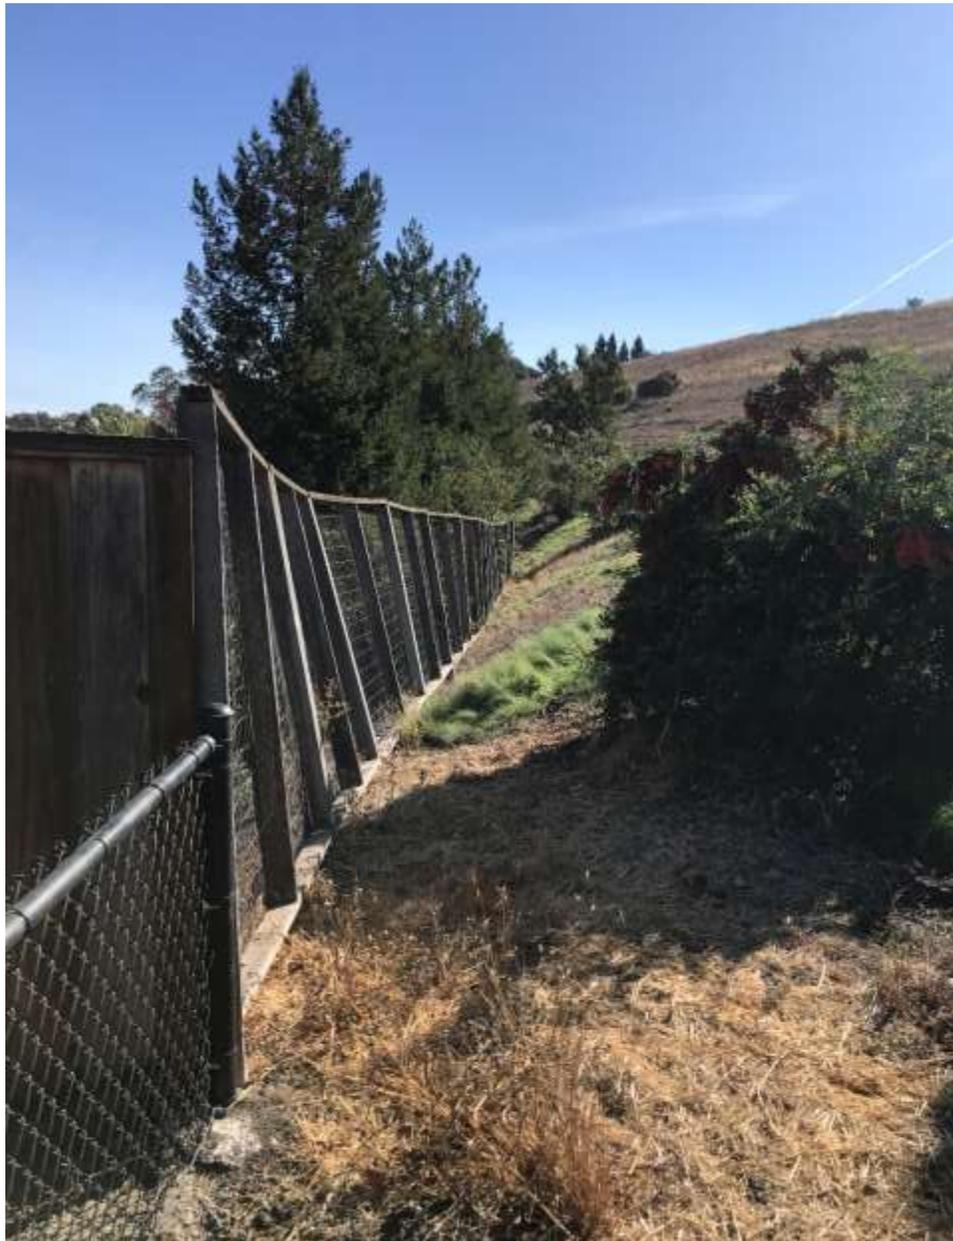
The rear fence at 6025 Westside Drive was tilted in the downslope direction, an indication of soil creep (Figure 1, Site Condition B, Photo 2). Fluctuations in moisture regimes of expansive soil may result in movement of soil related to shrinkage and swelling, which may result in adverse impact to overlying improvements. Soil creep involves the downslope movement of expansive soil due to wetting and drying of the soil. At the time of the site visit, soil creep did not appear to be of immediate concern and will be monitored in the future. Fences are not a GHAD-maintained improvement.

**PHOTO 2: Site Condition B – Creep movement affecting rear fence at 6025 Westside Drive.**

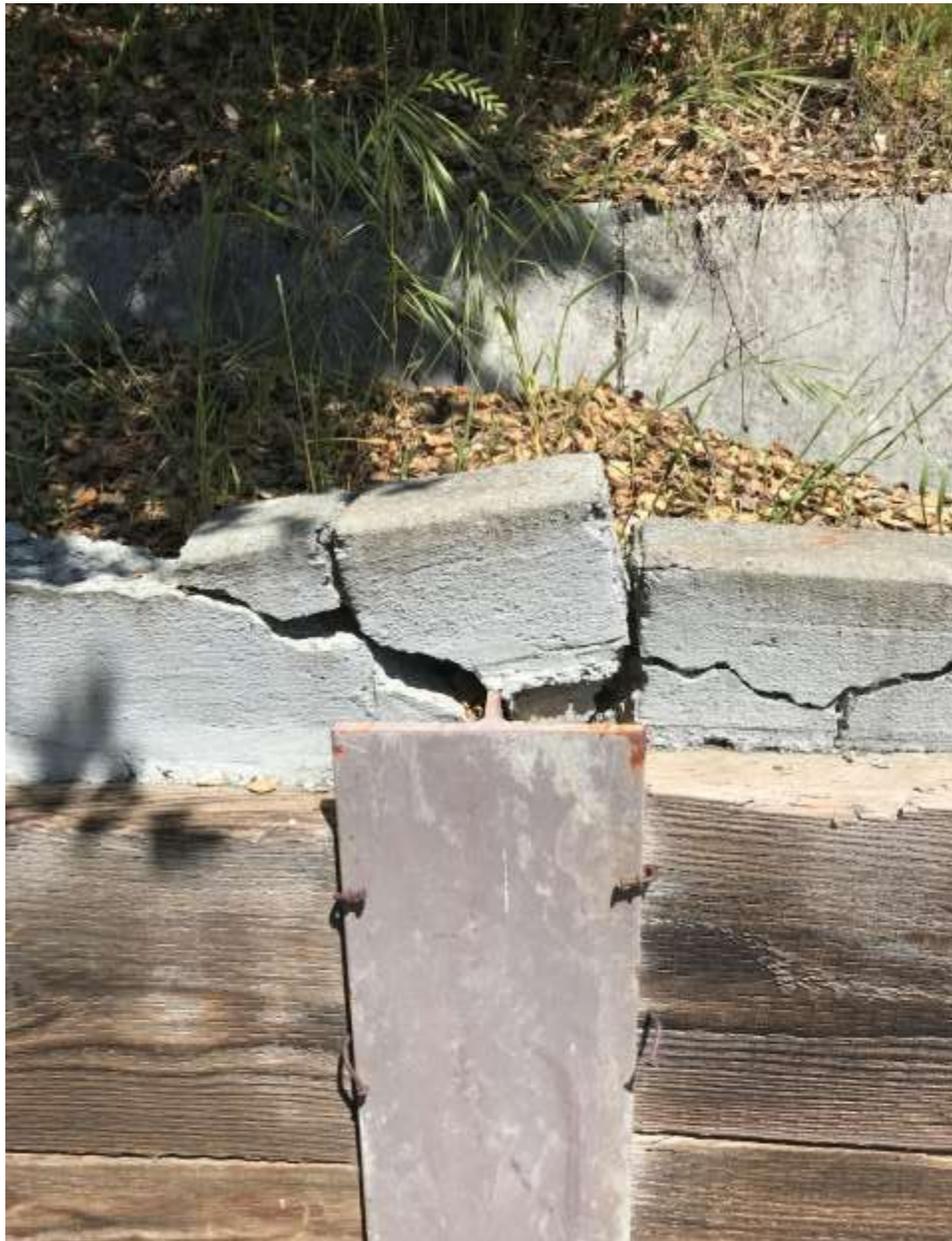
**PHOTO 3: Site Condition C –Damage to concrete-lined drainage ditch within easement.**

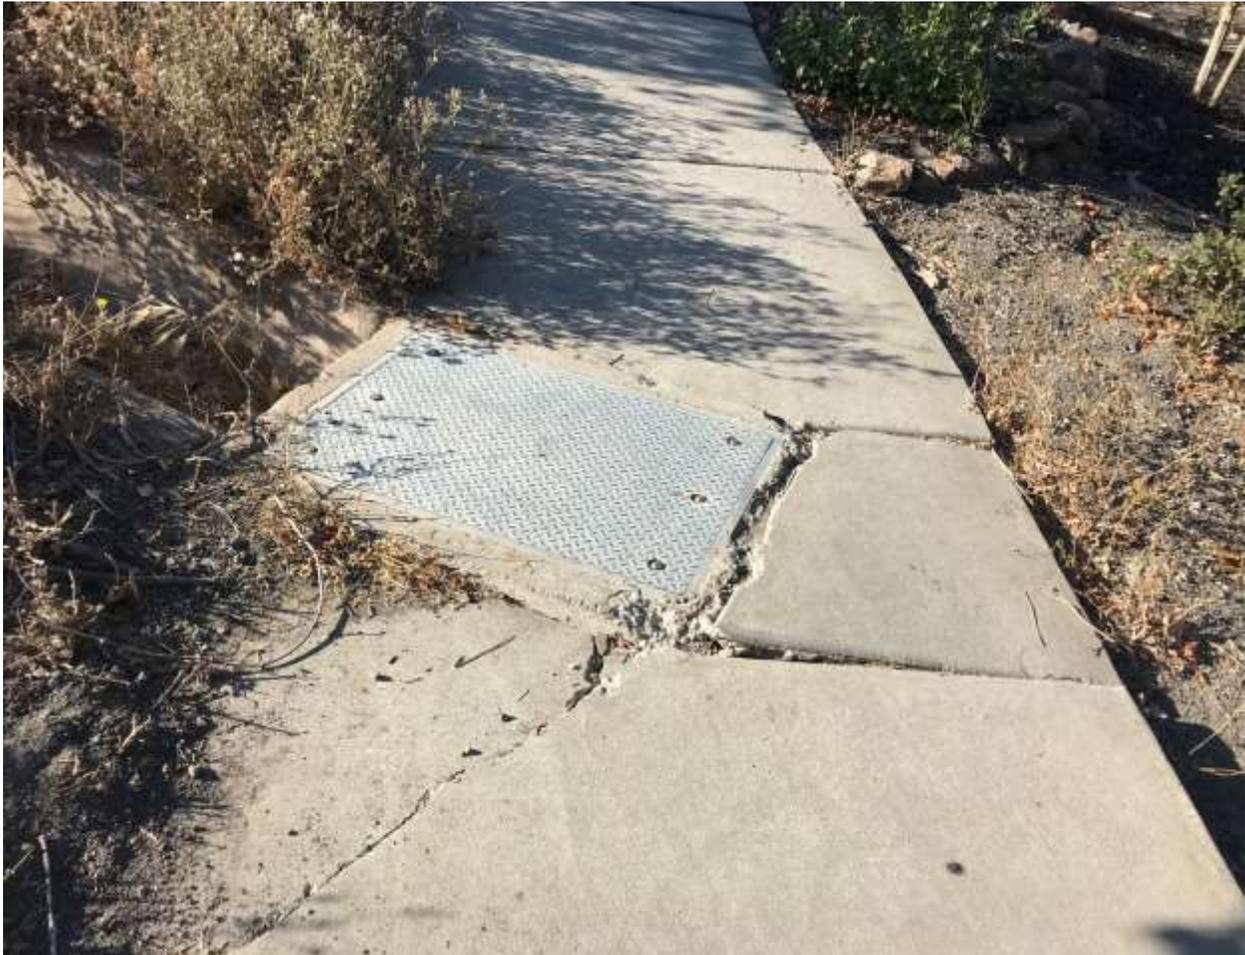
During our Spring 2018 monitoring event, we noted there is some cracking surrounding the storm drain inlet and sidewalk at the end of the concrete-lined drainage ditch located at the north end of Lone Tree Lane (Figure 1, Site Condition D, Photo 4). At the time of our monitoring event, the cracking remained unchanged. The sidewalk, which is not a GHAD-maintained improvement, should be repaired to prevent a potential trip hazard.

**PHOTO 4: Site Condition D – Cracking on sidewalk surrounding storm drain inlet.**

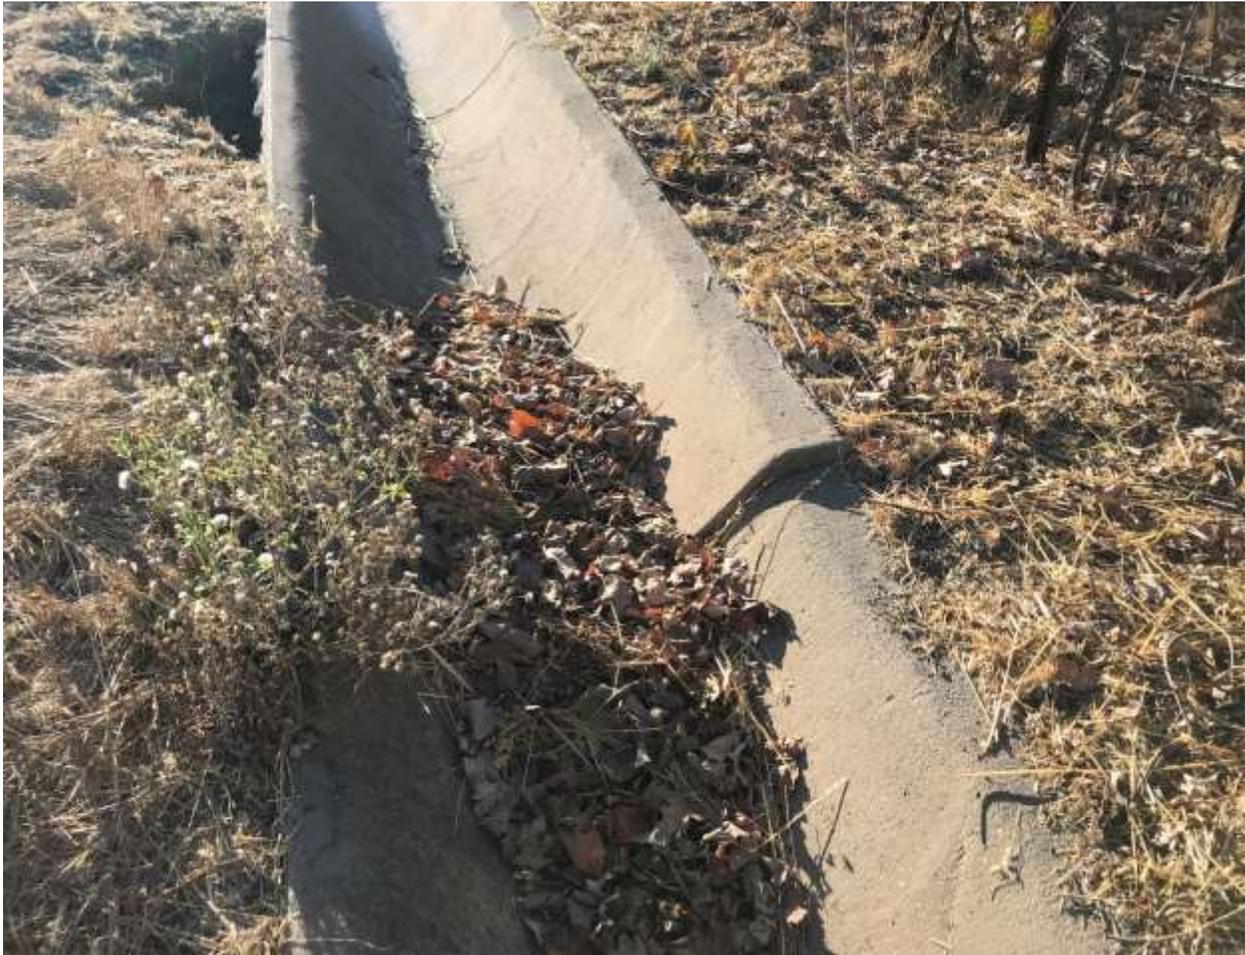
During our Fall 2019 monitoring event, we noted that there is an approximate 1-inch vertical offset at an expansion joint within the drainage ditch as well as a void underneath the drainage ditch approximately 20 feet east along the previously identified concrete-lined drainage ditch (Figure 1, Site Condition F, Photos 5 and 6). At the time of our monitoring event, the offset did not impede the flow of the drainage ditch. The void, however has continued to grow in size and now undermines a sizable portion of the drainage ditch. The GHAD will have the maintenance contractor fill the void with a controlled density fill to prevent the void from enlarging further. This area will continue to be monitored in future monitoring events.

**PHOTO 5: Site Condition F – Vertical offset in concrete-lined drainage ditch.**

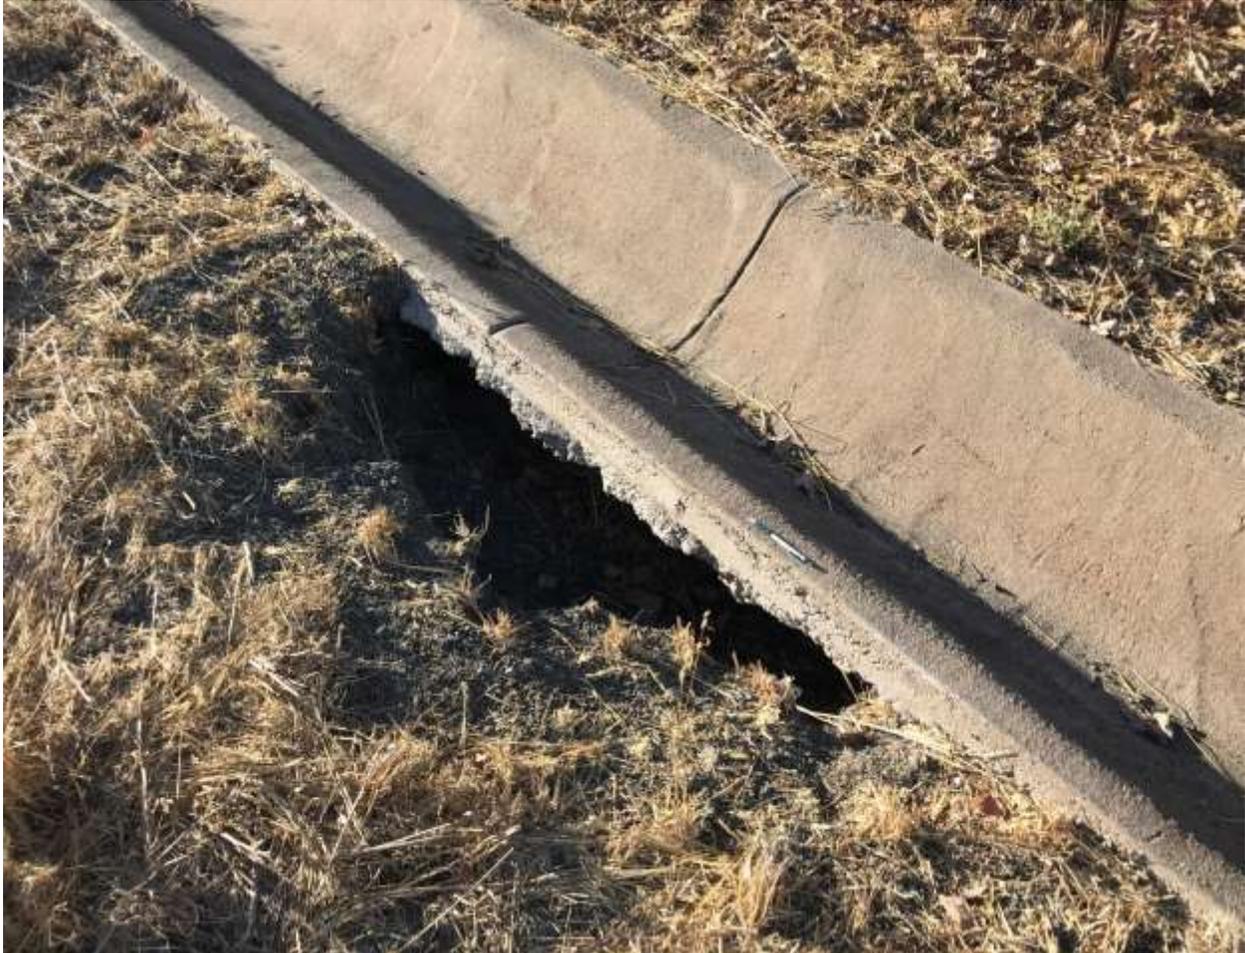
**PHOTO 6: Site Condition F – Void underneath concrete-lined drainage ditch.**

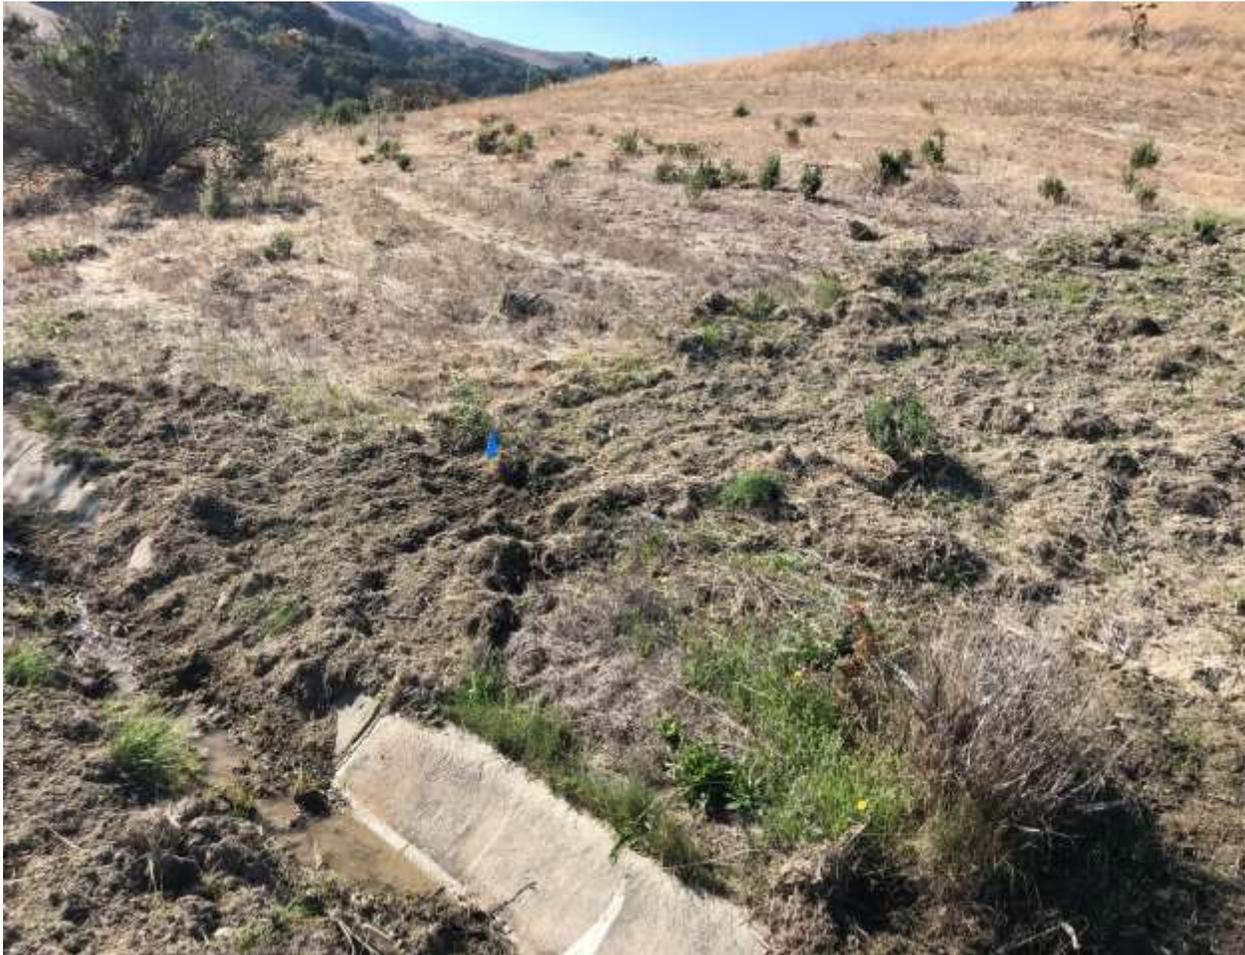
During our Spring 2018 monitoring event, we noted several areas of significantly disturbed and saturated soil located along the concrete-lined drainage ditches near the rear property fences of the residences. During this monitoring event, extensive damage to the slopes had been inflicted by rooting pigs (Figure 1, Site Condition G, Photos 7 through 9). Irrigation lines and sprinklers were broken resulting in excessive water being expelled and over-saturating the slopes. The earth was torn up and slopes behind several residences were eroded at the time of our recent monitoring. Areas that have been disturbed due to pig rooting are shown in Figure 1. The damage to the slopes did not appear to be impacting the nearby improvements. We will continue to monitor these slopes for evidence of instability and will repair the slopes as needed.

**PHOTO 7: Site Condition G – Erosion and slumping on slope above concrete-lined drainage ditch**

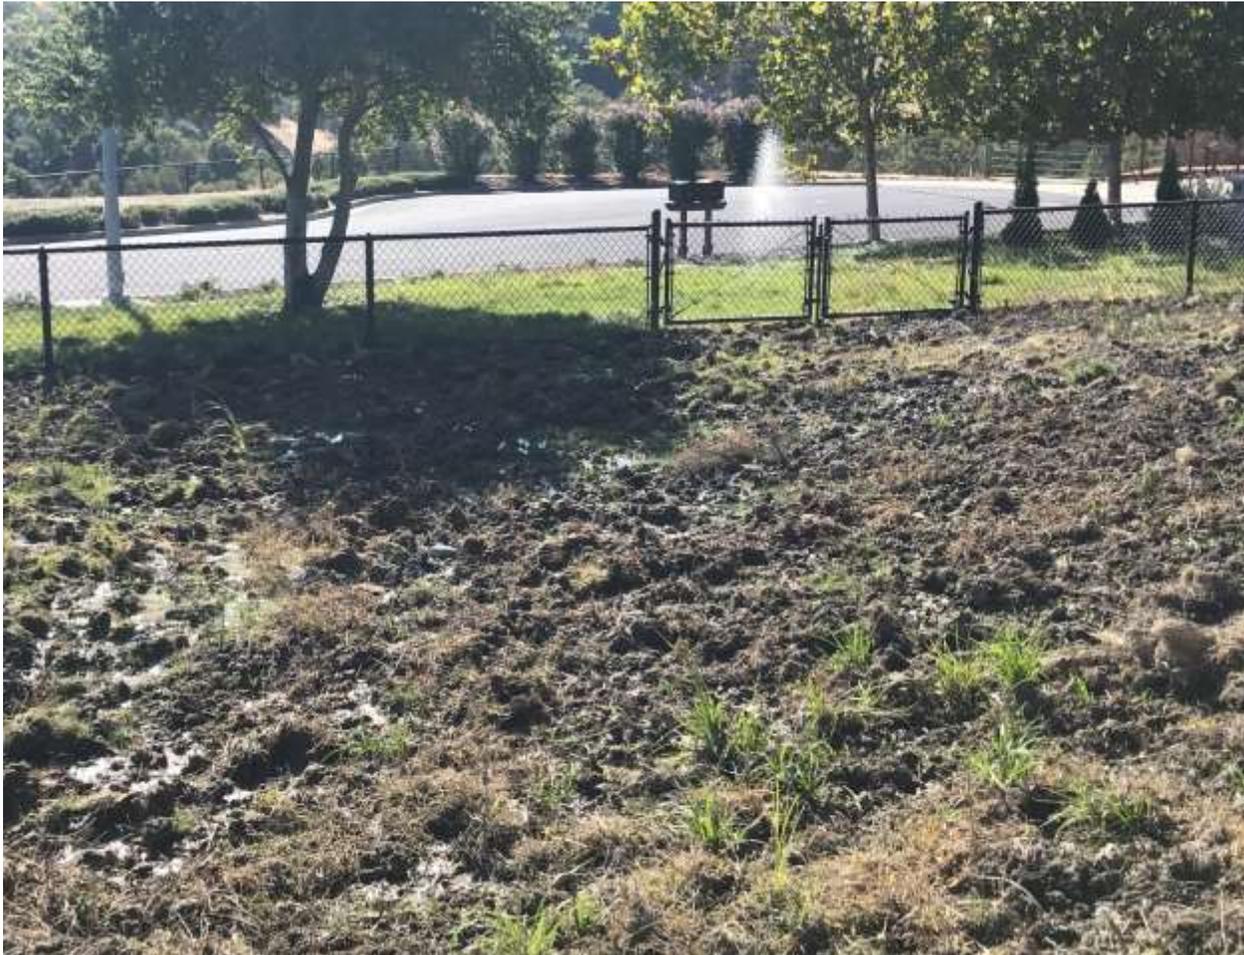
**PHOTO 8: Site Condition G – Erosion and rooting on over-saturated slope**

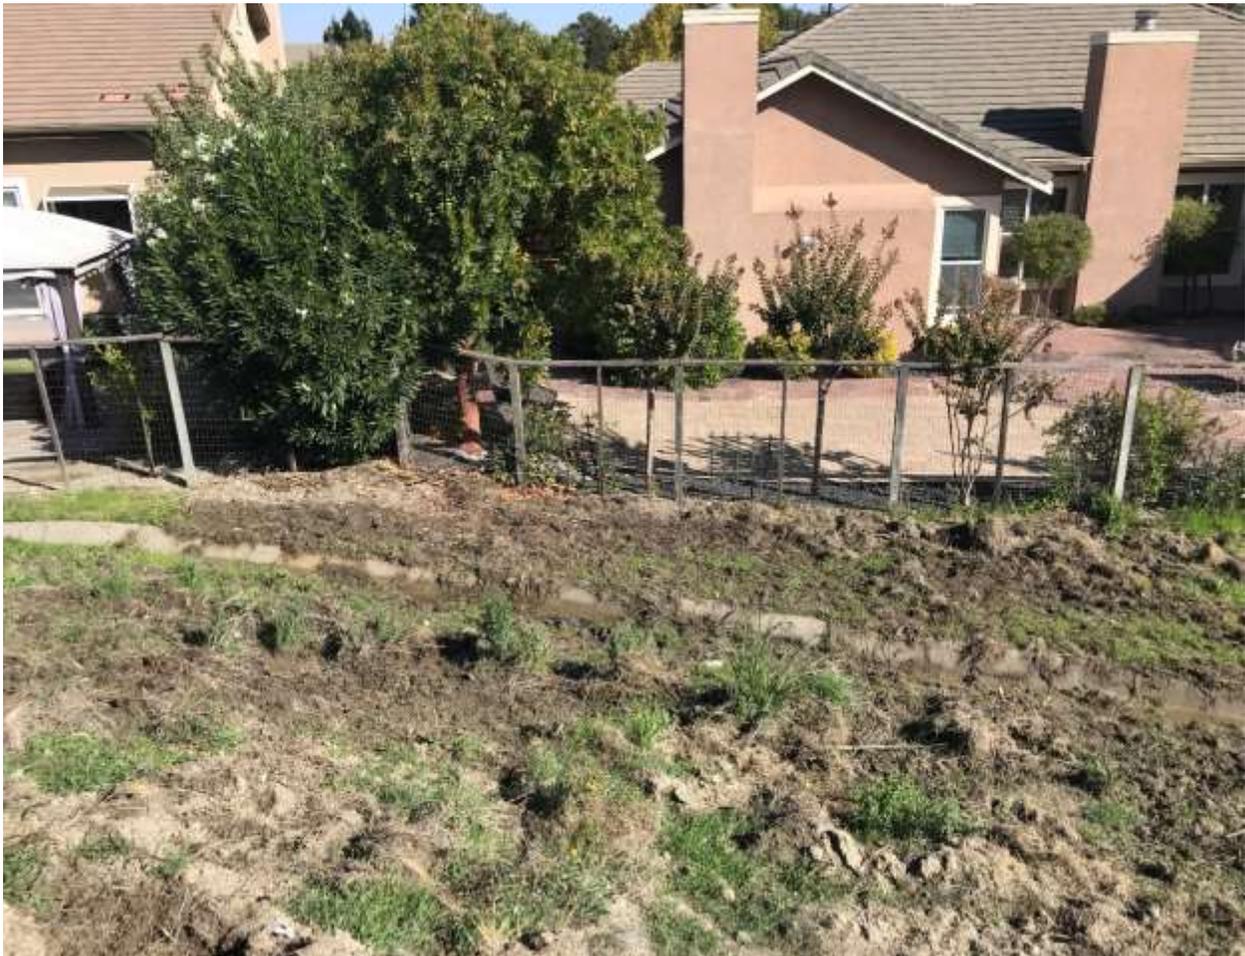
**PHOTO 9: Site Condition G – Erosion and rooting on slope above concrete-lined drainage ditch and next to property fence**

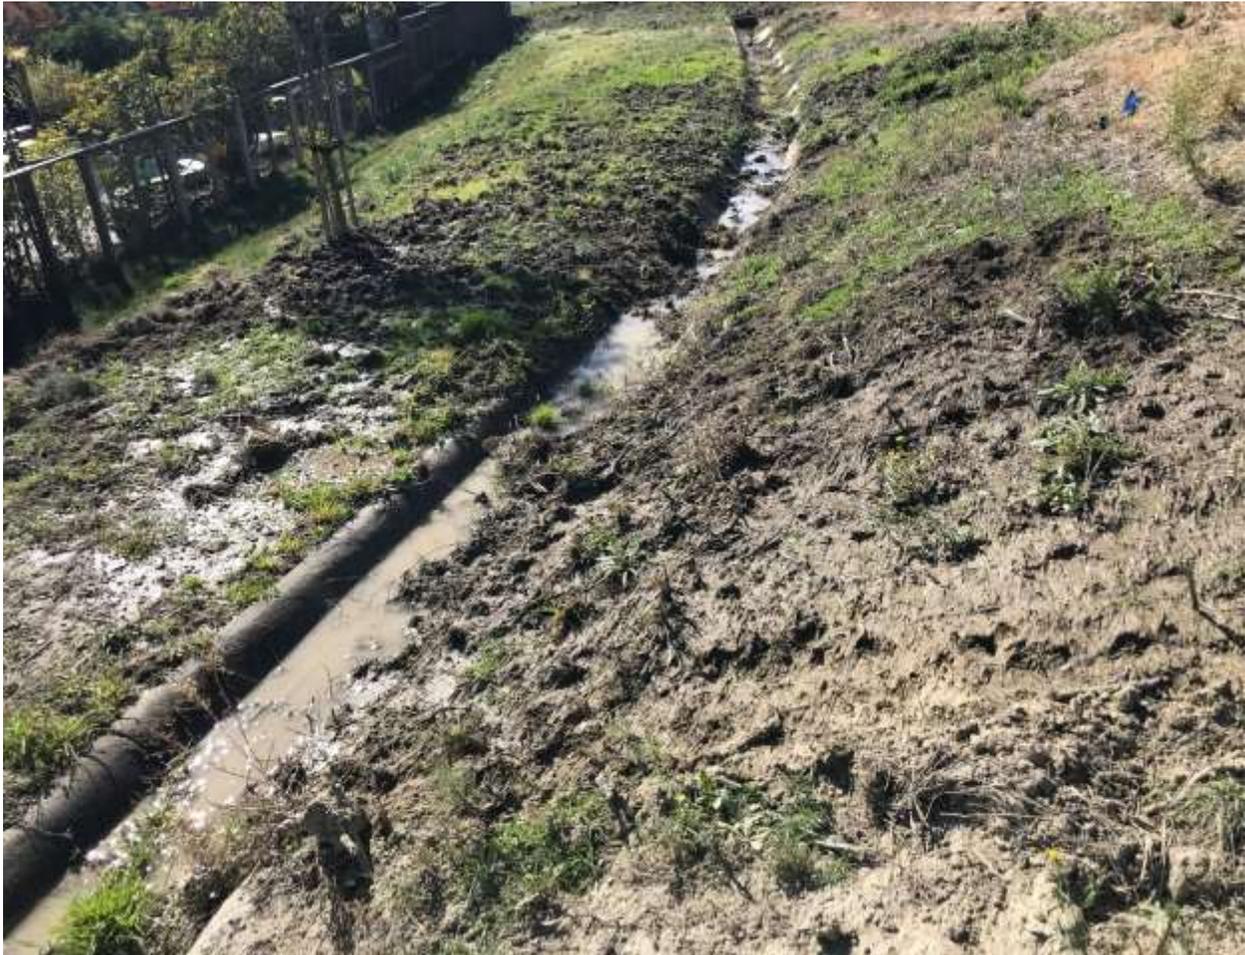
During this monitoring event, we noted that significant portions of the drainage ditches (Figure 1, Site Condition H, Photo 10) were full of standing water and soil from pig rooting activity. The excessive water was resulted from damage of the irrigation lines and sprinklers on the site slopes. The soil will be removed during routine fall maintenance, which will allow proper drainage and flow within the ditch.

**PHOTO 10: Site Condition H – Standing water and soil in concrete-lined drainage ditch**

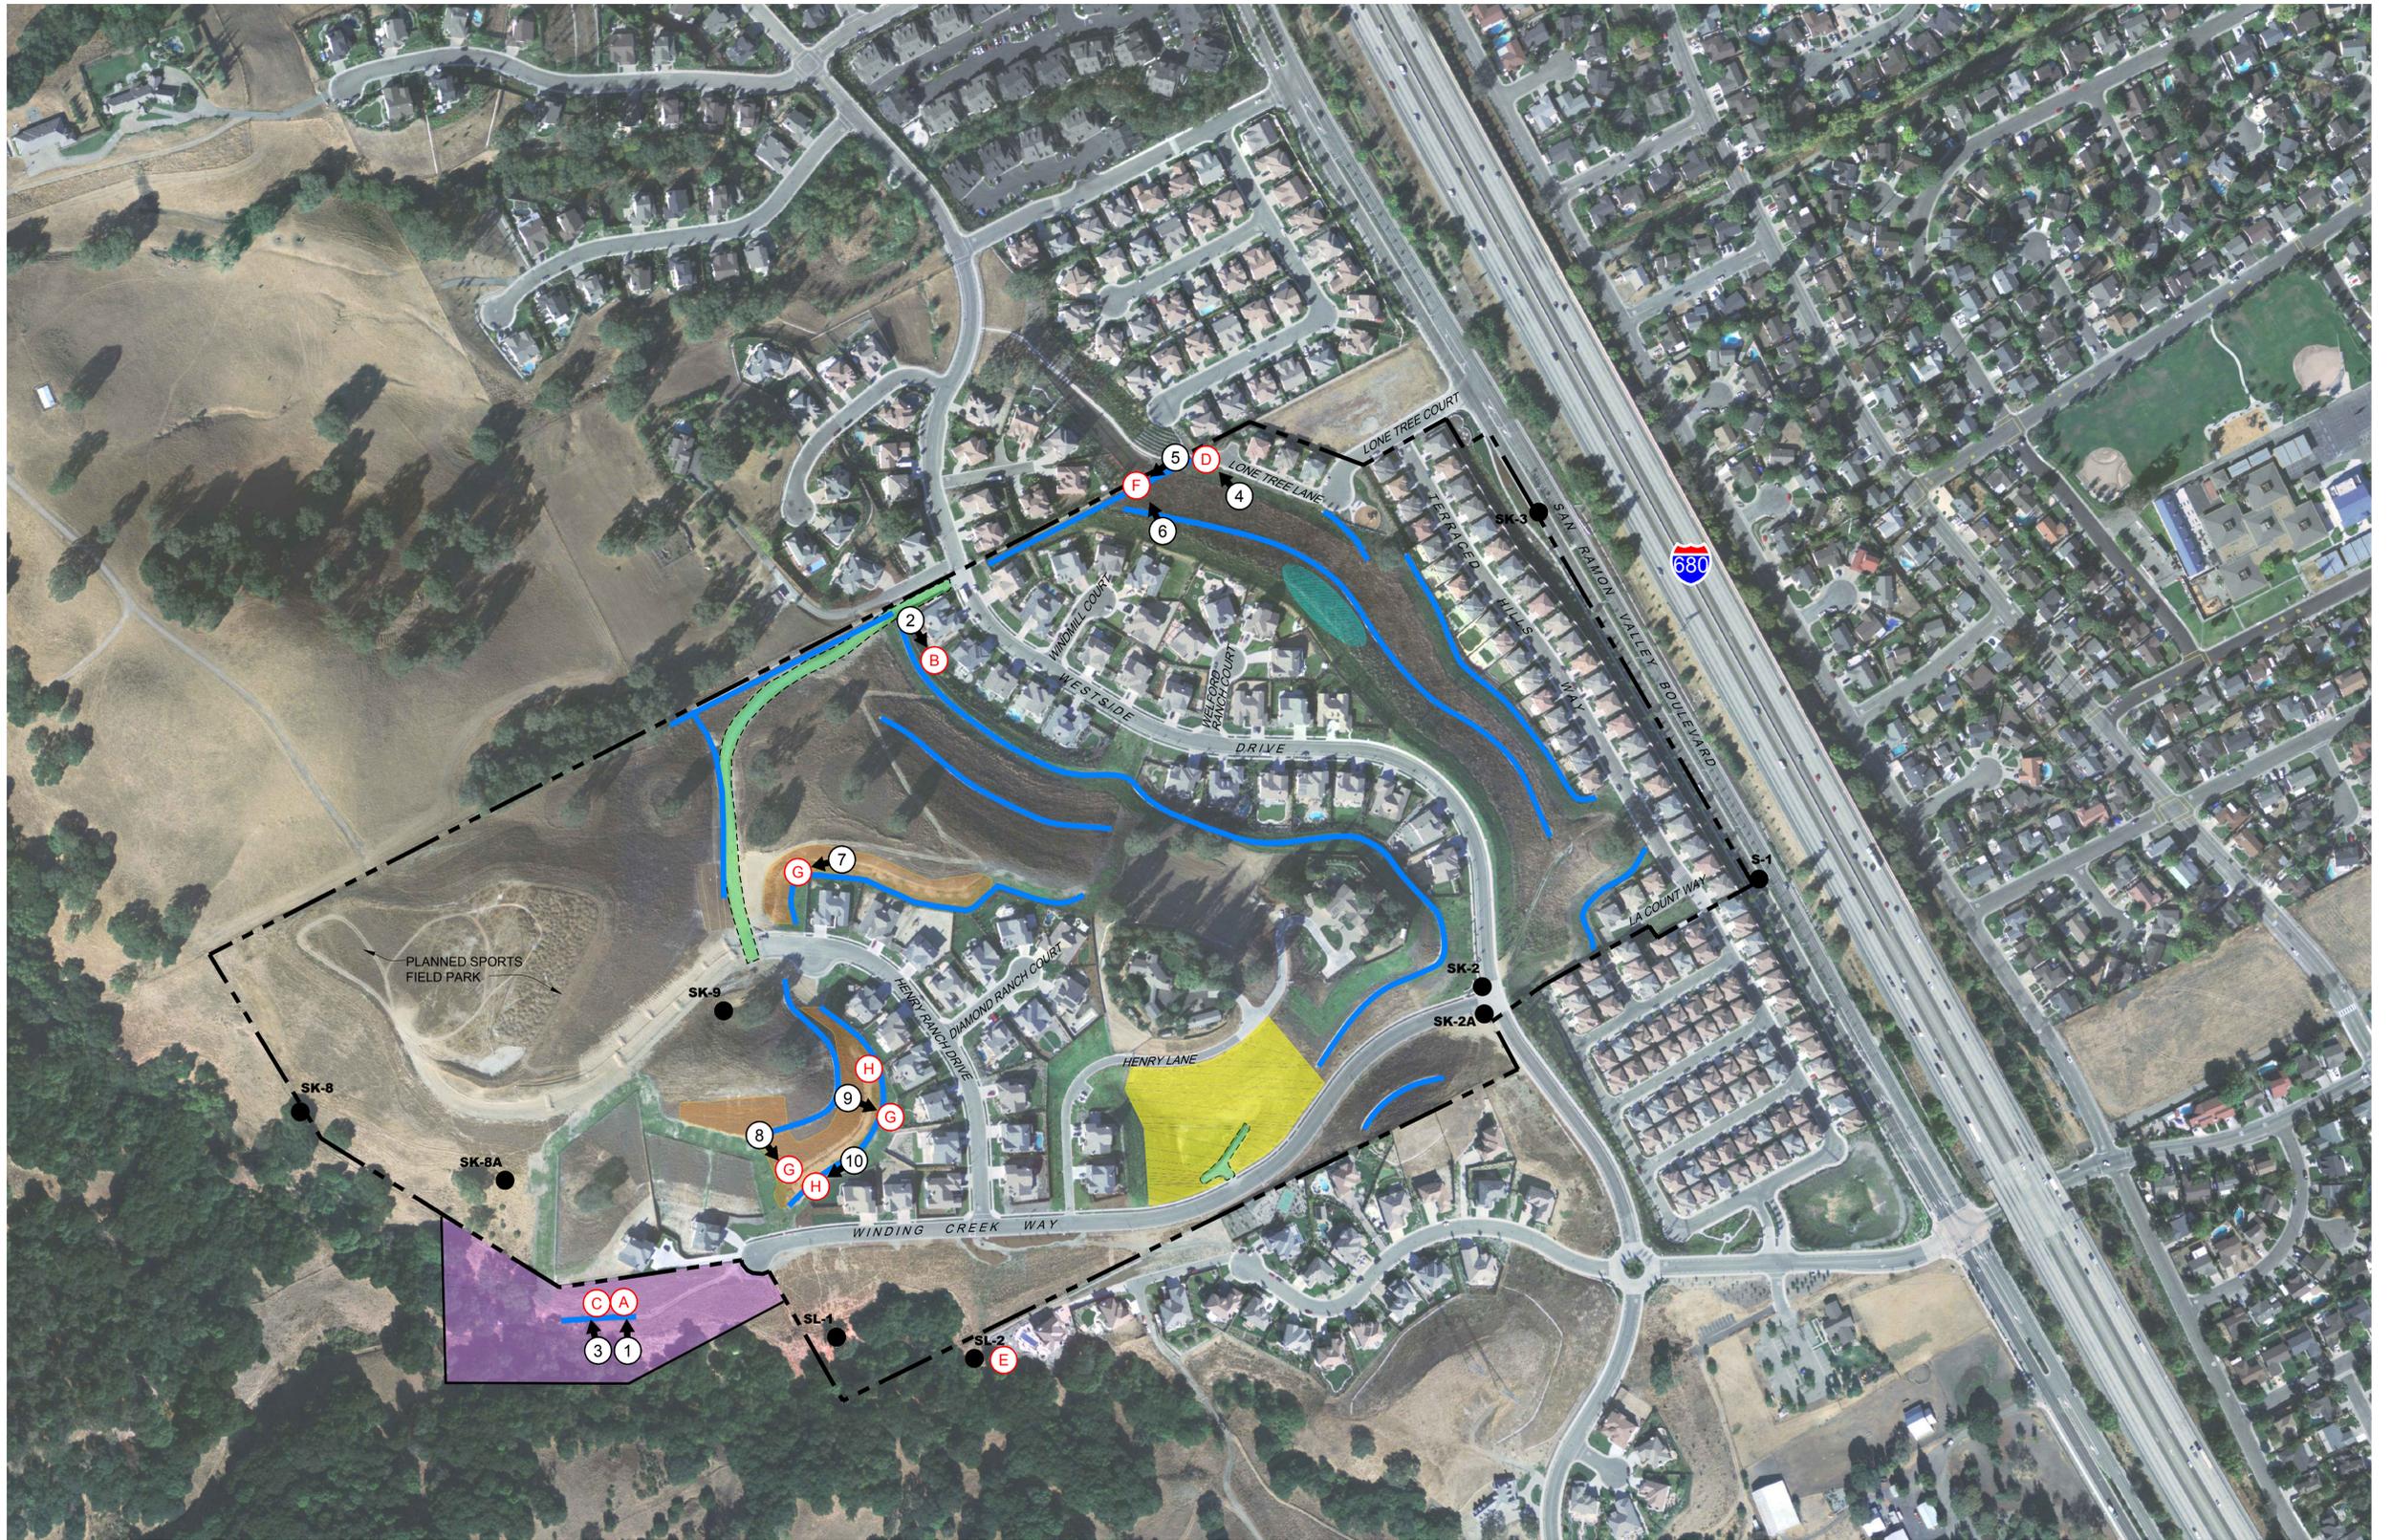
**Figure 1 – Site Plan**

Subdrain SL-2 outlet is located in an adjacent property not within the GHAD boundary. During our previous monitoring events (Fall 2019 and Spring 2020), the slope below the subdrain outfall appeared to be eroded (Figure 1, Site Condition E). However, if the erosion does threaten GHAD maintained improvements, such as the subdrain pipe, the GHAD will consider repairing the erosion. The area will continue to be monitored in the future.
