Project No.
3586.002.022

October 13, 2022

Subject: Elworthy Ranch
Danville, California

**GEOLOGIC HAZARD ABATEMENT DISTRICT MONITORING
FALL 2022**

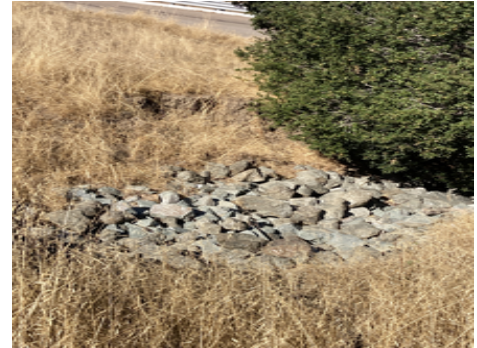
The common area and open-space slopes were observed for evidence of slope instability, including landslides, mudflows, erosion, diverted drainage, or standing water. In general, we observed the open space and slopes to be in a satisfactory condition. We noted in our spring 2021 monitoring that on Parcel "S," along the storm drain riprap apron within the channel, the sidewalls were in an oversteepened condition with erosion exposing scarps up to 3 feet on each side (Site Condition A.1, Appendix A, Figure 1). During this monitoring event, we noted that the condition remained unchanged since our last site visit and the slope was vegetated and stable. We also observed an oversteepened condition with erosion exposing portions of creek channel side wall on Parcel "P" (Site Condition A.2, Appendix A, Figure 1). The GHAD will continue to monitor and, if needed, mitigate these conditions to prevent the eroding soil from obstructing drainage at the outfall and creek channel.

Site Condition: A.1
Observation Date: 09/23/2022
Description: Scarp and exposed soil adjacent to rip rap apron and storm drain outfall.
Recommendation: Continue to monitor.
Field Representative: GH

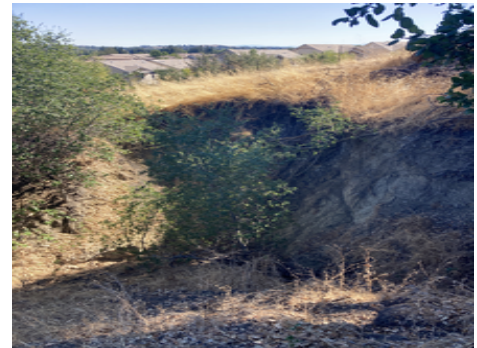
Site Condition: A.2
Observation Date: 09/23/2022
Description: Existing creek channel slope erosion.
Recommendation: Continue to monitor.
Field Representative: GH

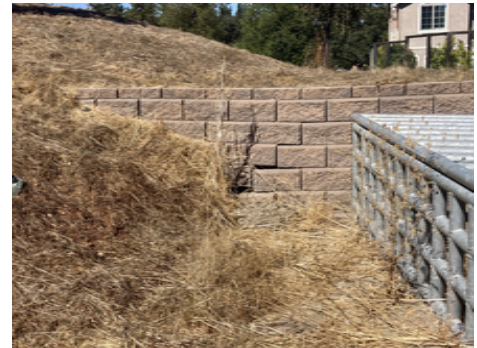
Retaining walls were inspected for significant cracking and damage. We observed that on the MSE retaining wall next to the trash rack between Elworthy Ranch Circle and Elworthy Ranch Lane, some of the cap and wall blocks were broken/distressed or displaced since our fall 2020 monitoring. During this monitoring event, we observed that the displaced caps had been reinstalled, and the broken/distressed blocks (Site Condition B, Appendix A, Figure 1) remained unchanged. The GHAD will continue to monitor and, if needed, will repair or replace the blocks to maintain the integrity of the wall. During our fall 2021 monitoring, we observed that erosion along the MSE retaining wall that supports the concrete-lined drainage ditch towards the southern end of Elworthy Ranch circle had worsened and created larger voids behind the MSE wall and below the concrete-lined drainage ditch (Site Condition C, Appendix A, Figure 1). During this monitoring, we noted that the erosion and voids remained the same. We will continue to monitor the condition of the slope and the stability of the wall during future monitoring. In addition, we first noted in our spring 2021 monitoring that animal burrows had undermined portions the MSE retaining wall along Elworthy Ranch Circle. During this monitoring event, we observed that the burrows had been backfilled.

Site Condition: B
Observation Date: 09/23/2022
Description: Distressed MSE retaining wall block.
Recommendation: Continue to monitor.
Field Representative: GH

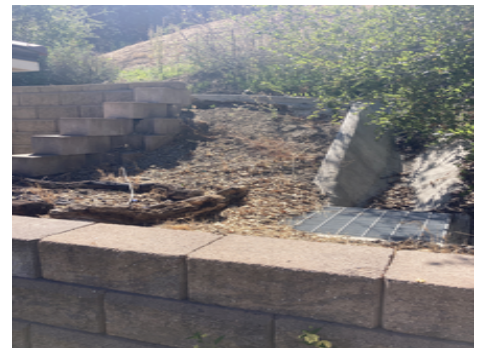
Site Condition: C
Observation Date: 09/23/2022
Description: Erosion behind MSE wall and below concrete-lined drainage ditch.
Recommendation: Continue to monitor.
Field Representative: GH
