Project No.  
**3586.002.022**

November 2, 2022

Subject: Henry Ranch  
San Ramon, California

**GEOLOGIC HAZARD ABATEMENT DISTRICT  
MONITORING – FALL 2022**

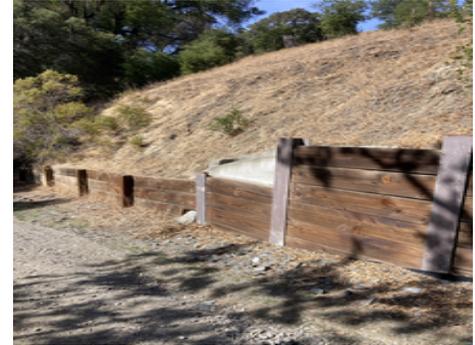
We previously noted that the slopes adjacent to the gravel-surfaced access road within the easement area were in an oversteepened condition and subject to shallow slope instability. Retaining walls or debris walls were constructed to protect the road from unstable materials from the uphill slope. During our most recent monitoring, soil continued to slough into the drainage ditch (Site Condition J, Appendix A, Figure 1). Erosion continued on portions of the slope, behind the debris wall (Site Condition A, Appendix A, Figure 1). The GHAD will remove soil materials that collected behind the debris walls to maintain the catchment capacity and from the ditch to allow for proper drainage.

Site Condition: A  
Observation Date: 10/06/2022  
Description: Oversteepened slope and erosion and sloughing on slope above debris wall.  
Recommendation: Continue to monitor.  
Field Representative: GH

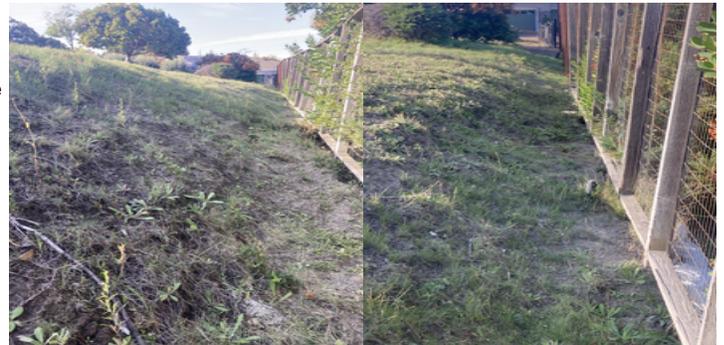
We noted in spring 2020 that the rear fence at 6025 Westside Drive was tilted in the downslope direction, which is an indication of soil creep. Fluctuations in moisture regimes of expansive soil may result in movement of soil related to shrinkage and swelling, which may result in adverse impact to overlying improvements. Soil creep involves the downslope movement of expansive soil due to wetting and drying of the soil. At the time of this site visit, the condition of the fence appeared to be in a similar condition as observed during our last monitoring event (Site Condition B, Appendix A, Figure 1). We also observed the soil creep to be localized directly adjacent to and along the fence alignment and common area irrigation/sprinkler line (Site Condition B, Appendix A, Figure 1). Fences are not a GHAD-maintained improvement. The GHAD will continue to monitor this condition.

Site Condition: B  
Observation Date: 10/06/2022  
Description: Tilted/leaning fence and localized soil creep due to irrigation.  
Recommendation: Continue to monitor.  
Field Representative: GH

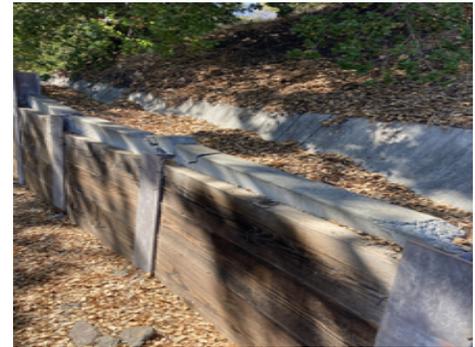
We did observe significant damage to the top of the concrete-lined drainage ditch within the easement area (Site Condition C, Appendix A, Figure 1). The damaged concrete will continue to be monitored, as needed, and will be repaired to allow for proper function of the drainage ditch.

Site Condition: C  
Observation Date: 10/06/2022  
Description: Damaged concrete-lined drainage ditch within Easement Area  
Recommendation: Continue to monitor.  
Field Representative: GH

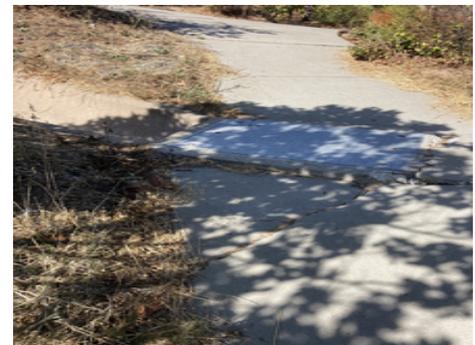
During our spring 2018 monitoring event, we noted some cracking was located surrounding the storm drain inlet and sidewalk at the end of the concrete-lined drainage ditch located at the northern end of Lone Tree Lane (Site Condition D, Appendix A, Figure 1). At the time of our monitoring event, the cracking did not appear to be elongating or widening. The sidewalk, which is not a GHAD-maintained improvement, should be repaired to prevent a potential trip hazard.

Site Condition: D  
Observation Date: 10/06/2022  
Description: Offset/cracked sidewalk concrete.  
Recommendation: Continue to monitor.  
Field Representative: GH

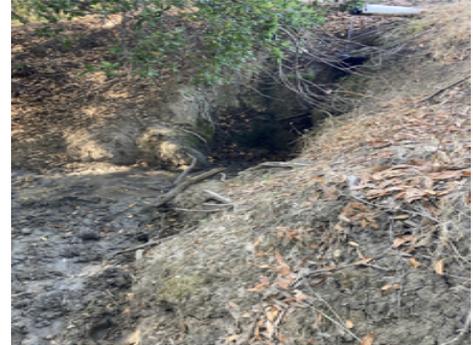
Subdrain SL-2 outlet is located in an adjacent property and not within the GHAD boundary. Since our fall 2019 monitoring, the creek slope below the subdrain outlet appeared to be eroded. During this monitoring event, we observed continued progression of the slope erosion (Site Condition E, Appendix A, Figure 1). If the erosion does threaten GHAD maintained improvements, such as the subdrain pipe, the GHAD will consider repairing the erosion. The area will continue to be monitored in the future.

Site Condition: E  
Observation Date: 10/06/2022  
Description: Slope erosion below subdrain outlet.  
Recommendation: Continue to monitor.  
Field Representative: GH

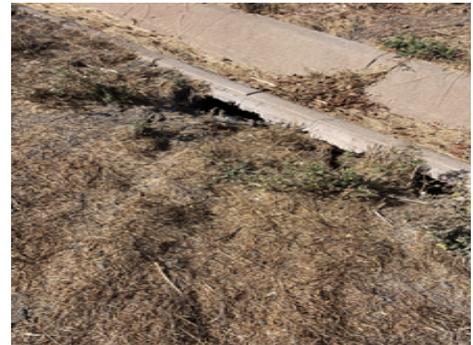
During our fall 2019 monitoring event, we noted that there is a significant void underneath a portion of drainage ditch at the north end of Lone Tree Lane (Site Condition F, Appendix A, Figure 1). The GHAD will have the maintenance contractor backfill the void to prevent the void from continued enlargement. This area will continue to be monitored in future monitoring events.

Site Condition: F  
Observation Date: 10/06/2022  
Description: Void beneath concrete-lined drainage ditch.  
Recommendation: Backfill void.  
Field Representative: GH

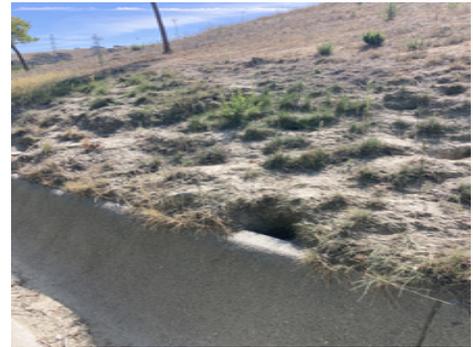
Site Condition: G.1  
Observation Date: 10/06/2022  
Description: Disturbed slope above concrete-lined drainage ditch from pig rooting activity.  
Recommendation: Continue to monitor.  
Field Representative: GH

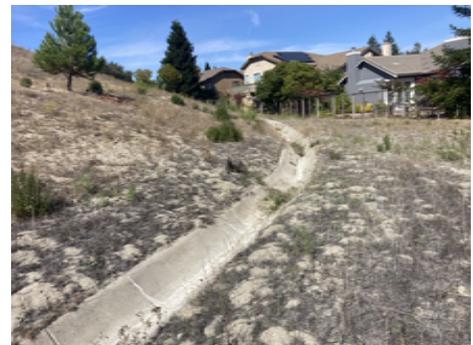
Site Condition: G.2  
Observation Date: 10/06/2022  
Description: Disturbed slope adjacent to concrete-lined drainage ditch from pig rooting activity.  
Recommendation: Continue to monitor.  
Field Representative: GH

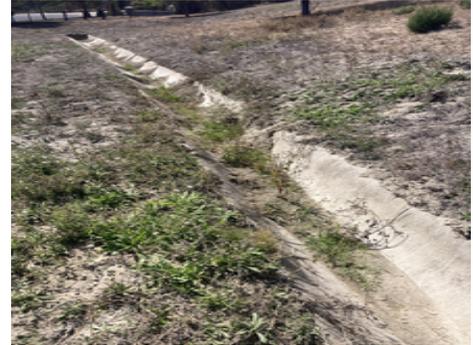
Site Condition: H  
Observation Date: 10/06/2022  
Description: Soil and debris accumulation in concrete-lined drainage ditch.  
Recommendation: Soil and debris to be removed during scheduled maintenance.  
Field Representative: GH

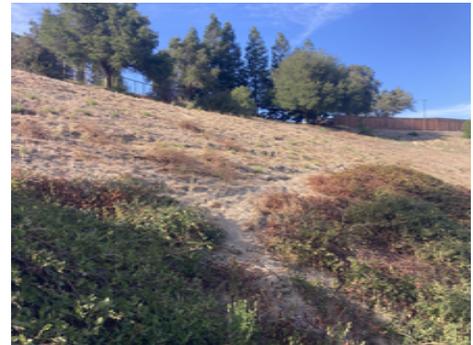
Site Condition: I.1  
Observation Date: 10/06/2022  
Description: Animal burrowing on slope.  
Recommendation: Continue to Monitor.  
Field Representative: GH

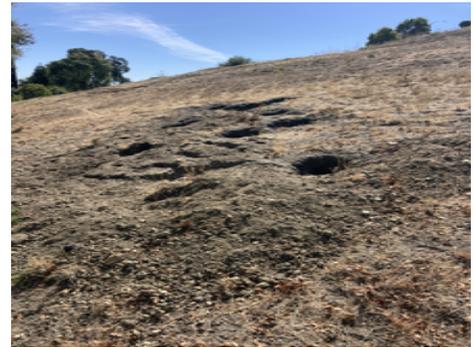
Site Condition: I.2  
Observation Date: 10/06/2022  
Description: Animal burrowing on slope.  
Recommendation: Continue to Monitor.  
Field Representative: GH

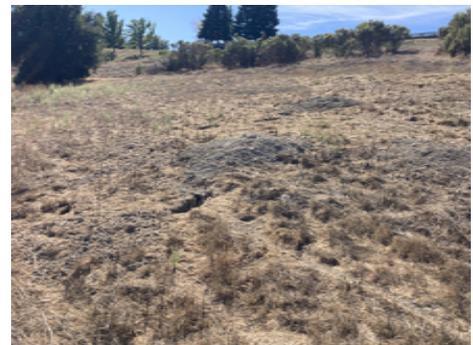
Site Condition: I.3  
Observation Date: 10/06/2022  
Description: Animal burrowing on slope.  
Recommendation: Continue to Monitor.  
Field Representative: GH

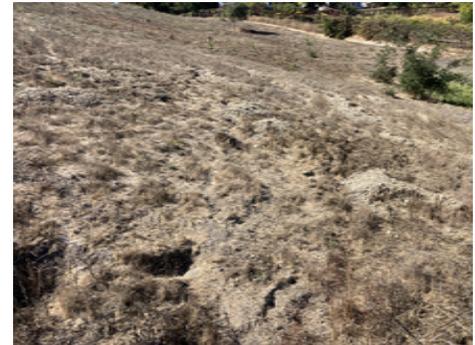
Site Condition: I.4  
Observation Date: 10/06/2022  
Description: Animal burrowing on slope.  
Recommendation: Continue to Monitor.  
Field Representative: GH

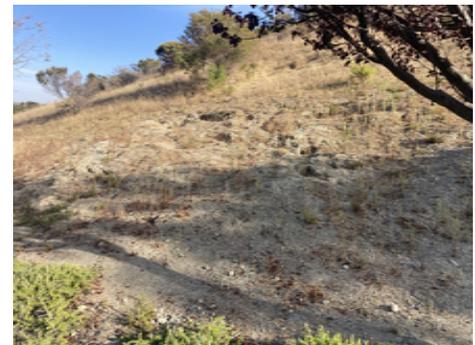
Site Condition: I.5  
Observation Date: 10/06/2022  
Description: Animal burrowing on slope.  
Recommendation: Continue to Monitor.  
Field Representative: GH

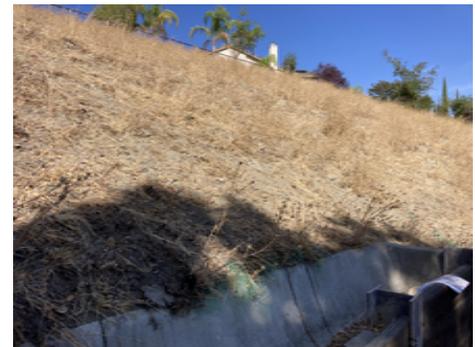
Site Condition: J  
Observation Date: 10/06/2022  
Description: Erosion and sloughing on slope above retaining wall.  
Recommendation: Continue to monitor.  
Field Representative: GH

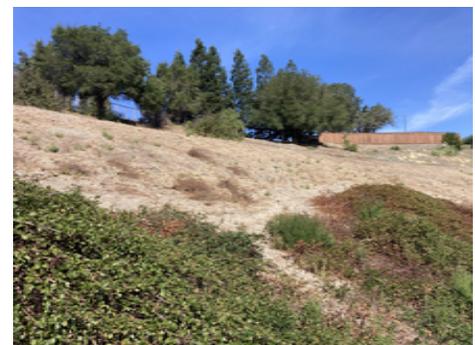
During our fall 2021 monitoring event, we noted erosion and rooting activities occurred on the slope adjacent to Winding Creek Way. The erosion exposed bare soil but did not appear to be impacting the sidewalk below or any other nearby improvements at the time of monitoring. During our most recent monitoring, the slope had partially revegetated (Site Condition K, Appendix A, Figure 1). The GHAD will continue to monitor this condition.

Site Condition: K  
Observation Date: 10/06/2022  
Description: Erosion and bare soil on slope above Winding Creek Way.  
Recommendation: Continue to monitor.  
Field Representative: GH

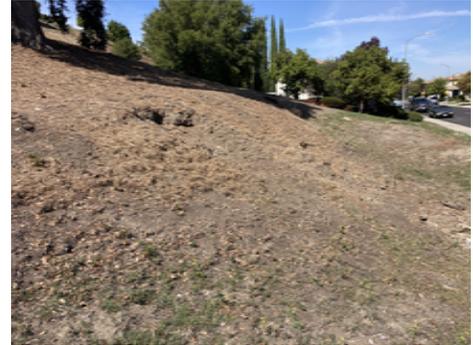
Site Condition: L  
Observation Date: 10/06/2022  
Description: Disturbed and bare soil on slope.  
Recommendation: Continue to monitor.  
Field Representative: GH
