Project No.  
**3586.002.022**

Subject: Norris Canyon Estates  
Contra Costa County, California

**GEOLOGIC HAZARD ABATEMENT DISTRICT  
MONITORING – Fall 2022**

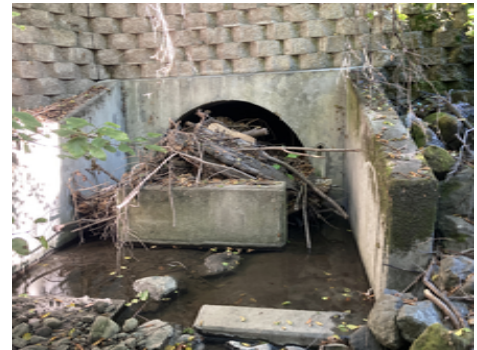
During our spring 2020 monitoring event, we observed a large piece of wood debris lodged against the flow reduction weir at the mouth of the culvert near Wall E and a wood pallet blocked the culvert outlet at Wall J. This debris prevented proper drainage and caused minor standing water within the culverts. The GHAD removed the debris and wood pallet to allow proper flow of the creek through the culverts. During the Fall 2020 monitoring event, we noted that tree branches had accumulated at the flow weir but did not appear to be obstructing channel flow. During this monitoring event, we observed dense accumulation of tree branches and debris at the flow weir (Site Condition A, Appendix A, Figure 1). The GHAD will remove the tree branches and debris during the GHAD's routine maintenance activities.

Site Condition: A  
Observation Date: 09/29/2022  
Description: Dense accumulation of tree branches and debris at culvert weir.  
Recommendation: Remove tree branches and debris to allow for proper drainage.  
Field Representative: GH

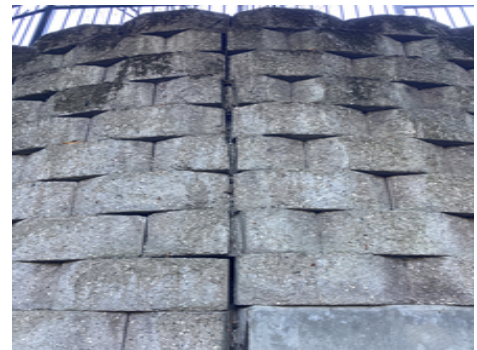
On Wall J, a 1-inch gap along an expansion joint was observed between the concrete headwall and the adjacent MSE retaining wall blocks during the 2002 monitoring event. During the 2007 site visit, it appeared that the gap had widened to approximately 2 inches. During the 2011 site visit, the gap had widened to approximately 2¼ inches. As observed during the most recent monitoring event, the gap has remained at approximately 2¼-inches wide (Site Condition B, Appendix A).

Site Condition: B  
Observation Date: 09/29/2022  
Description: 2 1/4-inch gap along retaining wall expansion joint.  
Recommendation: Continue to monitor.  
Field Representative: GH

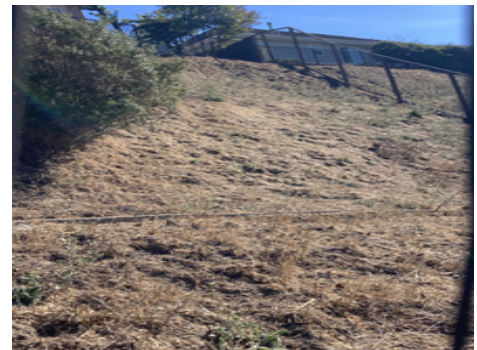
Since 2018, several minor landslides were observed along the 1:1 (horizontal:vertical) engineered fill slope, north of Lyndhurst Place, downhill from the nearby residences (Site Condition D, Appendix A, Figure 1). These shallow landslides were not of immediate concern but have been monitored during subsequent scheduled monitoring events. During this monitoring event, these landslides did not show any significant movement and the landslide areas were revegetated with wild grasses. The GHAD will continue monitoring these areas for slope stability.

Site Condition: D  
Observation Date: 09/29/2022  
Description: Shallow landslides along 1:1 slope.  
Recommendation: Continue to monitor.  
Field Representative: GH

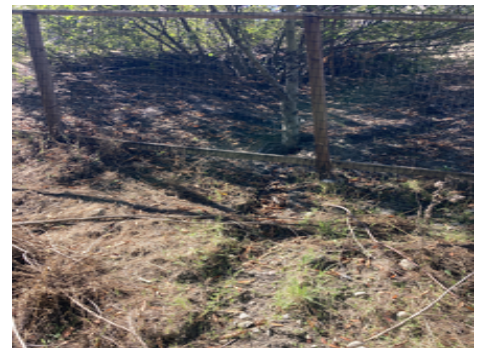
During the spring 2018 monitoring event, we observed minor erosion that extended east of 2263 Ashbourne Drive (Lot 47). The erosion gully was located below a riprap dissipater located on the property. During our Fall 2021 monitoring visit, we observed the area was vegetated and the erosion had not significantly increased. Conditions were observed to be unchanged during this monitoring event (Site Condition E.1, Appendix A, Figure 1). This area will be monitored in future monitoring events and the erosion gully will be repaired as necessary. We also observed a minor erosion rill extending southwest of 539 Wycombe Court (Lot 106). The erosion rill begins at the property fence line and appeared to be caused by an open or damaged irrigation drip line (Site Condition E.2, Appendix A, Figure 1). The development Homeowner's Association (HOA) and property owner will be notified of the need for irrigation repairs, and the area will be monitored in future events.

Site Condition: E.1  
Observation Date: 09/29/2022  
Description: Minor erosion gully below riprap dissipator.  
Recommendation: Continue to monitor.  
Field Representative: GH

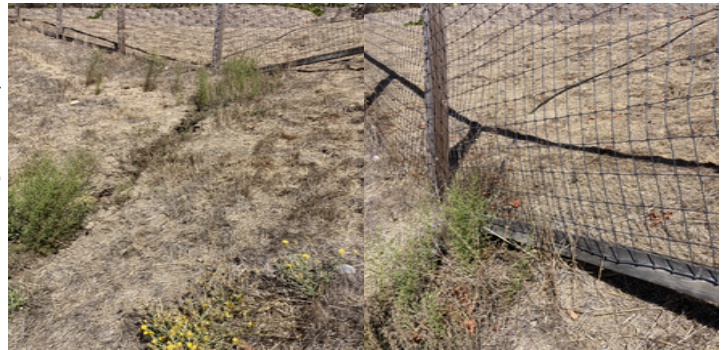
Site Condition: E.2  
Observation Date: 10/03/2022  
Description: Minor erosion rill in slope caused by homeowner irrigation (Lot 106).  
Recommendation: Request HOA and homeowner to cap open drip line.  
Field Representative: None

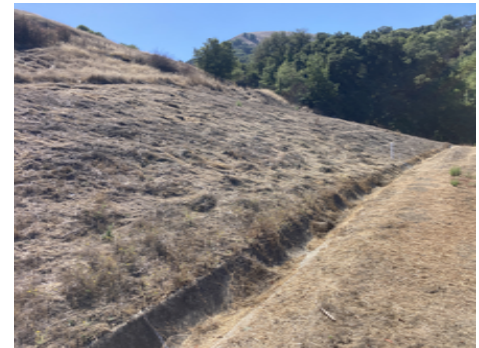
During the winter of 2017/2018, a landslide occurred south of Ardleigh Court measuring approximately 35 feet in length, 35 feet in width, and up to 5 feet in depth. In October 2018, the GHAD repaired the landslide and restored the slope to the original graded condition. The repaired slope was observed during this monitoring event and appeared to be performing well (Site Condition F, Appendix A, Figure 2). This area will be monitored in future events to ensure the effectiveness of the repair.

Site Condition: F  
Observation Date: 10/03/2022  
Description: Landslide repair.  
Recommendation: Continue to monitor.  
Field Representative: GH

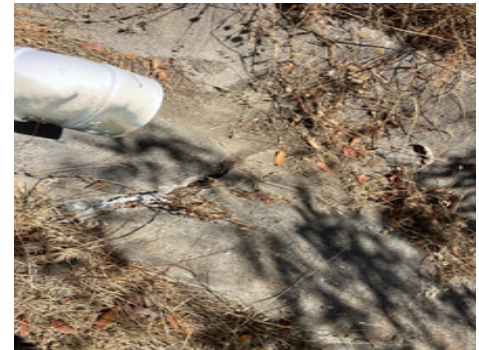
Retaining Wall L-5 subdrain outlet discharges directly over a separated drainage ditch expansion joint, and potential subdrain and/or surface water can seep through the separation and potentially saturate the soil of the slope (Site Condition H, Appendix A, Figure 2). During this monitoring event, the surrounding slope did not show significant saturation or movement. The expansion joint between segments of the concrete-lined drainage ditch should be sealed/patched, and the GHAD will continue monitoring the area for slope stability concerns.

Site Condition: H  
Observation Date: 10/03/2022  
Description: Concrete-lined drainage ditch separated at expansion joint. Approximate 1-inch separation.  
Recommendation: Seal expansion joint separation.  
Field Representative: GH

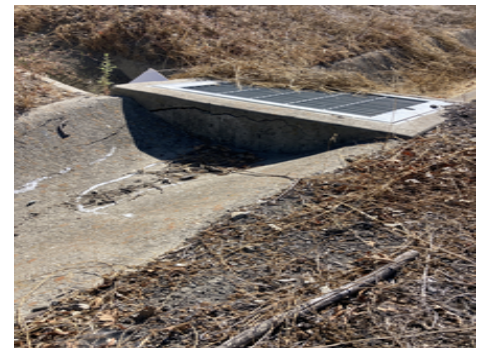
During the Spring 2020 monitoring event, the top of the storm drain inlet box at the concrete-lined drainage ditch, located southwest of 3057 Ashbourne Circle (Lot 85), showed cracking and significant separation from the inlet box structure. At the time of this monitoring event, the cracking had not progressed (Site Condition I, Appendix A, Figure 2). The inlet box and cracks should continue to be monitored and, if needed, sealed or replaced to maintain the integrity and longevity of the drain inlet.

Site Condition: I  
Observation Date: 10/03/2022  
Description: Crack along top portion of DI box.  
Recommendation: Continue to monitor and replace if cracking affects DI function.  
Field Representative: None

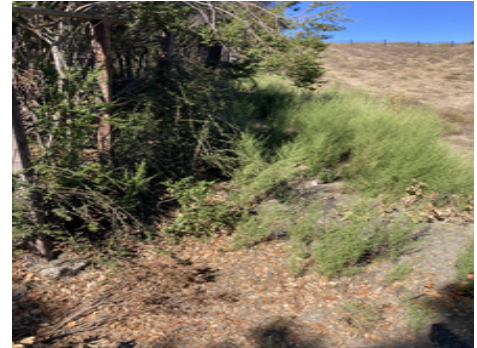
During our spring 2021 monitoring event, we observed that the eastern slope of 3327 Ashbourne Circle (Lot 38) was saturated, as well as the access road downslope from the residence. This saturation caused the eastern slope of the access road to begin eroding. During this monitoring event, we did not observe overly saturated conditions along the eastern slopes of Lot 38 or the access road, and slope erosion appeared to be unchanged (Site Condition L, Appendix A, Figure 2). The GHAD will continue monitoring these areas for slope stability.

Site Condition: L  
Observation Date: 10/04/2022  
Description: Minor surface erosion along eastern side of rear yard slopes and access road slope.  
Recommendation: Continue to monitor.  
Field Representative: None

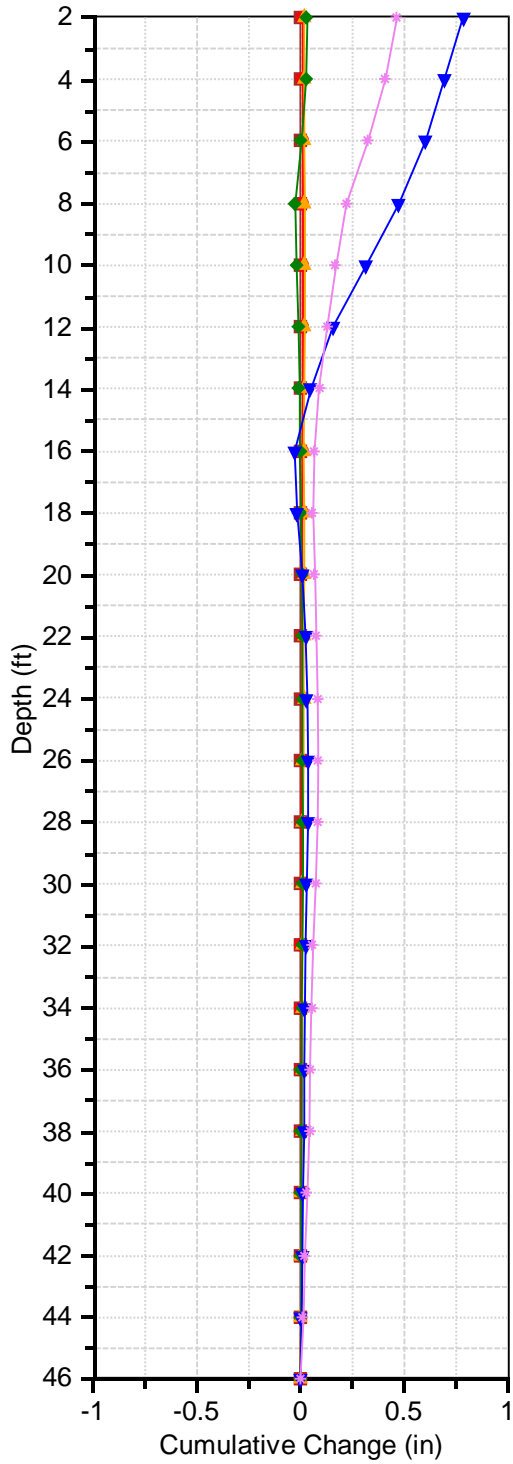
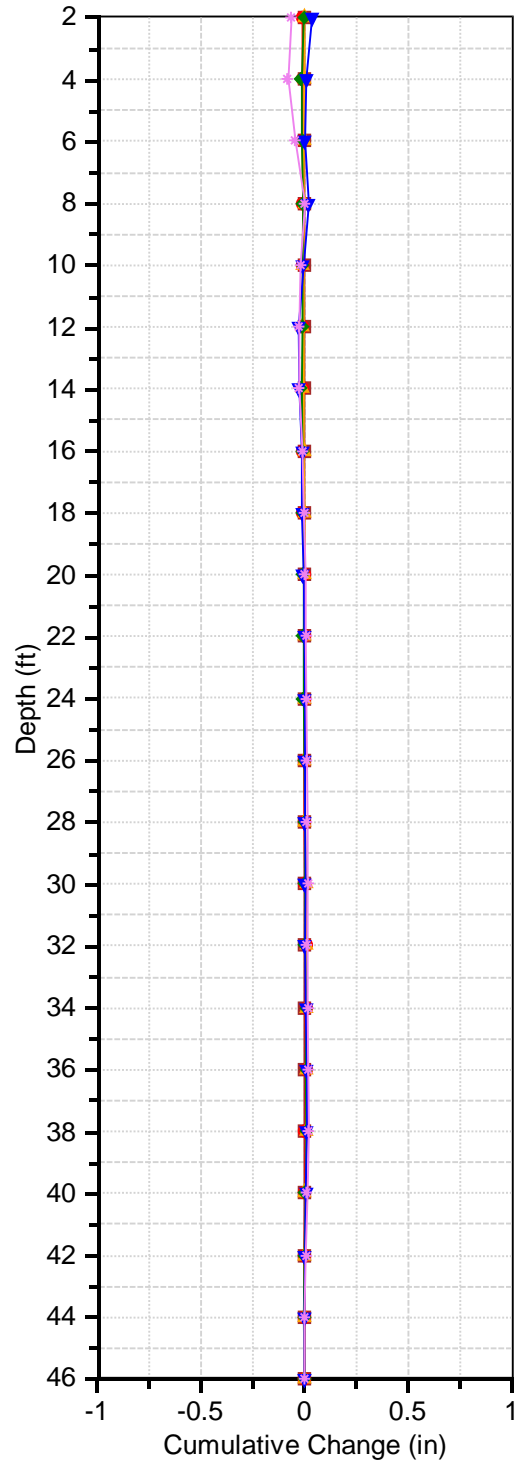
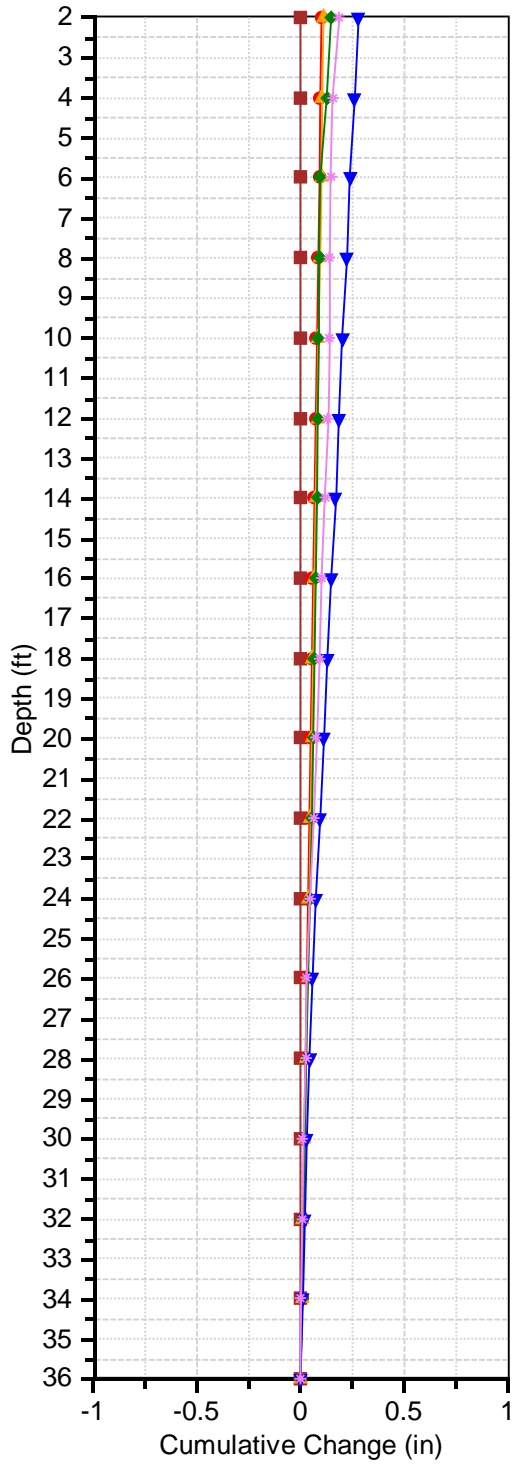
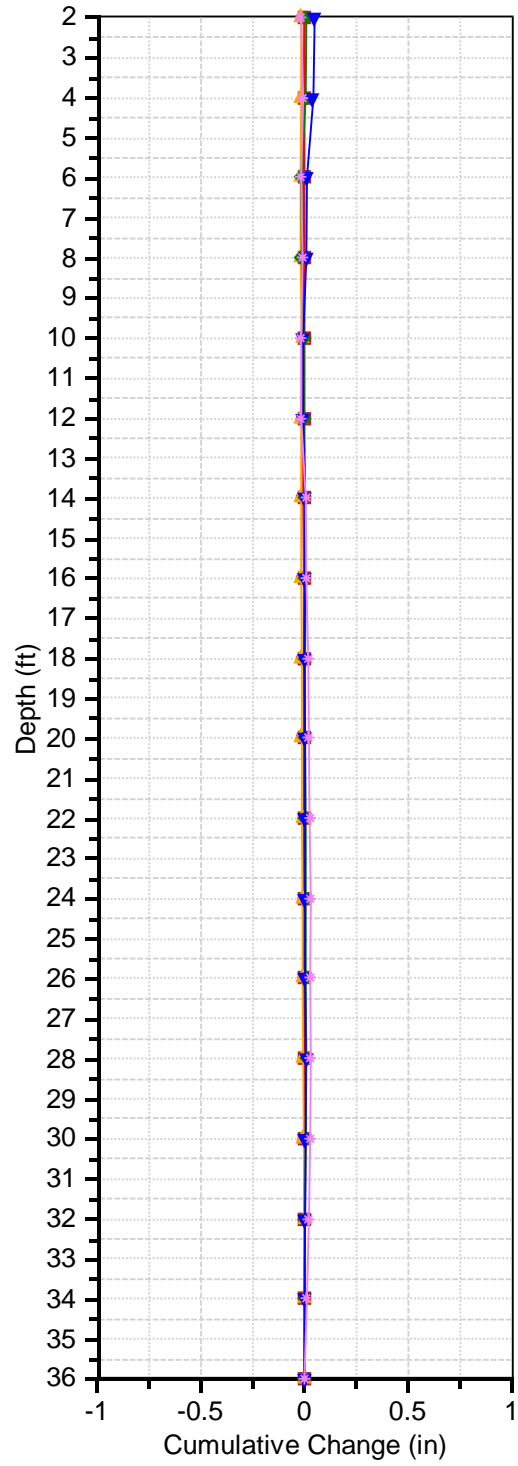
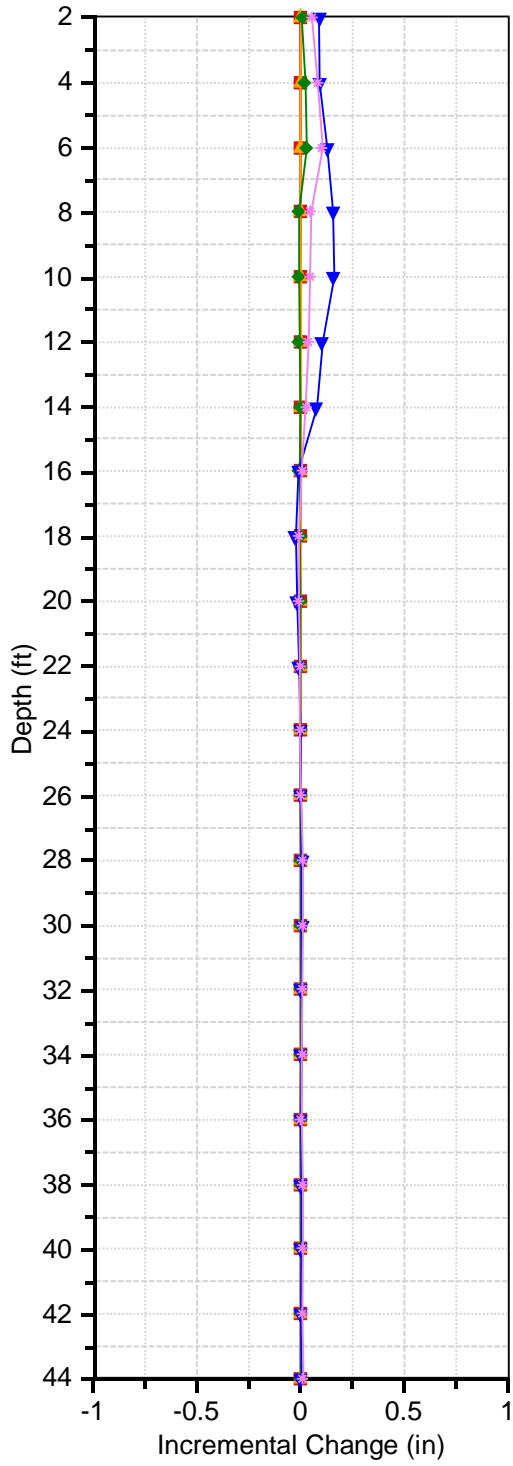
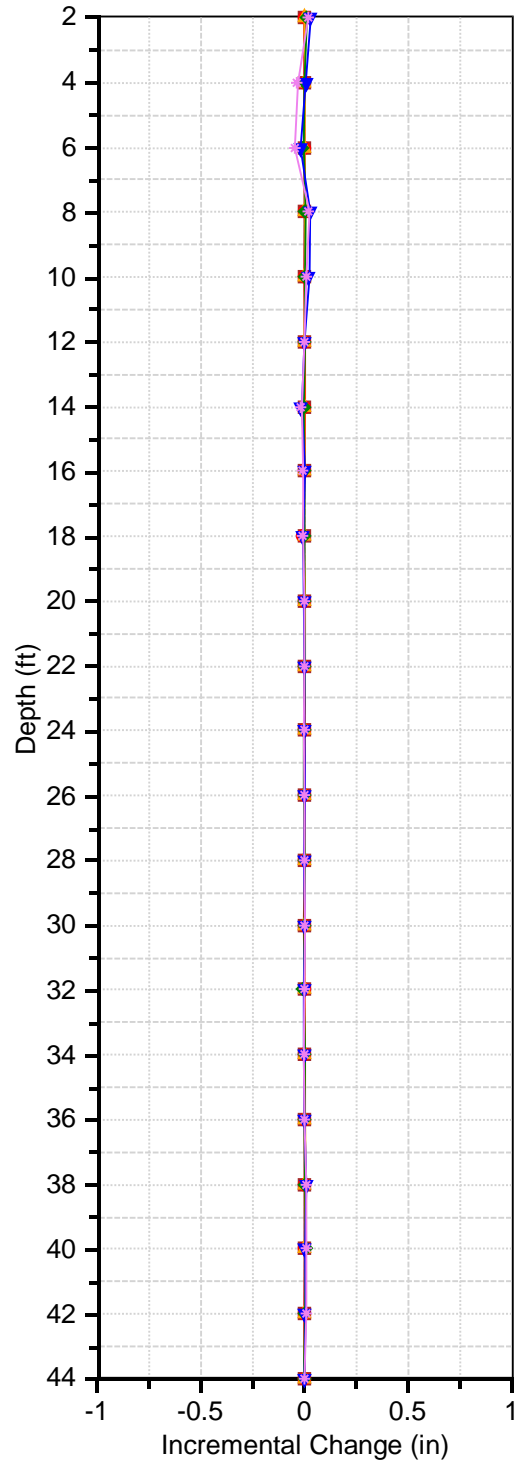
As previously mentioned in this report, The GHAD has an ongoing investigation in regard to AC cracking along Ashbourne Drive, which includes monitoring of two slope inclinometers installed between Ashbourne Drive and MSE Retaining Wall L2 (Figure 1). Test results of the inclinometer readings performed during this monitoring event are presented in Appendix B.
