Project No.
3586.002.022

April 20, 2023

Subject: Red Hawk Development
Danville, California

**GEOLOGIC HAZARD ABATEMENT DISTRICT MONITORING
SPRING 2023**

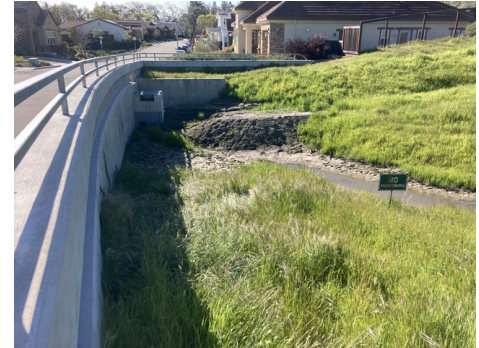
Site Condition: A
Observation Date: 04/04/2023
Description: Sediment accumulation adjacent to basin outlet structure.
Recommendation: Sediment should be removed during routine maintenance.
Field Representative: GH
