Project No.
3586.002.022

May 4, 2023

Subject: Elworthy Ranch
Danville, California

**GEOLOGIC HAZARD ABATEMENT DISTRICT MONITORING
SPRING 2023**

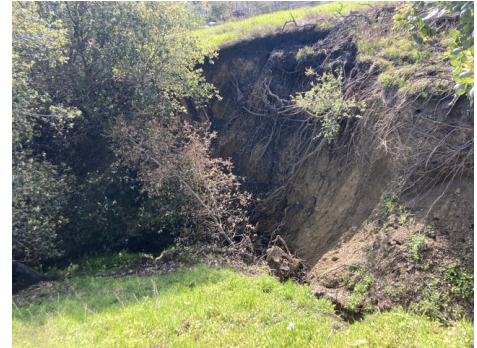
Site Condition: A.1
Observation Date: 04/05/2023
Description: Creek channel erosion.
Recommendation: Continue to monitor.
Field Representative: GH

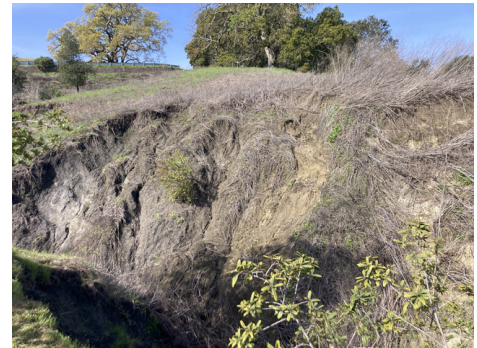
Site Condition: A.2
Observation Date: 04/05/2023
Description: Creek channel erosion.
Recommendation: Continue to monitor.
Field Representative: GH

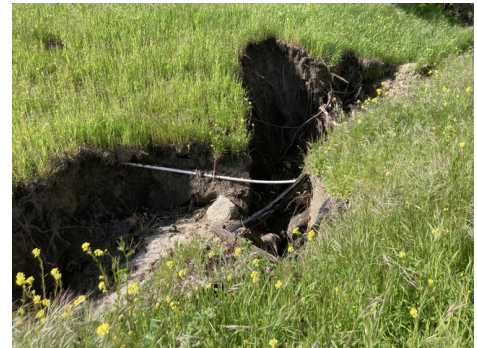
Site Condition: A.3
Observation Date: 04/05/2023
Description: Creek channel erosion.
Recommendation: Continue to monitor.
Field Representative: GH

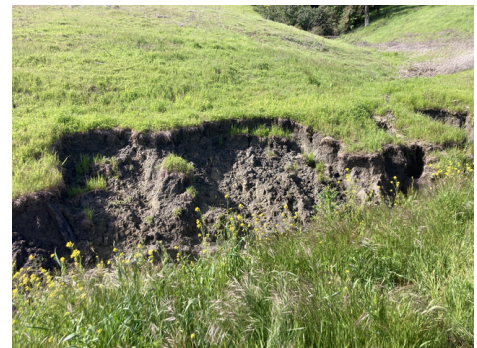
Site Condition: A.4
Observation Date: 04/05/2023
Description: Creek channel erosion.
Recommendation: Continue to monitor.
Field Representative: GH

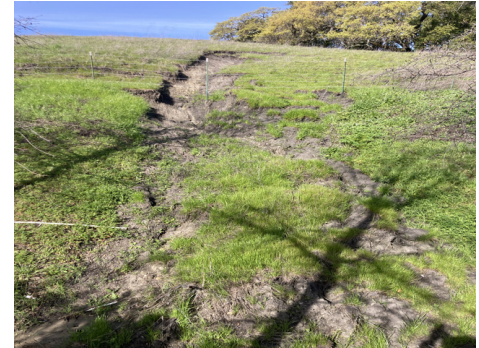
The common area and open-space slopes were observed for evidence of slope instability, including landslides, mudflows, erosion, diverted drainage, or standing water. In general, we observed the open space and slopes to be in a satisfactory condition. We noted in our fall 2022 monitoring an oversteepened condition with erosion exposing portions of creek channel side wall on Parcel P (Site Condition A.1, Appendix A, Figure 1). During this monitoring event, we observed that the condition remained relatively unchanged since our last site visit. We also observed significant erosion exposing creek channel side walls at other locations within Parcel P (Site Conditions A.2 through A.4, Appendix A, Figure 1) and shallow landslide/mudflows along slopes adjacent to creek channel (Site Conditions B.1 and B.2, Appendix A, Figure 1). The GHAD will continue to monitor and, if needed, mitigate these conditions to prevent the eroding soil from obstructing drainage at the outfall and creek channel.

Site Condition: B.1
Observation Date: 04/05/2023
Description: Shallow landslide/mudflow.
Recommendation: Continue to monitor.
Field Representative: GH

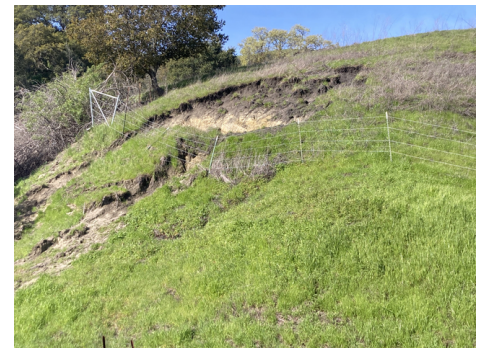
Site Condition: B.2
Observation Date: 04/05/2023
Description: Shallow landslide/mudflow.
Recommendation: Continue to monitor.
Field Representative: GH

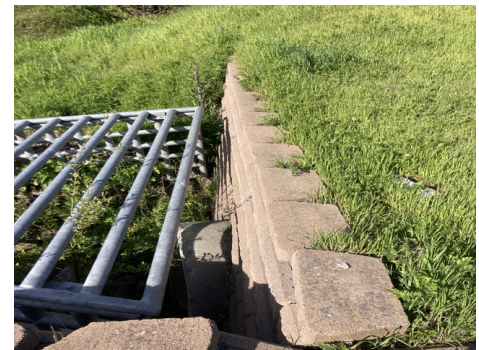
Retaining walls were inspected for significant cracking and damage. Since our fall 2020 monitoring, we have observed broken/distressed blocks on the MSE retaining wall next to the trash rack between Elworthy Ranch Circle and Elworthy Ranch Lane. During this monitoring event, we observed that the broken/distressed blocks remained unchanged since our last monitoring (Site Condition C, Appendix A, Figure 1). The GHAD will continue to monitor and, if needed, will repair or replace the blocks to maintain the integrity of the wall. Since our fall 2021 monitoring, we have observed that erosion between the MSE retaining wall and the concrete-lined drainage ditch at the southern end of Elworthy Ranch Circle created voids behind the wall and below the drainage ditch. During this monitoring, we noted that the erosion and voids remained the same since our last monitoring (Site Condition D, Appendix A, Figure 1). We will continue to monitor the condition of the slope and the stability of the wall and ditch during future monitoring.

Site Condition: C
Observation Date: 04/05/2023
Description: Distressed MSE retaining wall block.
Recommendation: Continue to monitor.
Field Representative: GH

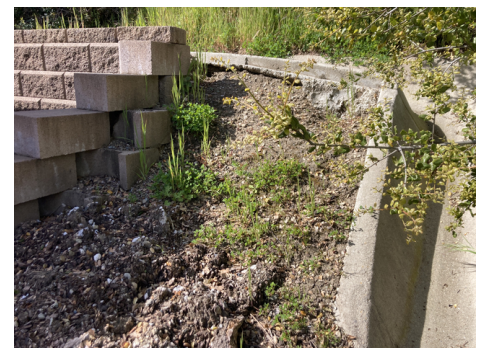
Site Condition: D
Observation Date: 04/05/2023
Description: Erosion behind MSE wall and below concrete-lined drainage ditch.
Recommendation: Continue to monitor.
Field Representative: GH
