Project No.  
**3586.002.022**

Subject: Henry Ranch  
San Ramon, California

**GEOLOGIC HAZARD ABATEMENT DISTRICT  
MONITORING – SPRING 2023**

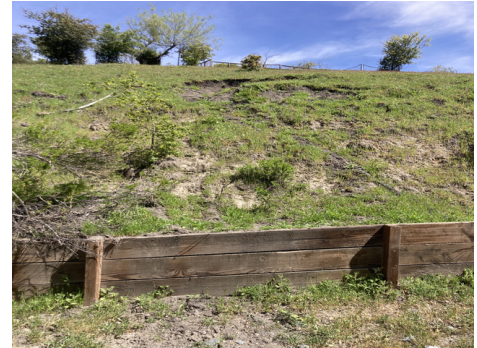
We previously noted that the slopes adjacent to the gravel-surfaced access road within the easement area were in an oversteepened condition and subject to shallow slope instability. Retaining walls and debris walls were constructed to protect the road from unstable materials from the uphill slope. During this monitoring event, we observed continued erosion on portions of the slope behind the debris walls (Site Conditions A.1 and A.2, Appendix A, Figure 1) and debris wall distress (Site Condition B, Appendix A, Figure 1). The GHAD will continue to monitoring the slope and wall conditions and remove, as needed, soil materials that collect behind the debris walls to maintain the catchment capacity.

Site Condition: A.1  
Observation Date: 04/21/2023  
Description: Oversteepened slope with erosion and sloughing on slope above debris wall.  
Recommendation: Continue to monitor.  
Field Representative: GH

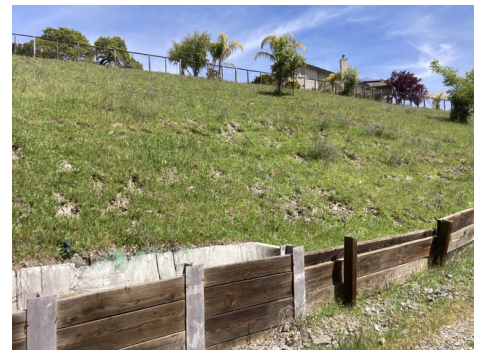
Site Condition: A.2  
Observation Date: 04/21/2023  
Description: Oversteepened slope with erosion and sloughing on slope above debris wall.  
Recommendation: Continue to monitor.  
Field Representative: GH

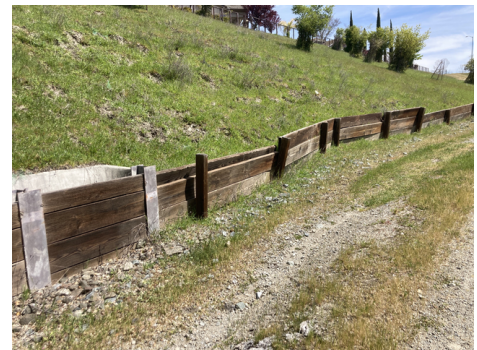
Site Condition: B  
Observation Date: 04/28/2023  
Description: Debris wall distress.  
Recommendation: Continue to monitor.  
Field Representative: GH

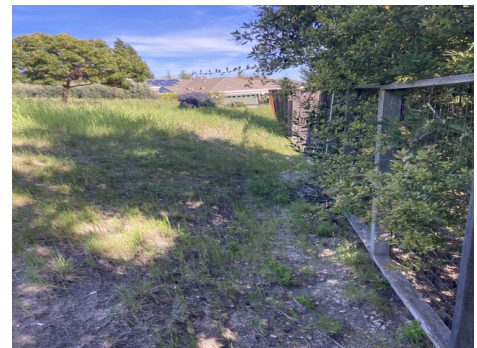
We noted in spring 2020 that the rear fence at 6025 Westside Drive was tilted in the downslope direction, which is an indication of soil creep. Fluctuations in moisture regimes of expansive soil may result in movement of soil related to shrinkage and swelling, which may result in adverse impact to overlying improvements. Soil creep involves the downslope movement of expansive soil due to wetting and drying of the soil. At the time of this site visit, the condition of the fence appeared to be in a similar condition as observed during our last monitoring event (Site Condition C, Appendix A, Figure 1). We observed the soil creep to be localized directly adjacent to and along the fence alignment and common area irrigation/sprinkler line. Fences are not a GHAD-maintained improvement. The GHAD will continue to monitor this condition.

Site Condition: C  
Observation Date: 04/21/2023  
Description: Tilted/leaning fence and localized soil creep due to irrigation.  
Recommendation: Continue to monitor.  
Field Representative: GH

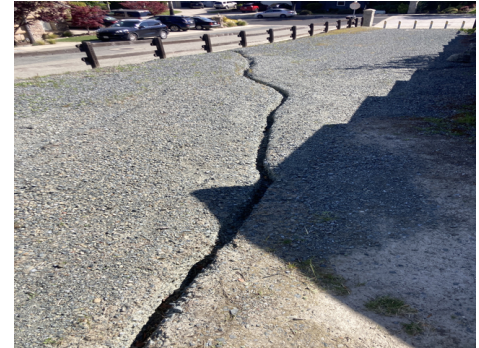
Site Condition: D.1  
Observation Date: 04/21/2023  
Description: Erosional rill within gravel maintenance road.  
Recommendation: Continue to monitor and backfill if vehicle access is impeded.  
Field Representative: GH

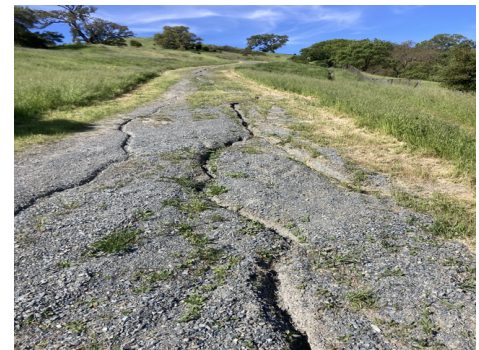
Site Condition: D.2  
Observation Date: 04/21/2023  
Description: Erosional rill within gravel maintenance road.  
Recommendation: Continue to monitor and backfill if vehicle access is impeded.  
Field Representative: GH

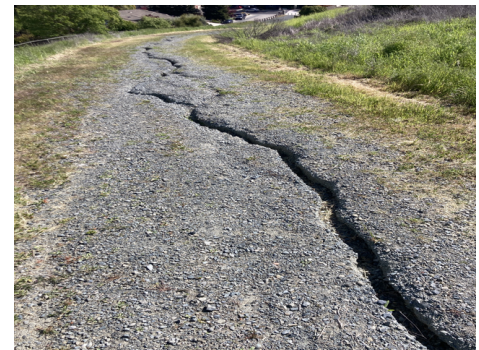
Site Condition: D.3  
Observation Date: 04/21/2023  
Description: Erosional rill within gravel maintenance road.  
Recommendation: Continue to monitor and backfill if vehicle access is impeded.  
Field Representative: GH

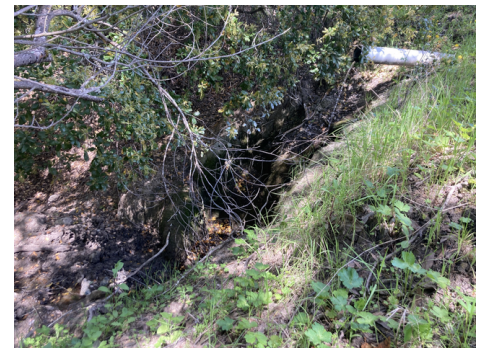
Site Condition: E  
Observation Date: 04/21/2023  
Description: Slope erosion below subdrain outlet.  
Recommendation: Continue to monitor.  
Field Representative: GH

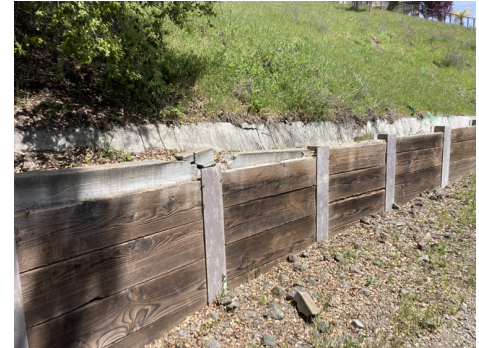
We did observe significant damage to the top of the concrete-lined drainage ditch within the easement area (Site Condition F, Appendix A, Figure 1). The damaged concrete will continue to be monitored and will be repaired, as needed, to allow for proper function of the drainage ditch.

Site Condition: F  
Observation Date: 04/21/2023  
Description: Damaged concrete-lined drainage ditch within Easement Area  
Recommendation: Continue to monitor.  
Field Representative: GH

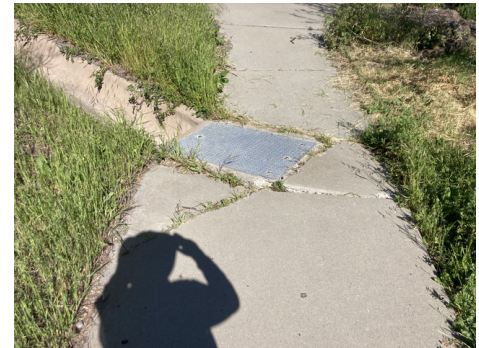
During our spring 2018 monitoring event, we noted some cracking was located around the storm drain inlet and sidewalk at the end of the concrete-lined drainage ditch located at the northern end of Lone Tree Lane. At the time of this monitoring event, the cracking did not appear to be impacting the drainage ditch or storm drain inlet (Site Condition G, Appendix A, Figure 1). The sidewalk, which is not a GHAD-maintained improvement, should be repaired to prevent a potential trip hazard.

Site Condition: G  
Observation Date: 04/21/2023  
Description: Offset/cracked sidewalk concrete.  
Recommendation: Continue to monitor.  
Field Representative: GH

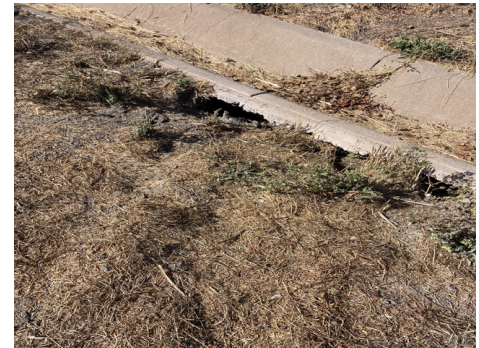
During our fall 2019 monitoring event, we noted that there is a significant void underneath a portion of drainage ditch at the north end of Lone Tree Lane (Site Condition H, Appendix A, Figure 1). During this monitoring event, we were not able to observe the condition of the void due to vegetation, but the drainage ditch did not appear to show significant distress. The GHAD will have the maintenance contractor backfill the void to prevent the void from continued enlargement. This area will continue to be monitored in future monitoring events.

Site Condition: H  
Observation Date: 04/28/2023  
Description: Void beneath concrete-lined drainage ditch.  
Recommendation: Backfill void.  
Field Representative: GH

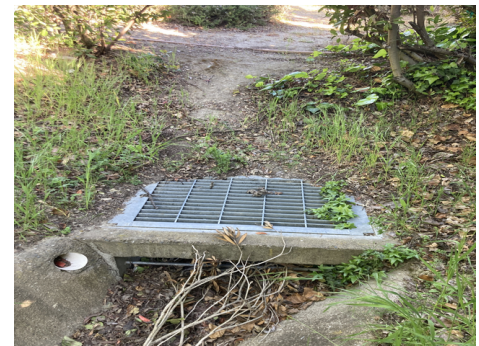
Storm drain inlets within the open space area of the GHAD appear to be in relatively good condition. Some storm drain inlets had accumulated sediment and overgrown vegetation in and around the inlets. During this monitoring event, we observed two drain inlets partially obstructed by vegetation at the north end of Parcel 211020032 (Site Conditions I.1 and I.2, Appendix A, Figure 1). As part of routine GHAD maintenance, the storm drain inlets will be cleared of vegetation.

Site Condition: I.1  
Observation Date: 04/21/2023  
Description: Drainage inlet partially obstructed by vegetation.  
Recommendation: Clean drainage inlet during routine maintenance.  
Field Representative: GH

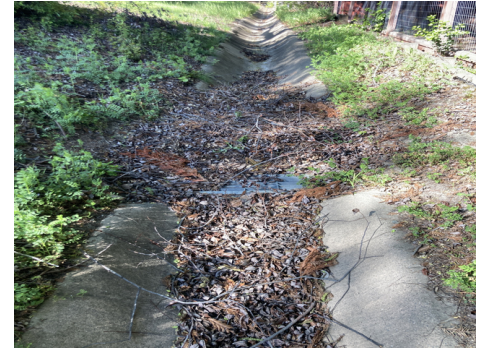
Site Condition: I.2  
Observation Date: 04/21/2023  
Description: Drainage inlet partially obstructed by vegetation.  
Recommendation: Clean drainage inlet during routine maintenance.  
Field Representative: GH
