Project No.
3586.002.023

October 5, 2023

Subject: Henry Ranch
San Ramon, California

**GEOLOGIC HAZARD ABATEMENT DISTRICT
MONITORING – FALL 2023**

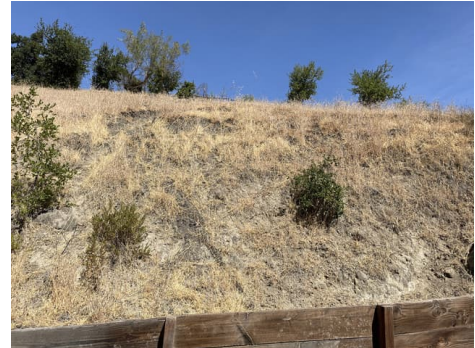
We previously noted that the slopes adjacent to the gravel-surfaced access road within the easement area were in an oversteepened condition and subject to shallow slope instability. Retaining walls and debris walls were constructed to protect the road from unstable materials from the uphill slope. During this monitoring event, we observed erosion on portions of the slope behind the debris walls (Site Conditions A.1 and A.2, Appendix A, Figure 1) that appeared to be unchanged from our last monitoring event. We also observed debris wall distress (Site Condition B, Appendix B, Figure 1). The GHAD will continue to monitoring the slope and wall conditions and remove, as needed, soil materials that collect behind the debris walls to maintain the catchment capacity.

Site Condition: A.1
Observation Date: 09/25/2023
Description: Oversteepened slope with erosion and sloughing on slope above debris wall.
Recommendation: Continue to monitor.
Field Representative: GH

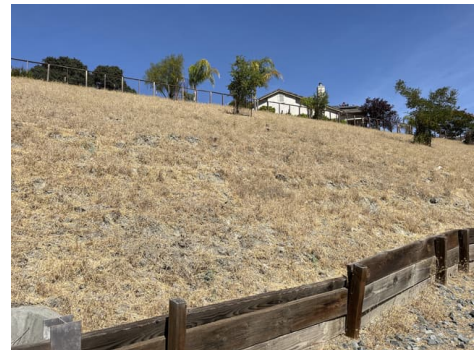
Site Condition: A.2
Observation Date: 09/25/2023
Description: Oversteepened slope with erosion and sloughing on slope above debris wall.
Recommendation: Continue to monitor.
Field Representative: GH

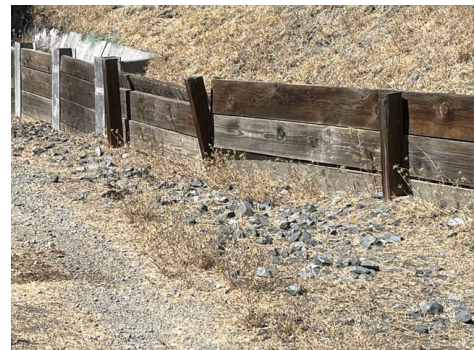
Site Condition: B
Observation Date: 09/25/2023
Description: Debris wall distress.
Recommendation: Continue to monitor.
Field Representative: GH

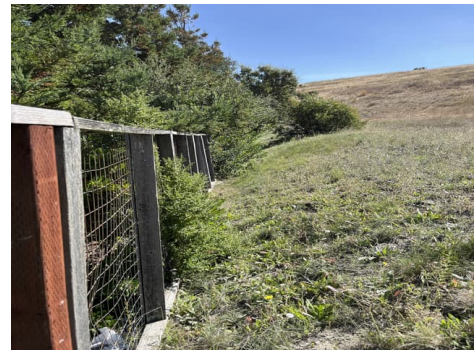
We noted in spring 2020 that the rear fence at 6025 Westside Drive was tilted in the downslope direction, which is an indication of soil creep. Fluctuations in moisture regimes of expansive soil may result in movement of soil related to shrinkage and swelling, which may result in adverse impact to overlying improvements. Soil creep involves the downslope movement of expansive soil due to wetting and drying of the soil. At the time of this site visit, the condition of the fence appeared to be in a similar condition as observed during our last monitoring event (Site Condition C, Appendix A, Figure 1). We observed the soil creep to be localized directly adjacent to and along the fence alignment and common area irrigation/sprinkler line. Fences are not a GHAD-maintained improvement. The GHAD will continue to monitor this condition.

Site Condition: C
Observation Date: 09/25/2023
Description: Tilted/leaning fence and localized soil creep due to irrigation.
Recommendation: Continue to monitor.
Field Representative: GH

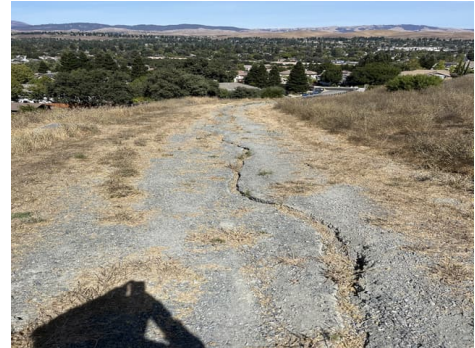
Site Condition: D.1
Observation Date: 09/25/2023
Description: Erosional rill within gravel maintenance road.
Recommendation: Continue to monitor and backfill if vehicle access is impeded.
Field Representative: GH

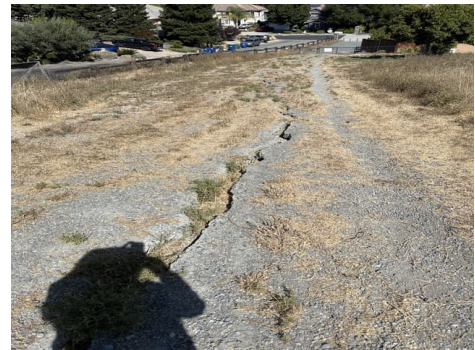
Site Condition: D.2
Observation Date: 09/25/2023
Description: Erosional rill within gravel maintenance road.
Recommendation: Continue to monitor and backfill if vehicle access is impeded.
Field Representative: GH

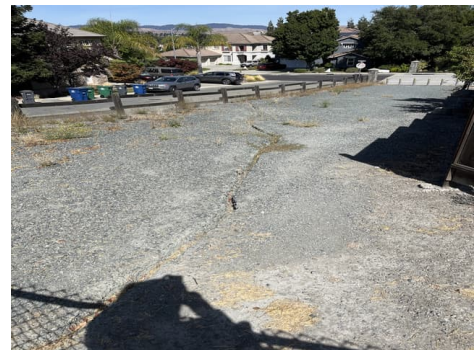
Site Condition: D.3
Observation Date: 09/25/2023
Description: Erosional rill within gravel maintenance road.
Recommendation: Continue to monitor and backfill if vehicle access is impeded.
Field Representative: GH

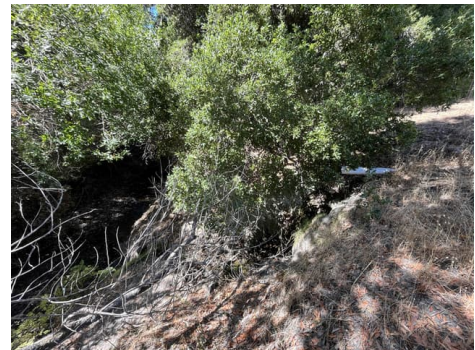
Site Condition: E
Observation Date: 09/25/2023
Description: Slope erosion below subdrain outlet.
Recommendation: Continue to monitor.
Field Representative: GH

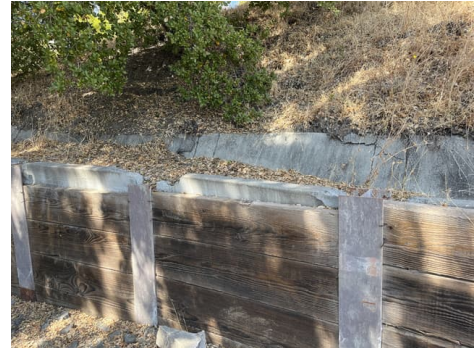
As noted in our previous monitoring reports, we observed significant damage to the top of the concrete-lined drainage ditch within the easement area (Site Condition F, Appendix A, Figure 1). The damaged concrete appeared to be unchanged from our last monitoring event. The drainage ditch will continue to be monitored and will be repaired, as needed, to allow for proper function of the drainage ditch.

Site Condition: F
Observation Date: 09/25/2023
Description: Damaged concrete-lined drainage ditch within Easement Area
Recommendation: Continue to monitor.
Field Representative: GH

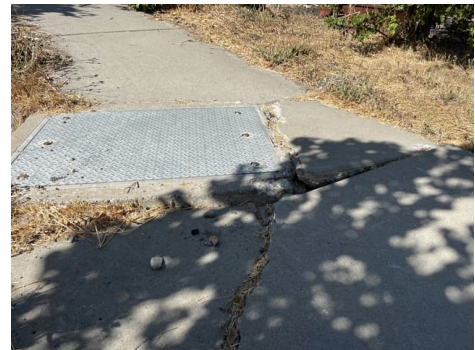
During our spring 2018 monitoring event, we noted some cracking was located around the storm drain inlet and sidewalk at the end of the concrete-lined drainage ditch located at the northern end of Lone Tree Lane. At the time of this monitoring event, the cracking did not appear to be impacting the drainage ditch or storm drain inlet (Site Condition G, Appendix A, Figure 1). The sidewalk, which is not a GHAD-maintained improvement, should be repaired to prevent a potential trip hazard.

Site Condition: G
Observation Date: 09/25/2023
Description: Offset/cracked sidewalk concrete.
Recommendation: Continue to monitor.
Field Representative: GH

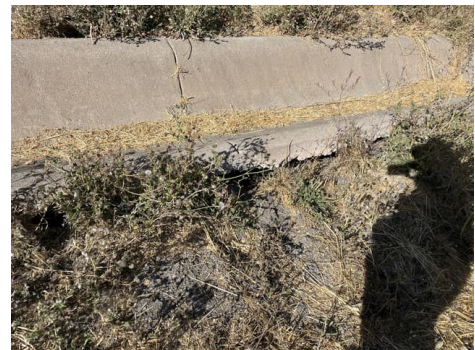
During our fall 2019 monitoring event, we noted that there is a significant void underneath a portion of drainage ditch at the northern end of Lone Tree Lane (Site Condition H, Appendix A, Figure 1). During this monitoring event, we were able to observe the condition of the void to be unchanged, and the drainage ditch did not appear to show significant distress. The GHAD will have the maintenance contractor backfill the void to prevent the void from continued enlargement. This area will continue to be monitored in future monitoring events.

Site Condition: H
Observation Date: 09/25/2023
Description: Void beneath concrete-lined drainage ditch.
Recommendation: Backfill void.
Field Representative: GH
