Project No.  
**3586.002.023**

Subject: Elworthy Ranch  
Danville, California

**GEOLOGIC HAZARD ABATEMENT DISTRICT  
MONITORING - FALL 2023**

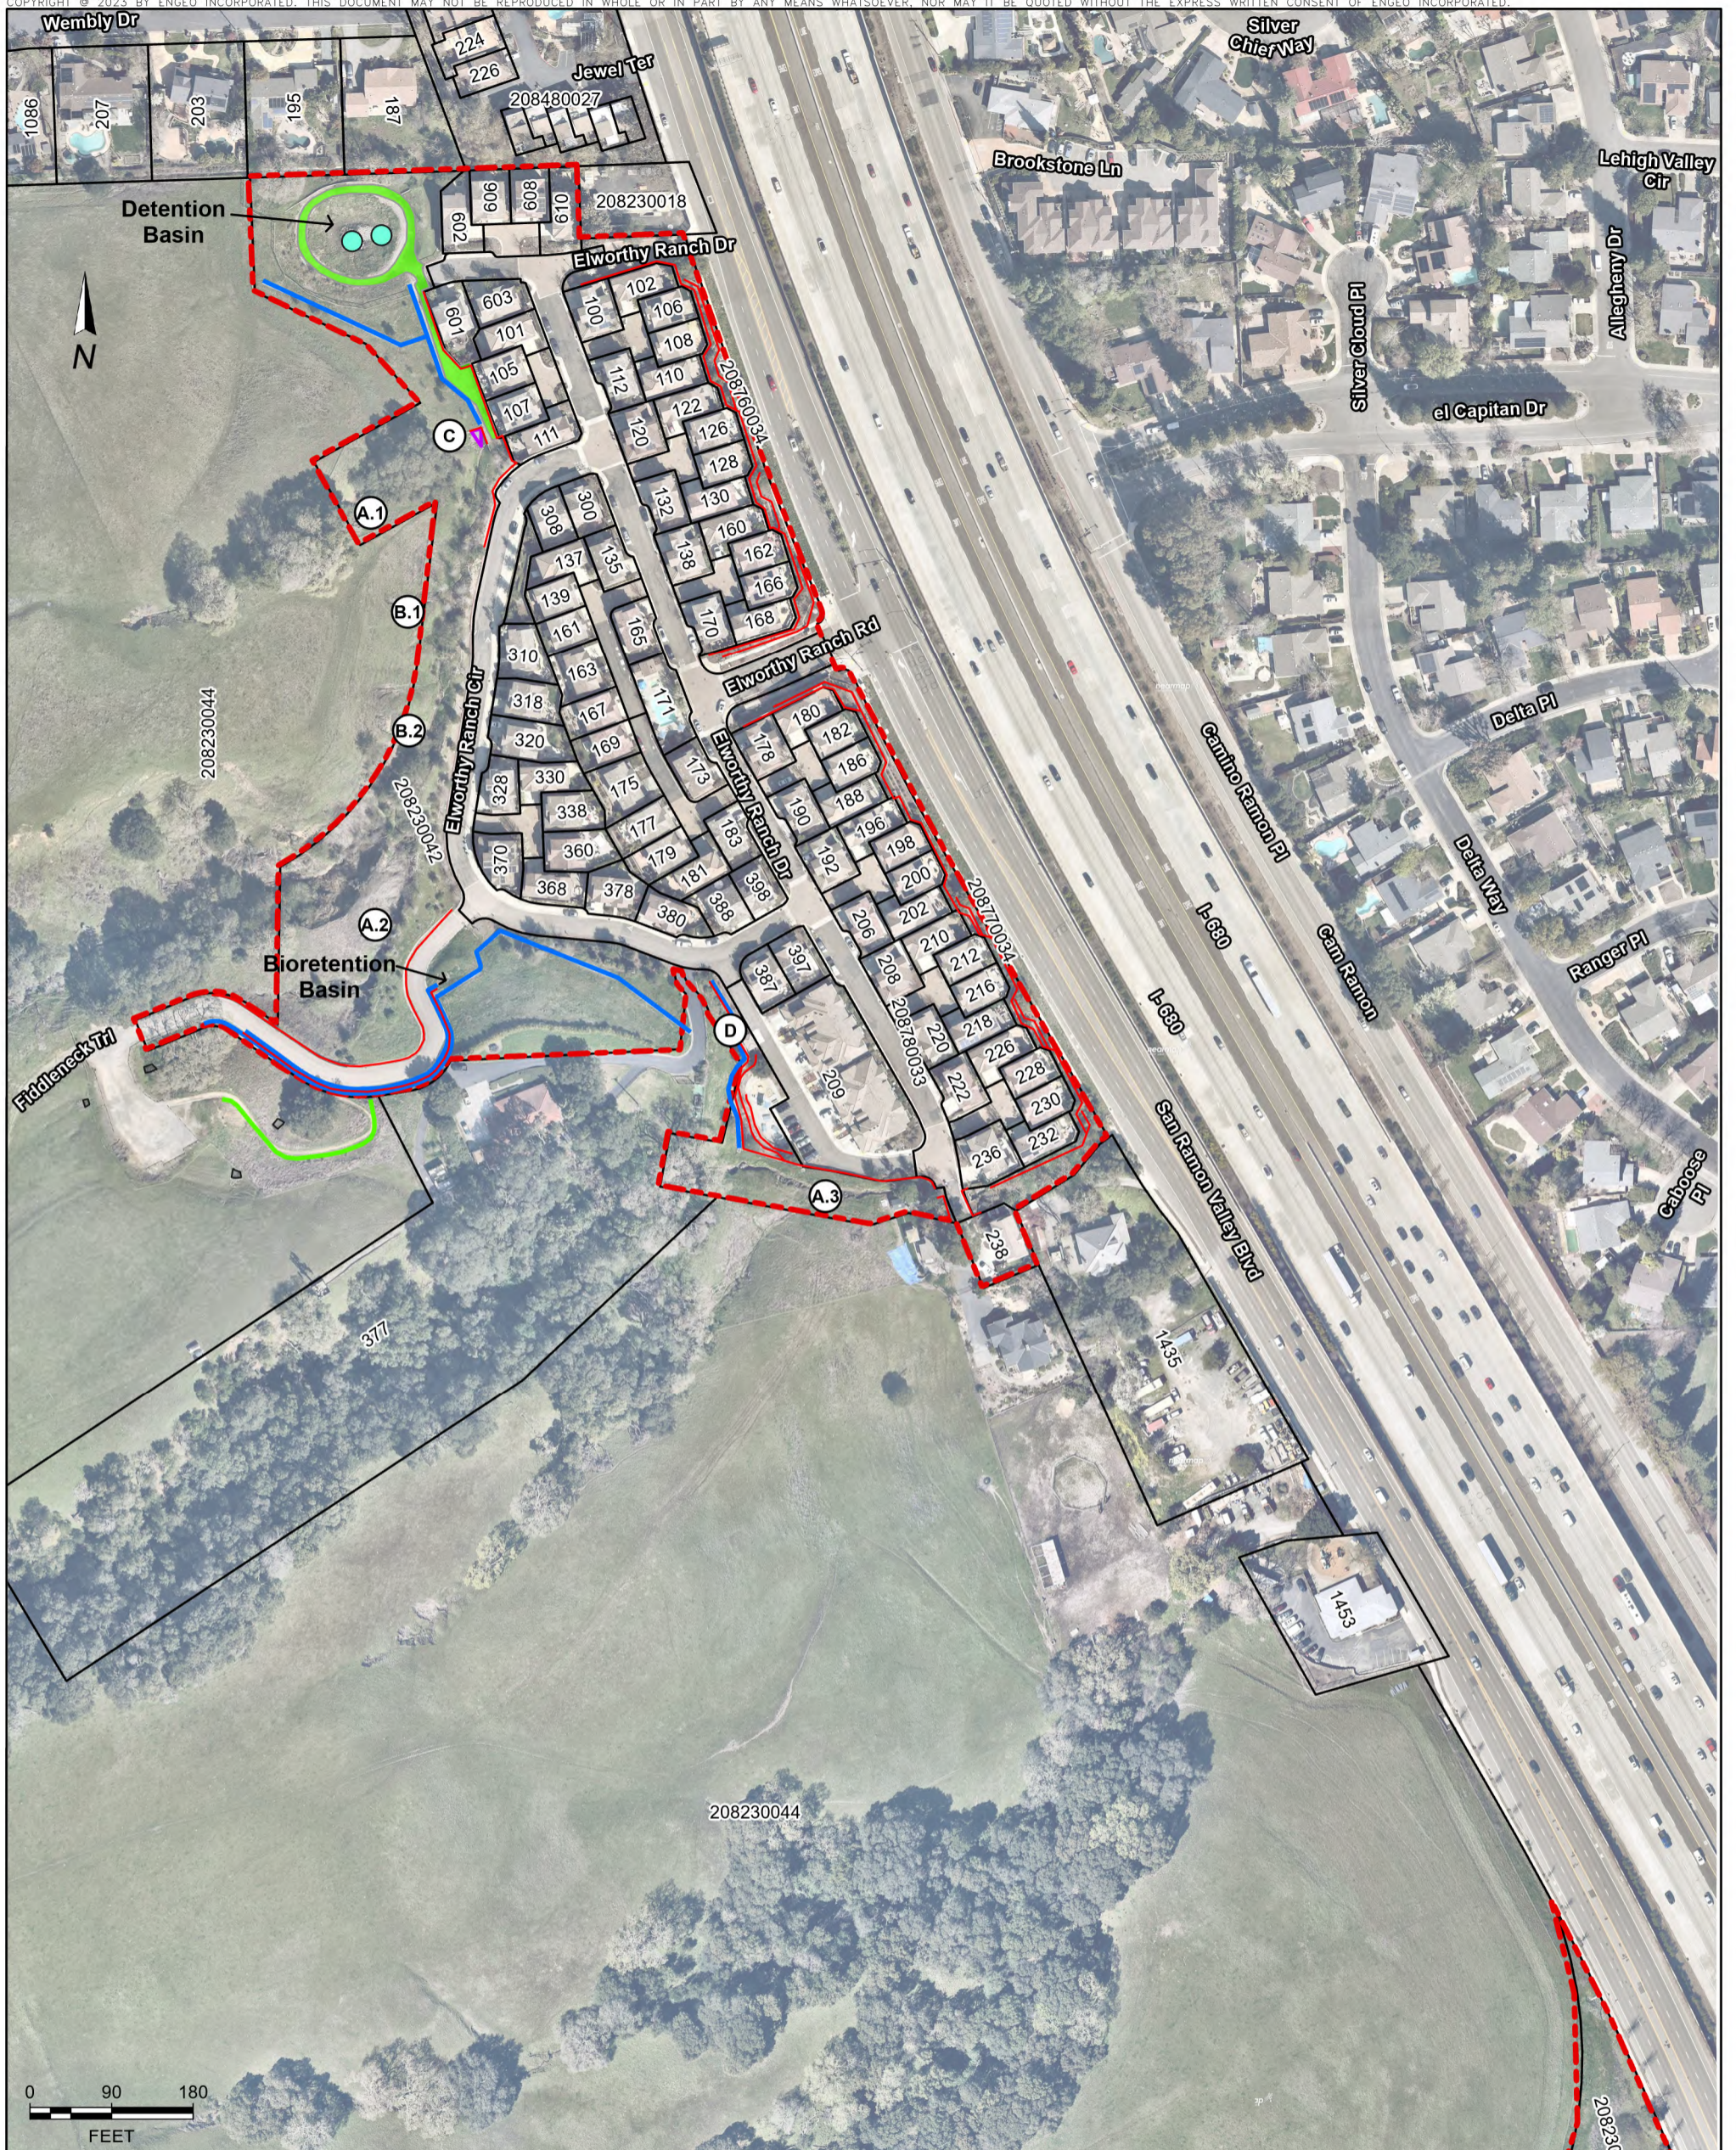
**Figure 1 – Site Plan**

A detention basin (Figure 1) is located at the end of Elworthy Ranch Lane. Monitoring of the detention basin was conducted as part of the Open Space monitoring. The observed conditions for the detention basin are described in the attached Elworthy Ranch Detention Basin Site Monitoring and Maintenance Form. Contracted ongoing routine maintenance within the water quality/detention basin currently includes roadway maintenance, weed abatement, and woody vegetation removal. At the time of our visit, the detention basin appeared to be functioning properly and was in good condition.

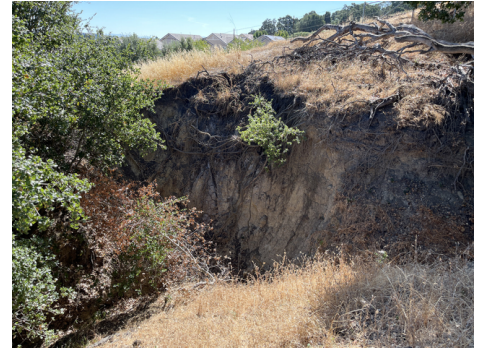
Site Condition: A.1  
Observation Date: 09/28/2023  
Description: Creek channel erosion.  
Recommendation: Continue to monitor.  
Field Representative: GH

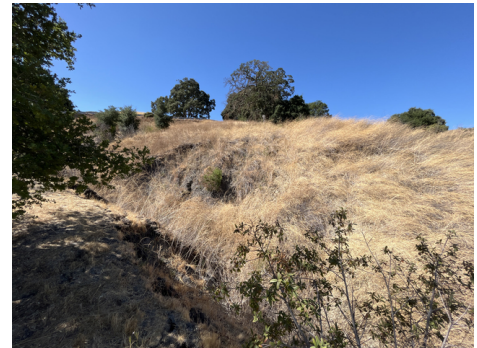
Site Condition: A.2  
Observation Date: 09/28/2023  
Description: Creek channel erosion.  
Recommendation: Continue to monitor.  
Field Representative: GH

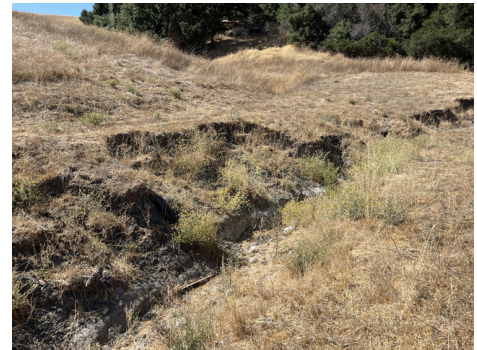
Site Condition: A.3  
Observation Date: 09/28/2023  
Description: Creek channel erosion.  
Recommendation: Continue to monitor.  
Field Representative: GH

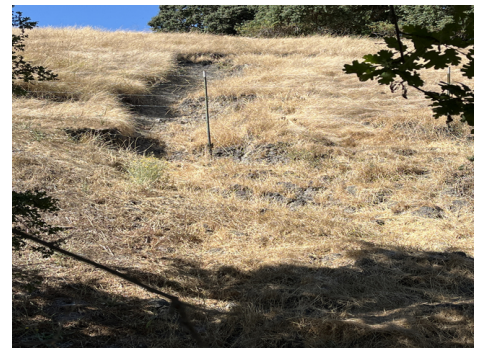
Site Condition: B.1  
Observation Date: 09/28/2023  
Description: Shallow landslide/mudflow.  
Recommendation: Continue to monitor.  
Field Representative: GH

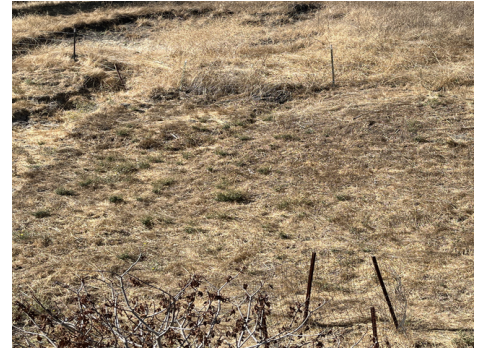
Site Condition: B.2  
Observation Date: 09/28/2023  
Description: Shallow landslide/mudflow.  
Recommendation: Continue to monitor.  
Field Representative: GH

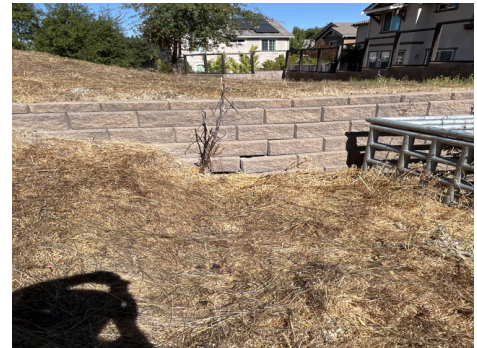
Retaining walls were inspected for significant cracking and damage. Since our fall 2020 monitoring, we have observed broken/distressed blocks on the MSE retaining wall next to the trash rack between Elworthy Ranch Circle and Elworthy Ranch Lane. During this monitoring event, we observed that the broken/distressed blocks remained unchanged since our last monitoring (Site Condition C, Appendix A, Figure 1). The GHAD will continue to monitor and, if needed, will repair or replace the blocks to maintain the integrity of the wall. Since our fall 2021 monitoring, we have observed that erosion between the MSE retaining wall and the concrete-lined drainage ditch at the southern end of Elworthy Ranch Circle created voids behind the wall and below the drainage ditch. During this monitoring, we noted that the erosion and voids remained the same since our last monitoring (Site Condition D, Appendix A, Figure 1). We will continue to monitor the condition of the slope and the stability of the wall and ditch during future monitoring.

Site Condition: C  
Observation Date: 09/28/2023  
Description: Distressed MSE retaining wall block.  
Recommendation: Continue to monitor.  
Field Representative: GH

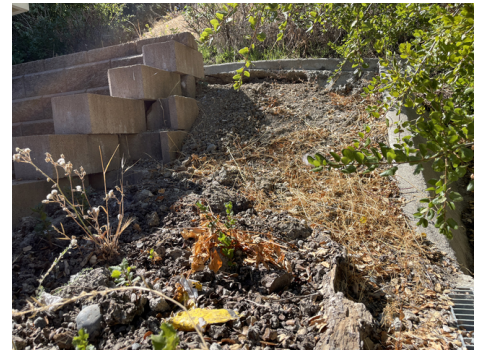
Site Condition: D  
Observation Date: 09/28/2023  
Description: Erosion behind MSE wall and below concrete-lined drainage ditch.  
Recommendation: Continue to monitor.  
Field Representative: GH
