Project No.  
**3586.002.023**

October 12, 2023

Subject: Red Hawk Development  
 Danville, California

**GEOLOGIC HAZARD ABATEMENT DISTRICT  
 MONITORING – FALL 2023**

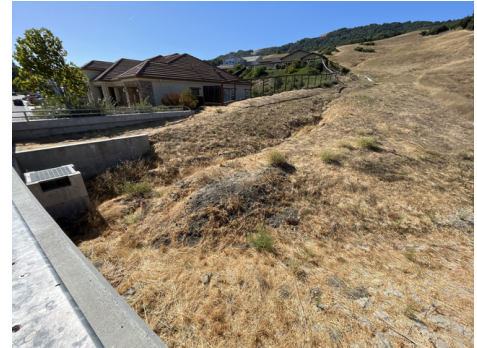
A detention basin (Figure 1) is located at the end of Red Tail Court. Monitoring of the detention basin was conducted as part of the open-space monitoring. The observed conditions for the detention basin are described in the attached Red Hawk Development Detention Basin Site Monitoring and Maintenance Form. Contracted ongoing routine maintenance within the detention basin currently includes roadway maintenance, weed abatement, and woody vegetation removal. At the time of our visit, the detention basin appeared to be functioning properly and was in good condition. We observe significant accumulation of sediment adjacent to the basin outlet structure (Site Condition A, Appendix A, Figure 1). The excess sediment will be removed by the GHAD during routine maintenance.

Site Condition: A  
Observation Date: 09/28/2023  
Description: Sediment accumulation adjacent to basin outlet structure.  
Recommendation: Sediment should be removed during routine maintenance.  
Field Representative: GH
