Project No.
3586.002.023

Subject: Norris Canyon Estates
Contra Costa County, California

**GEOLOGIC HAZARD ABATEMENT DISTRICT
MONITORING – FALL 2023**

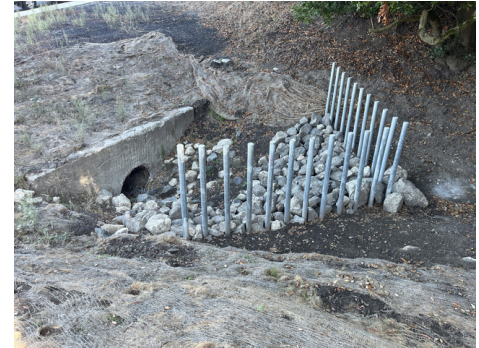
Site Condition: A
Observation Date: 10/26/2023
Description: Damaged trash rack. Trash rack replaced.
Recommendation: None
Field Representative: GH

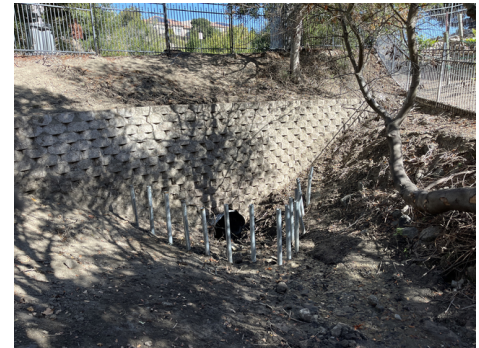
During the winter of 2022-2023, the culvert inlets at 2380 Ashbourne Drive and 3221 Ashbourne Circle were obstructed by debris. Woody vegetation became lodged within the culvert adjacent to 3221 Ashbourne Circle and damaged the trash rack upstream of the culvert. We observed during this monitoring event that the woody vegetation had been removed from the culvert pipe and the trash rack had been reconstructed (Site Condition A, Appendix A, Figure 2). We also observed that the culvert at 2380 Ashbourne Drive had been cleared of sediment and debris and a trash rack had been installed upstream of the culvert (Site Condition B, Appendix A, Figure 2).

Site Condition: B
Observation Date: 10/26/2023
Description: Culvert pipe obstructed by sediment and vegetation. Sediment and vegetation removal completed and trash rack installed.
Recommendation: Continue to monitor.
Field Representative: GH

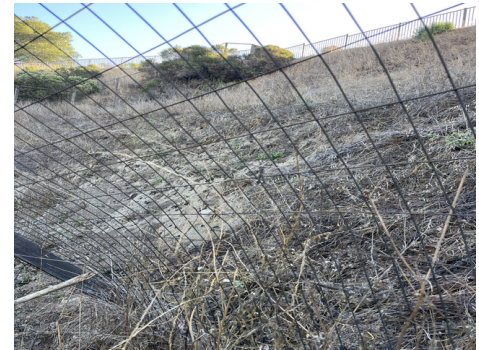
Site Condition: C
Observation Date: 10/26/2023
Description: Surficial mudslide along 1:1 slope.
Recommendation: Continue to monitor.
Field Representative: GH

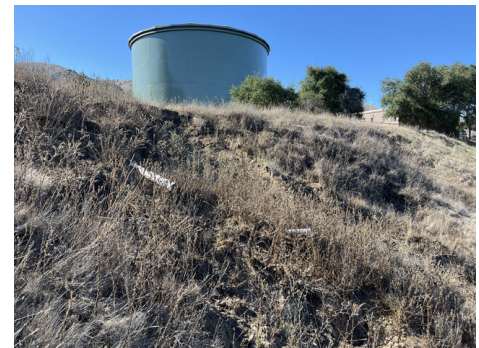
- Shallow earthflow northeast of Bishop Tank Site pad measuring 18 feet wide by 25 feet long with an estimated depth of 1 to 2 feet. Condition unchanged (Site Condition D.1, Appendix A, Figure 1).

Site Condition: D.1
Observation Date: 10/26/2023
Description: Shallow earthflow (18 feet wide by 25 feet long with an estimated depth of 1 to 2 feet).
Recommendation: Continue to monitor.
Field Representative: GH

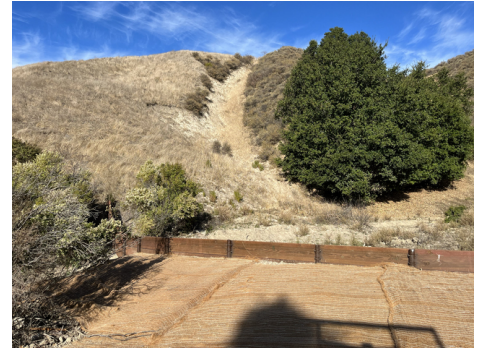
- Shallow earthflow northwest of 3581 Ashbourne Circle rear yard (west) measuring 10 to 15 feet wide by 185 feet long with an estimated depth of 1 to 5 feet. Condition unchanged. Debris wall constructed within open space below earthflow and adjacent to homeowner property (Site Condition D.2, Appendix A, Figure 1).

Site Condition: D.2
Observation Date: 10/27/2023
Description: Shallow earthflow (10 to 15 feet wide by 185 feet long with an estimated depth of 1 to 2 feet). Debris wall constructed below earthflow.
Recommendation: Continue to monitor.
Field Representative: GH

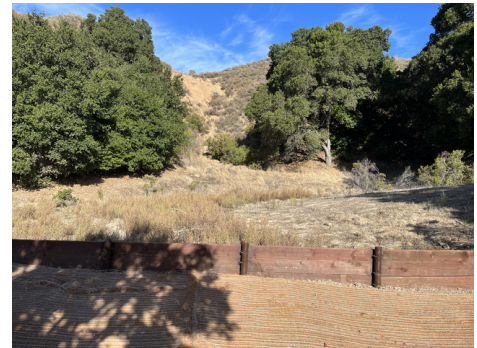
- Shallow earthflow northwest of 3581 Ashbourne Circle rear yard (east) measuring 40 feet wide by 150 feet long with an estimated depth of 2 to 3 feet. Condition unchanged. Debris wall constructed within open space below earthflow and adjacent to homeowner property (Site Condition D.3, Appendix A, Figure 1).

Site Condition: D.3
Observation Date: 10/27/2023
Description: Shallow earthflow (40 feet wide by 150 feet long with an estimated depth of 2 to 3 feet). Debris wall constructed below earthflow.
Recommendation: Continue to monitor.
Field Representative: GH

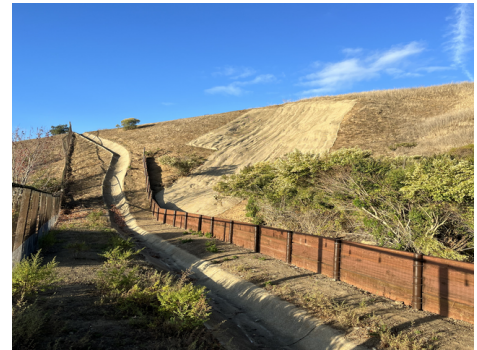
- Shallow earthflow northwest of 3551 Ashbourne Circle rear yard measuring 10 to 30 feet wide by 75 feet long with an estimated depth of 3 to 4 feet. Erosion control mitigation installed on affected slope. Debris wall constructed within open space below earthflow and adjacent to homeowner property (Site Condition D.4, Appendix A, Figure 1).

Site Condition: D.4
Observation Date: 10/27/2023
Description: Shallow earthflow (10 to 30 feet wide by 75 feet long with an estimated depth of 3 to 4 feet). Earth flow mitigation installed and debris wall constructed below earthflow.
Recommendation: Continue to monitor.
Field Representative: GH

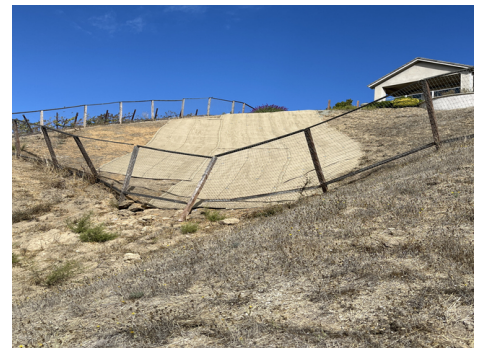
- Shallow earthflow within the natural rear slope of 547 Wycombe Court measuring 10 to 15 feet wide by 60 feet long with an estimated depth of 2 to 3 feet. Erosion control mitigation installed on affected slope (Site Condition D.5, Appendix A, Figure 2).

Site Condition: D.5
Observation Date: 10/27/2023
Description: Shallow earthflow (10 to 15 feet wide by 60 feet long with an estimated depth of 2 to 3 feet). Earthflow mitigation installed.
Recommendation: Continue to monitor.
Field Representative: GH

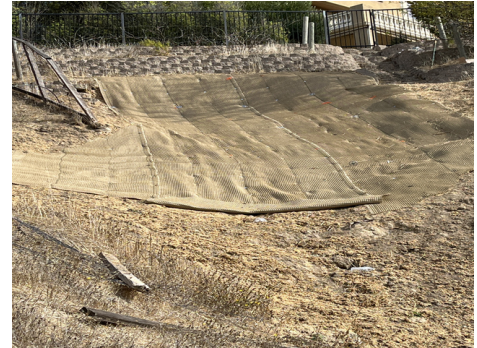
- Shallow earthflow within the natural rear slope of 539 Wycombe Court measuring 10 feet wide by 25 feet long with an estimated depth of 1 to 2 feet. Erosion control mitigation installed on affected slope (Site Condition D.6, Appendix A, Figure 2).

Site Condition: D.6
Observation Date: 10/27/2023
Description: Shallow earthflow (10 feet wide by 25 feet long with an estimated depth of 1 to 2 feet). Earthflow mitigation installed.
Recommendation: Continue to monitor.
Field Representative: GH

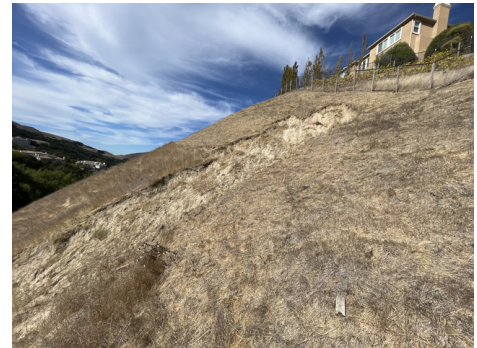
- Shallow earthflow southwest of 539 Wycombe Court rear yard measuring 10 to 15 feet wide by 185 feet long with an estimated depth of 1 to 5 feet. Condition unchanged (Site Condition D.7, Appendix A, Figure 2).

Site Condition: D.7
Observation Date: 10/27/2023
Description: Shallow earthflow (25 feet wide by 35 feet long with an estimated depth of 2 to 3 feet).
Recommendation: Continue to monitor.
Field Representative: GH

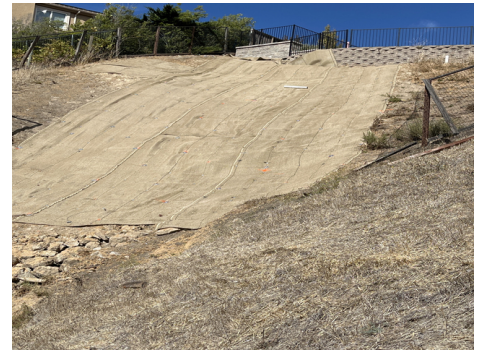
- Shallow earthflow within the natural rear slope of 533 Wycombe Court measuring 15 to 20 feet wide by 60 feet long with an estimated depth of 12 to 4 feet. Erosion control mitigation installed on affected slope (Site Condition D.8, Appendix A, Figure 2).

Site Condition: D.8
Observation Date: 10/27/2023
Description: Shallow earthflow (15-20 feet wide by 60 feet long with an estimated depth of 2 to 4 feet). Earthflow mitigation installed.
Recommendation: Continue to monitor.
Field Representative: GH

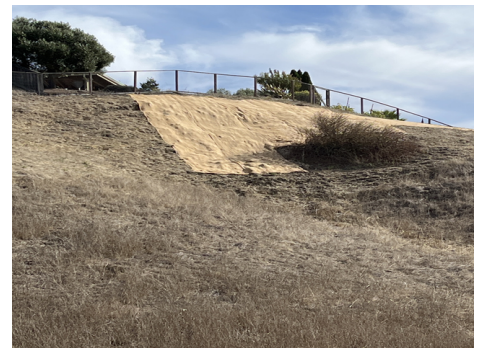
- Shallow earthflow west of 3340 Ashbourne Circle rear yard measuring 15 feet wide by 20 feet long with an estimated depth of 2 to 3 feet. Slope repair was completed and erosion control installed on affected slope (Site Condition D.9, Appendix A, Figure 2).

Site Condition: D.9
Observation Date: 10/27/2023
Description: Shallow earthflow (15 feet wide by 20 feet long with an estimated depth of 2 to 3 feet). Slope repair completed.
Recommendation: Continue to monitor.
Field Representative: GH

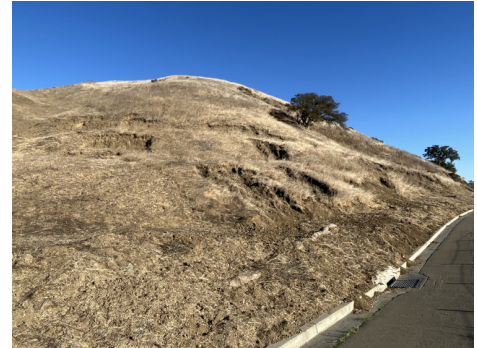
Site Condition: D.10
Observation Date: 10/27/2023
Description: Multiple shallow earthflows along northwest side of EVA Road.
Recommendation: Continue to monitor.
Field Representative: GH

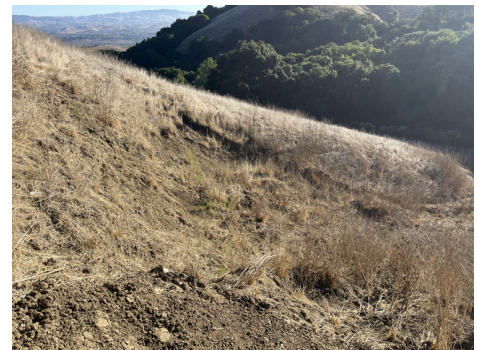
Site Condition: D.11
Observation Date: 10/27/2023
Description: Shallow earthflow (50 to 60 feet wide by 40 feet long with an estimated depth of 2 to 3 feet).
Recommendation: Continue to monitor.
Field Representative: GH

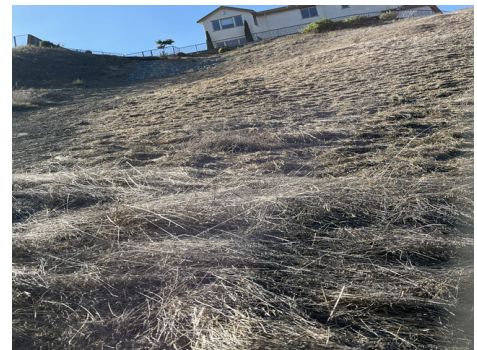
- Shallow earthflow within the natural rear slope of 231 Cliffecastle Court measuring 15 wide by 30 feet long with an estimated depth of 4 to 5 feet. Slope repair completed (Site Condition D.12, Appendix A, Figure 2).

Site Condition: D.12
Observation Date: 10/26/2023
Description: Shallow earthflow (15 feet wide by 30 feet long with an estimated depth of 4 to 5 feet). Slope repair completed.
Recommendation: Continue to monitor.
Field Representative: GH

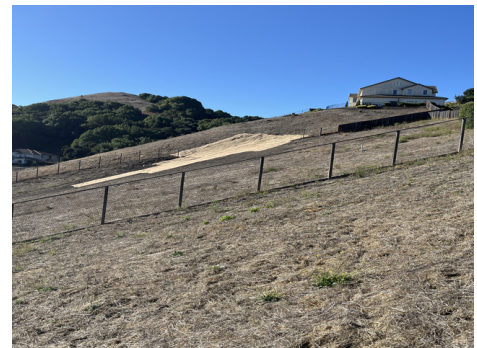
- Shallow earthflow within the natural rear slope of 223 and 231 Cliffecastle Court measuring 15 feet wide by 30 to 40 feet long with an estimated depth of 2 to 3 feet. Slope repair completed. (Site Condition D.13, Appendix A, Figure 2).

Site Condition: D.13
Observation Date: 10/26/2023
Description: Shallow earthflow (15 feet wide by 30 to 40 feet long with an estimated depth of 2 to 3 feet). Slope repair completed.
Recommendation: Continue to monitor.
Field Representative: GH

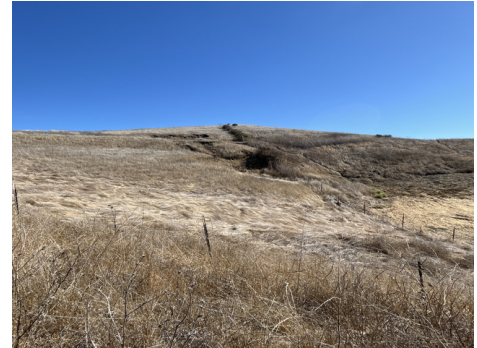
- Slope erosion rills northeast of Whitcliffe Court (outside of the GHAD boundary) measuring 1 to 2 feet wide by 35 feet long with an estimated depth of 1 to 2 feet. Condition unchanged with partial revegetation on affected slope. (Site Condition E, Appendix A, Figure 1).

Site Condition: E
Observation Date: 10/26/2023
Description: Off-site slope erosion adjacent to GHAD boundary
Recommendation: Continue to monitor.
Field Representative: GH

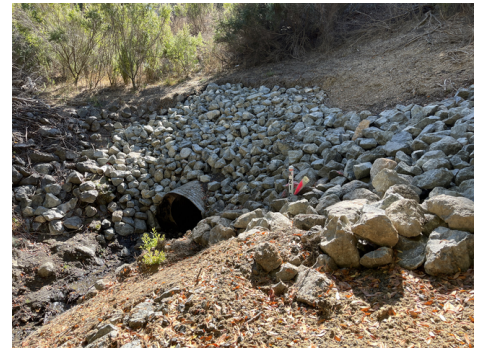
Site Condition: F.1
Observation Date: 10/26/2023
Description: Eroded and displaced backfill above culvert pipe. Culvert and slope repair completed.
Recommendation: Continue to monitor.
Field Representative: GH

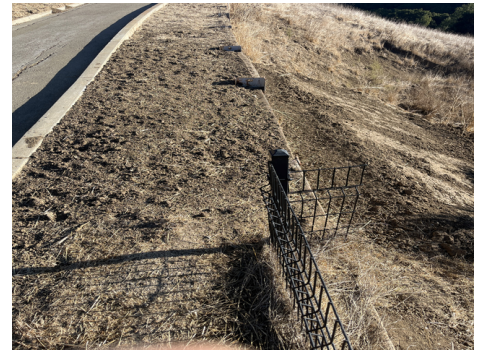
Site Condition: F.2
Observation Date: 10/27/2023
Description: Eroded and displaced backfill behind retaining wall and below wall lagging. Backfill restored.
Recommendation: Continue to monitor.
Field Representative: GH

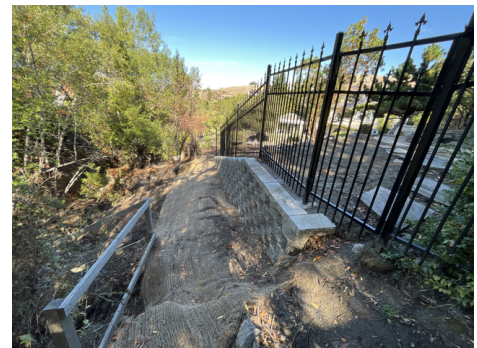
Site Condition: G
Observation Date: 10/26/2023
Description: Creek bank failure/slump measuring 40 to 45 feet wide by 35 feet long with an estimated depth of 5 to 6 feet. Slide mitigation/wall construction completed.
Recommendation: Continue to monitor.
Field Representative: GH

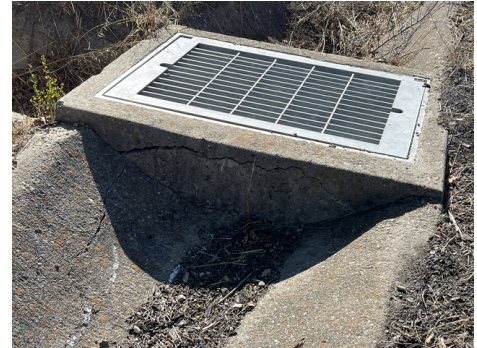
Site Condition: H
Observation Date: 10/26/2023
Description: Crack along top portion of DI box.
Recommendation: Continue to monitor.
Field Representative: GH

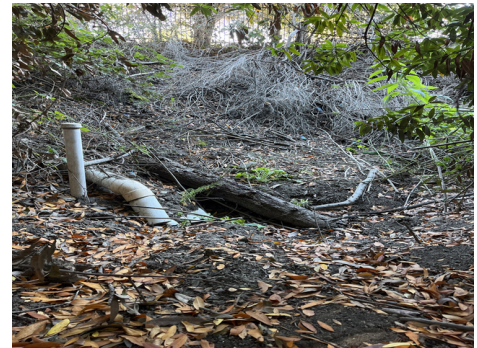
We observed that the storm drain inlet located at the southeastern corner of 101 Lyndhurst Place was obstructed by vegetation and sediment (Site Condition I, Appendix A, Figure 1). The drain inlet will be cleared during annual maintenance work.

Site Condition: I
Observation Date: 10/26/2023
Description: Storm drain inlet obstructed by vegetation and sediment.
Recommendation: Storm drain inlet should be cleared of vegetation and sediment.
Field Representative: GH

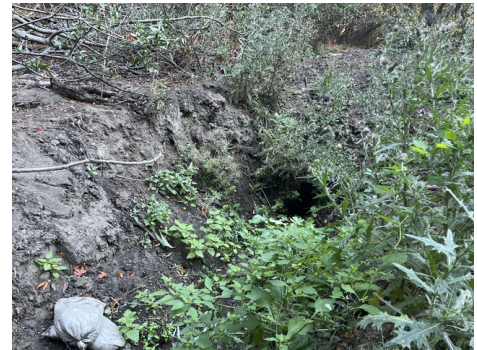
Site Condition: J.1
Observation Date: 10/26/2023
Description: Maintained drainage culvert.
Recommendation: Continue to monitor.
Field Representative: GH

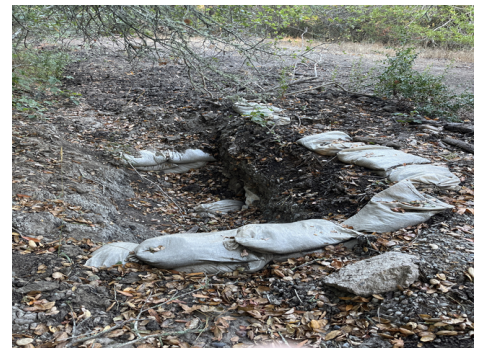
Site Condition: J.2
Observation Date: 10/26/2023
Description: Maintained drainage culvert.
Recommendation: Continue to monitor.
Field Representative: GH

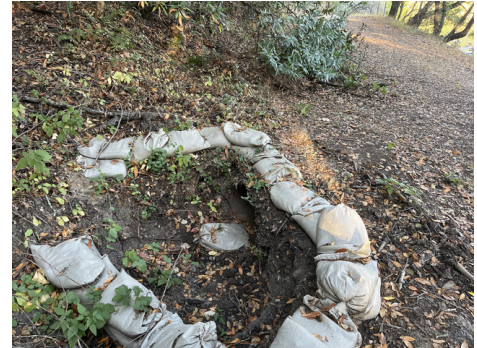
Site Condition: J.3
Observation Date: 10/26/2023
Description: Maintained drainage culvert.

Recommendation: Continue to monitor.
