Project No.  
**3586.002.023**

April 17, 2024

Subject: Norris Canyon Estates  
Contra Costa County, California

**GEOLOGIC HAZARD ABATEMENT DISTRICT  
MONITORING – SPRING 2024**

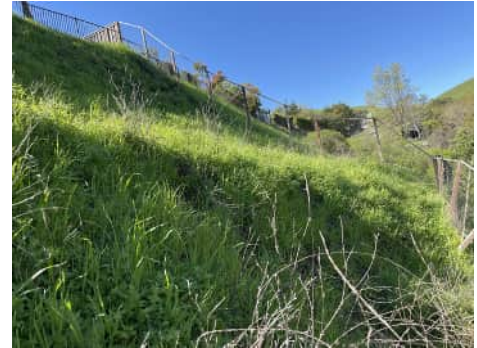
Since 2018, several minor landslides/earthflows have been observed along the 1:1 (horizontal:vertical) engineered fill slope, north of Lyndhurst Place, downhill from the nearby residences. These shallow landslides were not of immediate concern but have been monitored during subsequent scheduled monitoring events. During this monitoring event, the landslides did not show any significant movement. We did observe a new earthflow and damaged fence at the rear of 149 Lyndhurst Place during the spring 2023 monitoring event. During this monitoring event, the earthflow appeared to have stabilized and did not appear to be impacting the house pad or mid-slope drainage ditch (Site Condition A, Appendix A, Figure 1B). The GHAD will continue monitoring these areas for slope stability.

Site Condition: A  
Observation Date: 04/02/2024  
Description: Surficial earthflow along 1:1 slope.  
Recommendation: Continue to monitor.  
Field Representative: GH

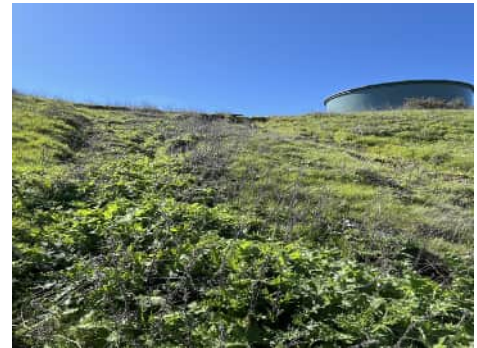
- Shallow earthflow northeast of Bishop Tank Site pad. Earthflow is stabilized with partial revegetation on affected slope (Site Condition B.1, Appendix A, Figure 1B).

Site Condition: B.1  
Observation Date: 04/02/2024  
Description: Shallow earthflow (18 feet wide by 25 feet long with an estimated depth of 1 to 2 feet).  
Recommendation: Continue to monitor.  
Field Representative: GH

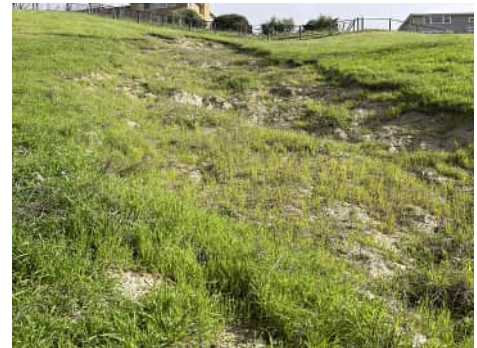
- Shallow earthflow southwest of 539 Wycombe Court rear yard. Earthflow is stabilized with partial revegetation on affected slope (Site Condition B.2, Appendix A, Figure 1C).

Site Condition: B.2  
Observation Date: 04/03/2024  
Description: Shallow earthflow (25 feet wide by 35 feet long with an estimated depth of 2 to 3 feet).  
Recommendation: Continue to monitor.  
Field Representative: GH

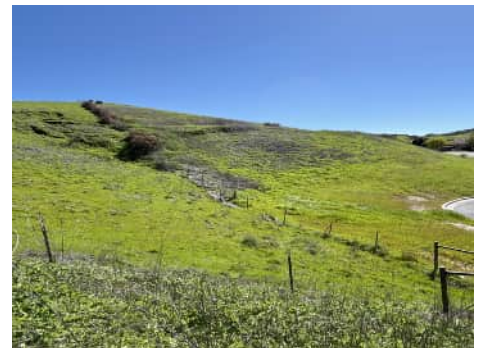
- Slope erosion rills northeast of Whitcliffe Court (outside of the GHAD boundary). Condition unchanged with partial revegetation on affected slope. (Site Condition C, Appendix A, Figure 1C).

Site Condition: C  
Observation Date: 04/02/2024  
Description: Off-site slope erosion adjacent to GHAD boundary  
Recommendation: Continue to monitor.  
Field Representative: GH

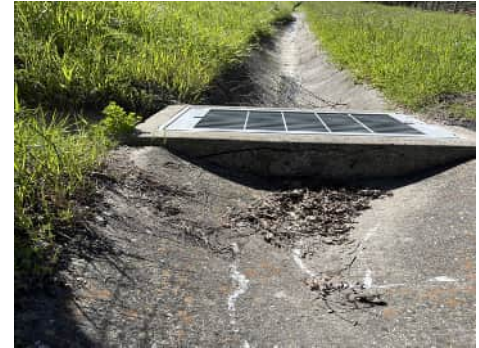
During the spring 2020 monitoring event, the top of the storm drain inlet box at the concrete-lined drainage ditch, located southwest of 3057 Ashbourne Circle, showed cracking and significant

separation from the inlet box structure. At the time of this monitoring event, the cracking had not progressed (Site Condition D, Appendix A, Figure 1C). The inlet box and cracks should continue to be monitored and, if needed, sealed or replaced to maintain the integrity and longevity of the drain inlet.

Site Condition: D  
Observation Date: 04/02/2024  
Description: Crack along top portion of DI box.  
Recommendation: Continue to monitor.  
Field Representative: GH

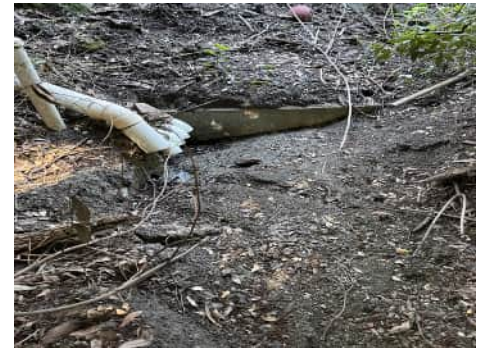
We observed that the storm drain inlet located at the southeastern corner of 101 Lyndhurst Place was obstructed by vegetation and sediment (Site Condition E, Appendix A, Figure 1B). The drain inlet will be cleared during annual maintenance work.

Site Condition: E  
Observation Date: 04/02/2024  
Description: Storm drain inlet obstructed by sediment.  
Recommendation: Storm drain inlet should be cleared of sediment.  
Field Representative: GH

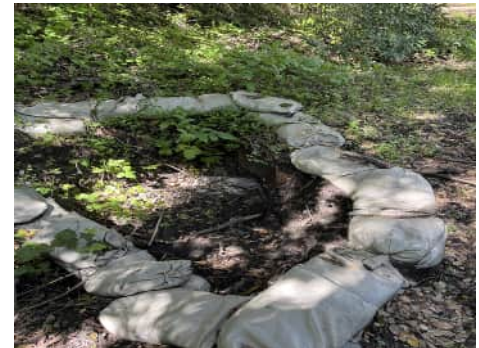
A series of pre-development culvert pipe inlets along the upslope side of an access road west of Ashbourne Drive (APN 211210045) were obstructed during the rains of winter 2022/2023 and required maintenance. We noted during our spring 2023 monitoring that performed maintenance of the pipe inlets allowed for proper drainage. During this monitoring event, we observed the pipe inlets to be functioning properly (Site Condition F.1-F.3, Appendix A, Figure 1B). The GHAD will continue to monitor the culvert pipes during future monitoring and will provide maintenance, as needed.

Site Condition: F.1  
Observation Date: 04/02/2024  
Description: Maintained drainage culvert.  
Recommendation: Continue to monitor.  
Field Representative: GH

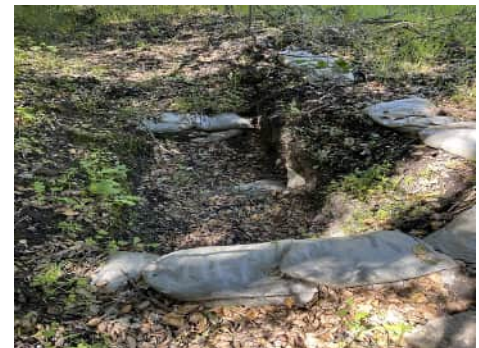
Site Condition: F.2  
Observation Date: 04/02/2024  
Description: Maintained drainage culvert.  
Recommendation: Continue to monitor.  
Field Representative: GH

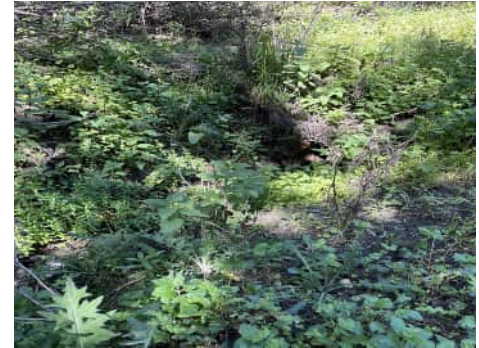
Site Condition: F.3  
Observation Date: 04/02/2024  
Description: Maintained drainage culvert.

Recommendation: Continue to monitor.
