Project No.
3586.002.023

May 3, 2024

Subject: Elworthy Ranch
Danville, California

**GEOLOGIC HAZARD ABATEMENT DISTRICT
MONITORING – SPRING 2024**

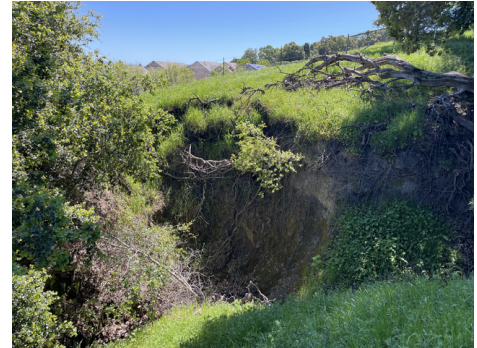
The common area and open-space slopes were observed for evidence of slope instability, including landslides, earthflows, erosion, diverted drainage, or standing water. In general, we observed the open space and slopes to be in satisfactory condition. We noted an oversteepened condition with erosion exposing portions of the creek channel side wall on Parcel P in our fall 2022 monitoring. During this monitoring event, we observed that the condition remained relatively unchanged since our last site visit (Site Condition A.1, Appendix A, Figure 1, attached). We also observed significant erosion exposing creek channel side walls at other locations within Parcel P (Site Condition A.2 through A.3, Appendix A, Figure 1) and shallow landslide/earthflows along slopes adjacent to the creek channel (Site Conditions B.1 and B.2, Appendix A, Figure 1). The GHAD will continue to monitor and, if needed, mitigate these conditions to prevent the eroding soil from obstructing drainage at the outfall and creek channel.

Site Condition: A.1
Observation Date: 04/09/2024
Description: Creek channel erosion.

Recommendation: Continue to monitor.

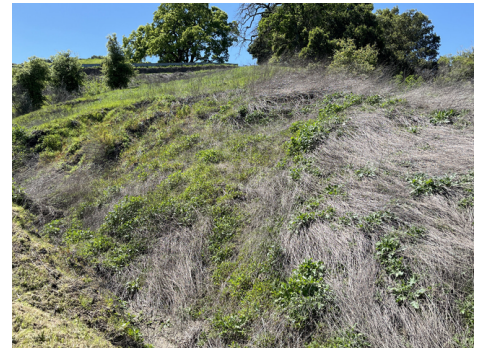
Site Condition: A.2
Observation Date: 04/09/2024
Description: Creek channel erosion.

Recommendation: Continue to monitor.

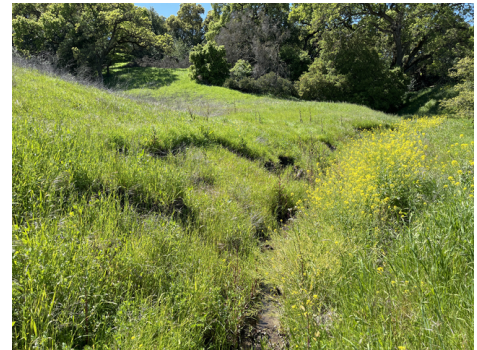
Site Condition: A.3
Observation Date: 04/09/2024
Description: Creek channel erosion.

Recommendation: Continue to monitor.

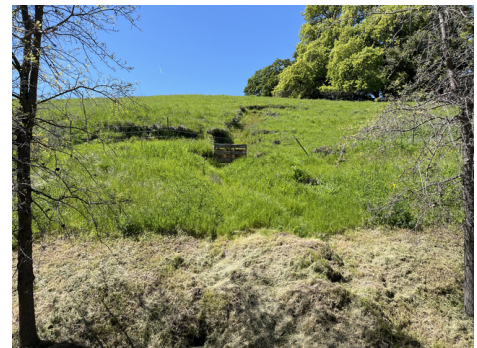
Site Condition: B.1
Observation Date: 04/09/2024
Description: Shallow landslide/earthflow.

Recommendation: Continue to monitor.

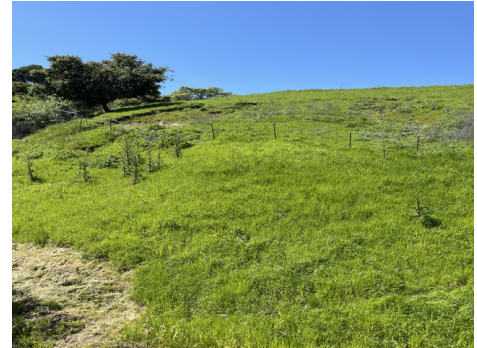
Site Condition: B.2
Observation Date: 04/09/2024
Description: Shallow landslide/earthflow.

Recommendation: Continue to monitor.

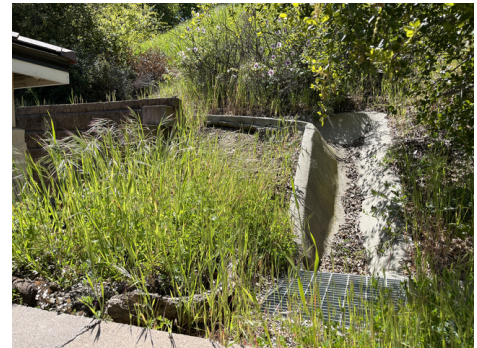
The concrete-lined drainage ditches were checked for accumulation of debris/sediment and for obvious distress, such as cracking or shifting of the concrete. During this monitoring event, we observed minor soil and vegetation within the drainage ditches. Soil and vegetation will be cleaned as part of the routine GHAD maintenance. We observed minor cracks and voids in the concrete ditches; however, the minor cracks do not appear to compromise the integrity of the concrete-lined drainage ditches. The GHAD will continue to monitor, and as needed, the minor cracks and voids will be resealed to maintain ditch integrity. Since our fall 2021 monitoring, we have noted that erosion between the MSE retaining wall and the concrete-lined drainage ditch at the southern end of Elworthy Ranch Circle created a void below the drainage ditch. During this monitoring, we observed that the erosion and void remained the same since our last monitoring (Site Condition C, Appendix A, Figure 1). We will continue to monitor the condition of the void and the stability of the ditch during future monitoring.

Site Condition: C
Observation Date: 04/09/2024
Description: Erosion behind MSE wall and below concrete-lined drainage ditch.

Recommendation: Continue to monitor.

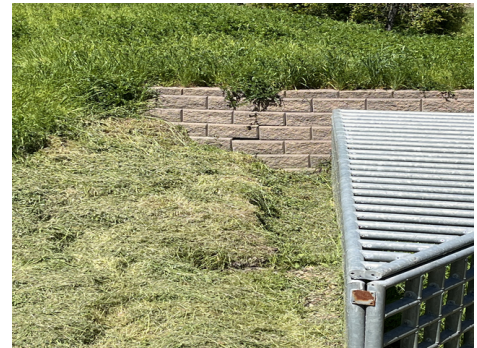
Retaining walls were inspected for significant cracking and damage. Since our fall 2020 monitoring, we have observed broken/distressed blocks on the MSE retaining wall next to the trash rack between Elworthy Ranch Circle and Elworthy Ranch Lane. During this monitoring event, we observed that the broken/distressed blocks remained unchanged since our last monitoring (Site Condition D, Appendix A, Figure 1). The GHAD will continue to monitor and, if needed, will repair or replace the blocks to maintain the integrity of the wall.

Site Condition: D
Observation Date: 04/09/2024
Description: Distressed MSE retaining wall block.

Recommendation: Continue to monitor.

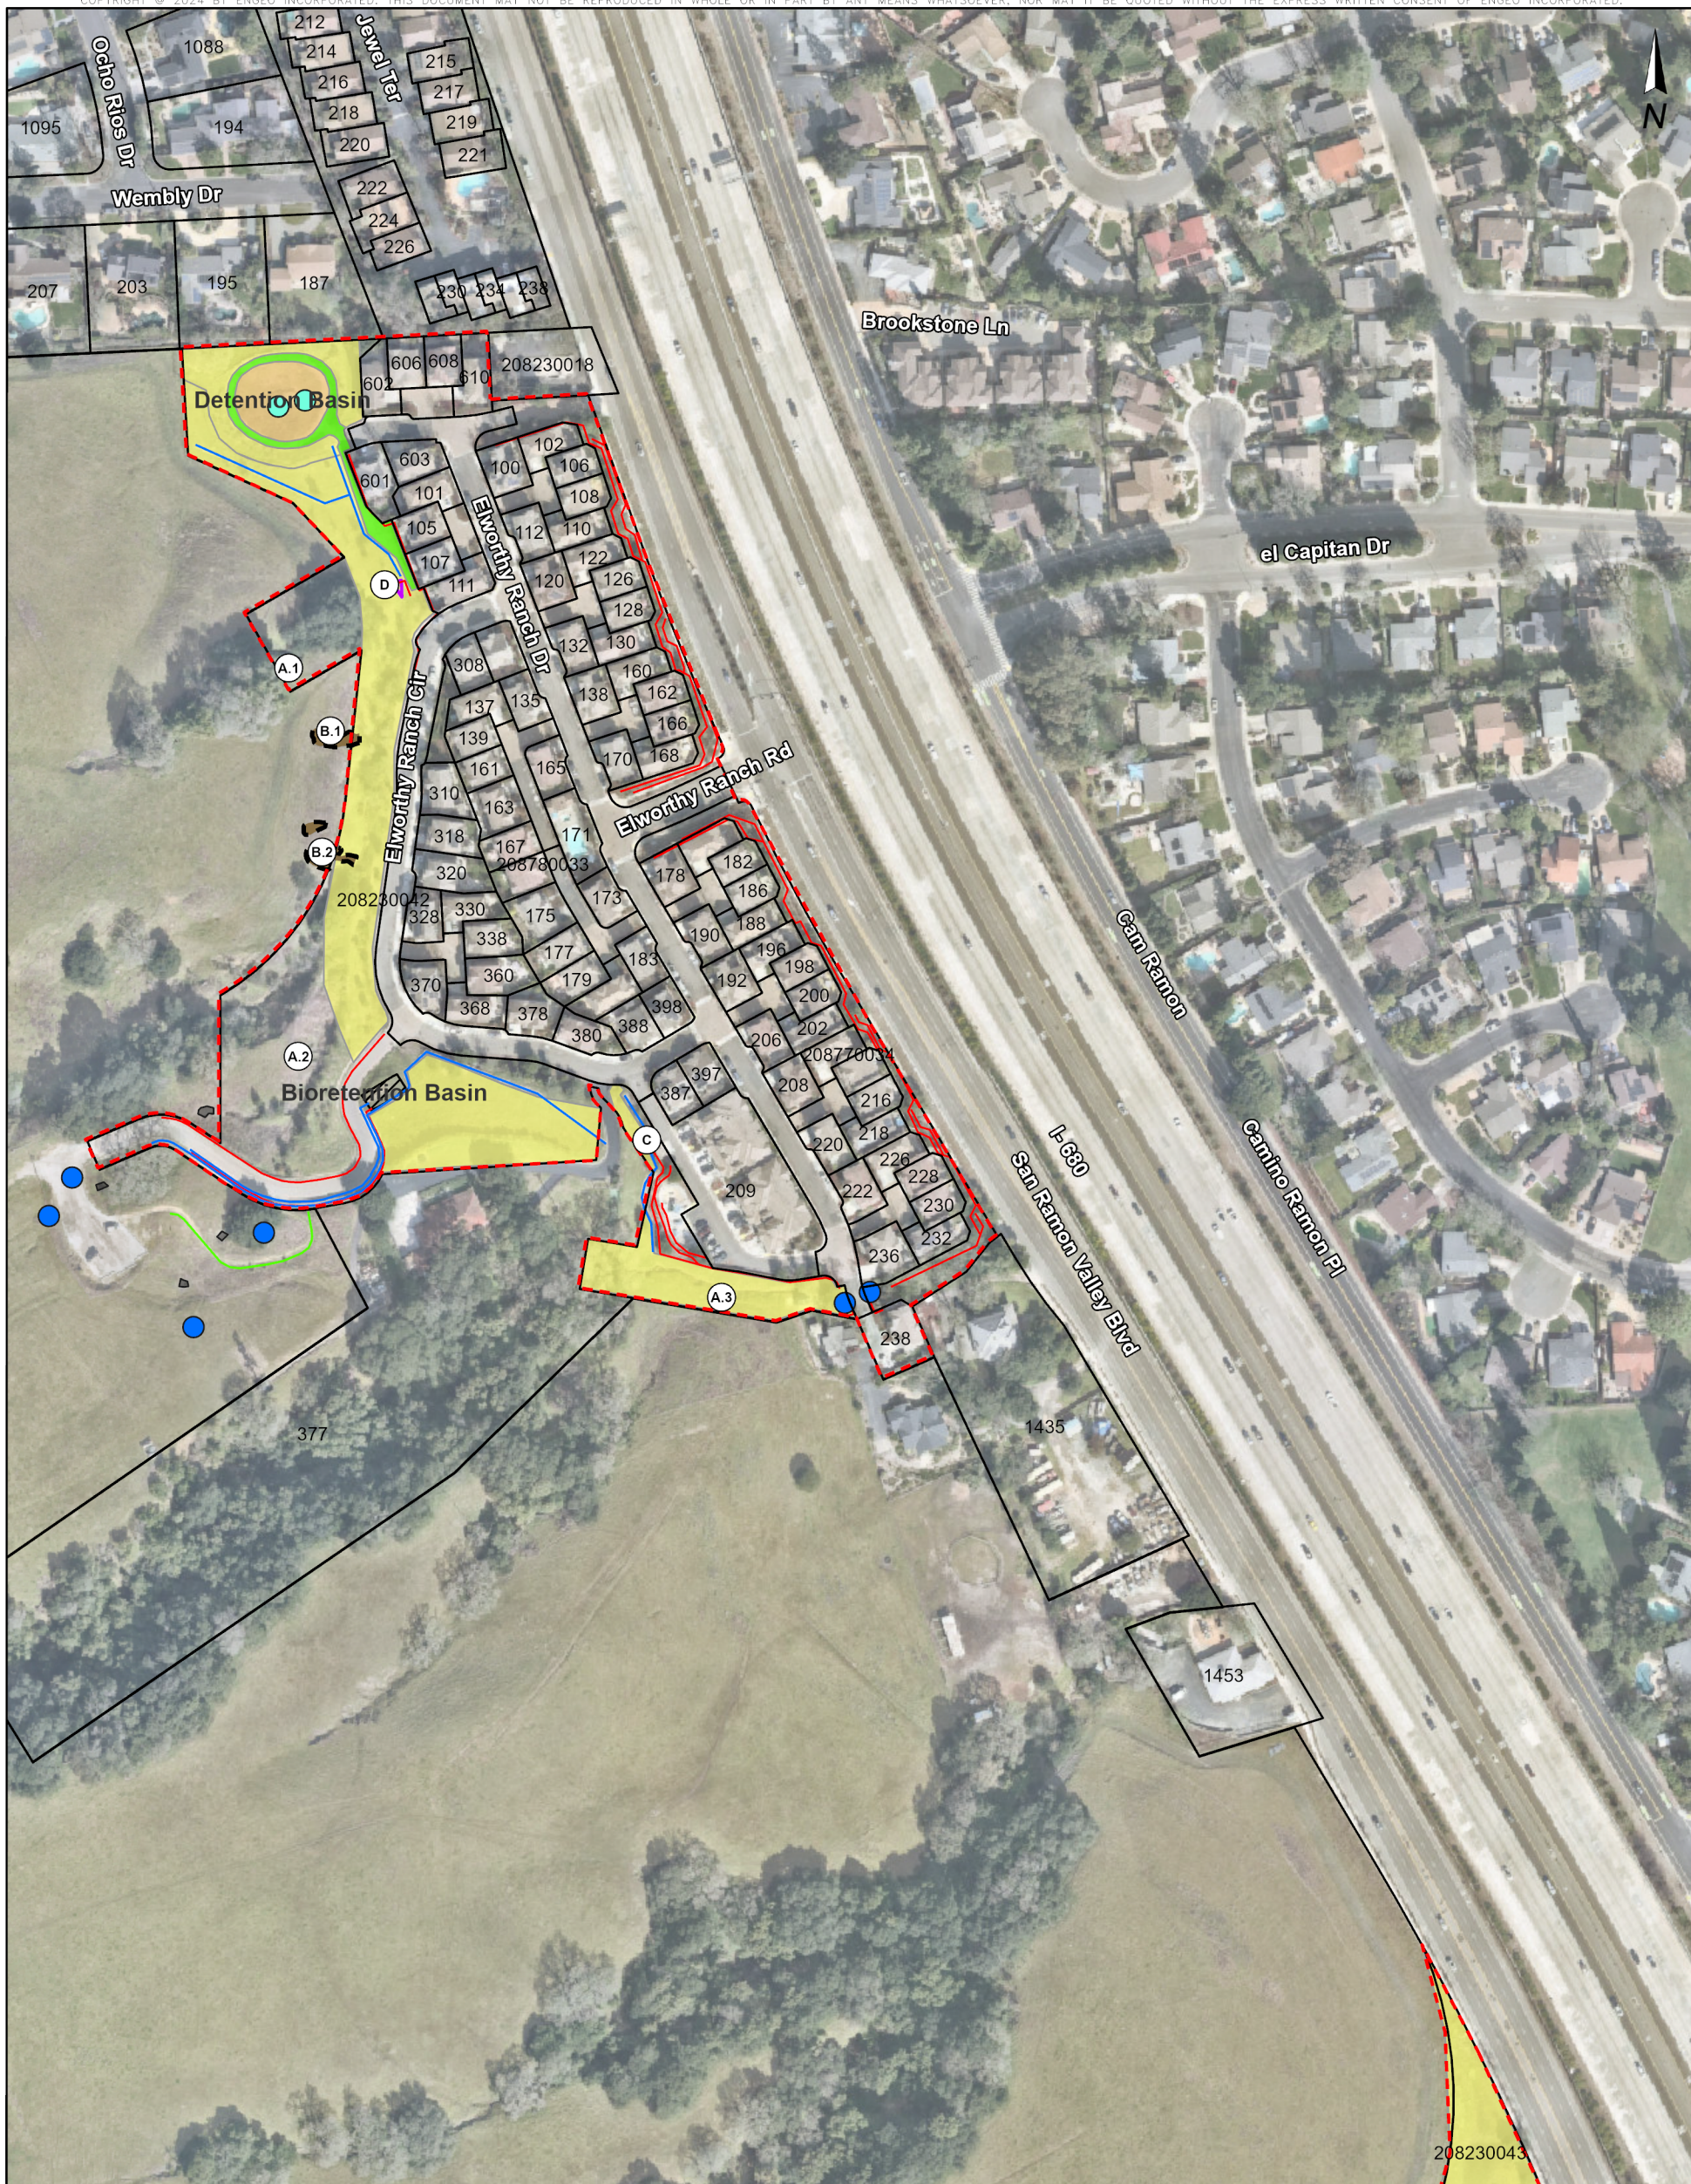
FIGURE 1

A detention basin (Figure 1) is located at the end of Elworthy Ranch Lane. Monitoring of the detention basin was conducted as part of the open-space monitoring. The observed conditions for the detention basin are described in the attached Elworthy Ranch Detention Basin Site Monitoring and Maintenance Form. Contracted ongoing routine maintenance within the detention basin currently includes roadway maintenance, weed abatement, and woody vegetation removal. At the time of our visit, the detention basin appeared to be functioning properly and was in good condition.
