May 3, 2024

Project No.
3586.002.023

Subject: Red Hawk Development
 Danville, California

**GEOLOGIC HAZARD ABATEMENT DISTRICT
 MONITORING – SPRING 2024**

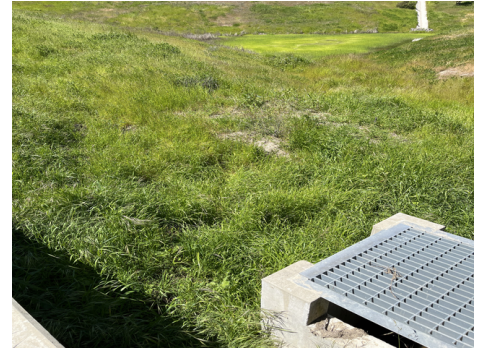
Site Condition: A
Observation Date: 04/09/2024
Description: Accumulated sediment at basin outlet. Natural sediment migration in progress.
Recommendation: Continue to monitor.
Field Representative: GH

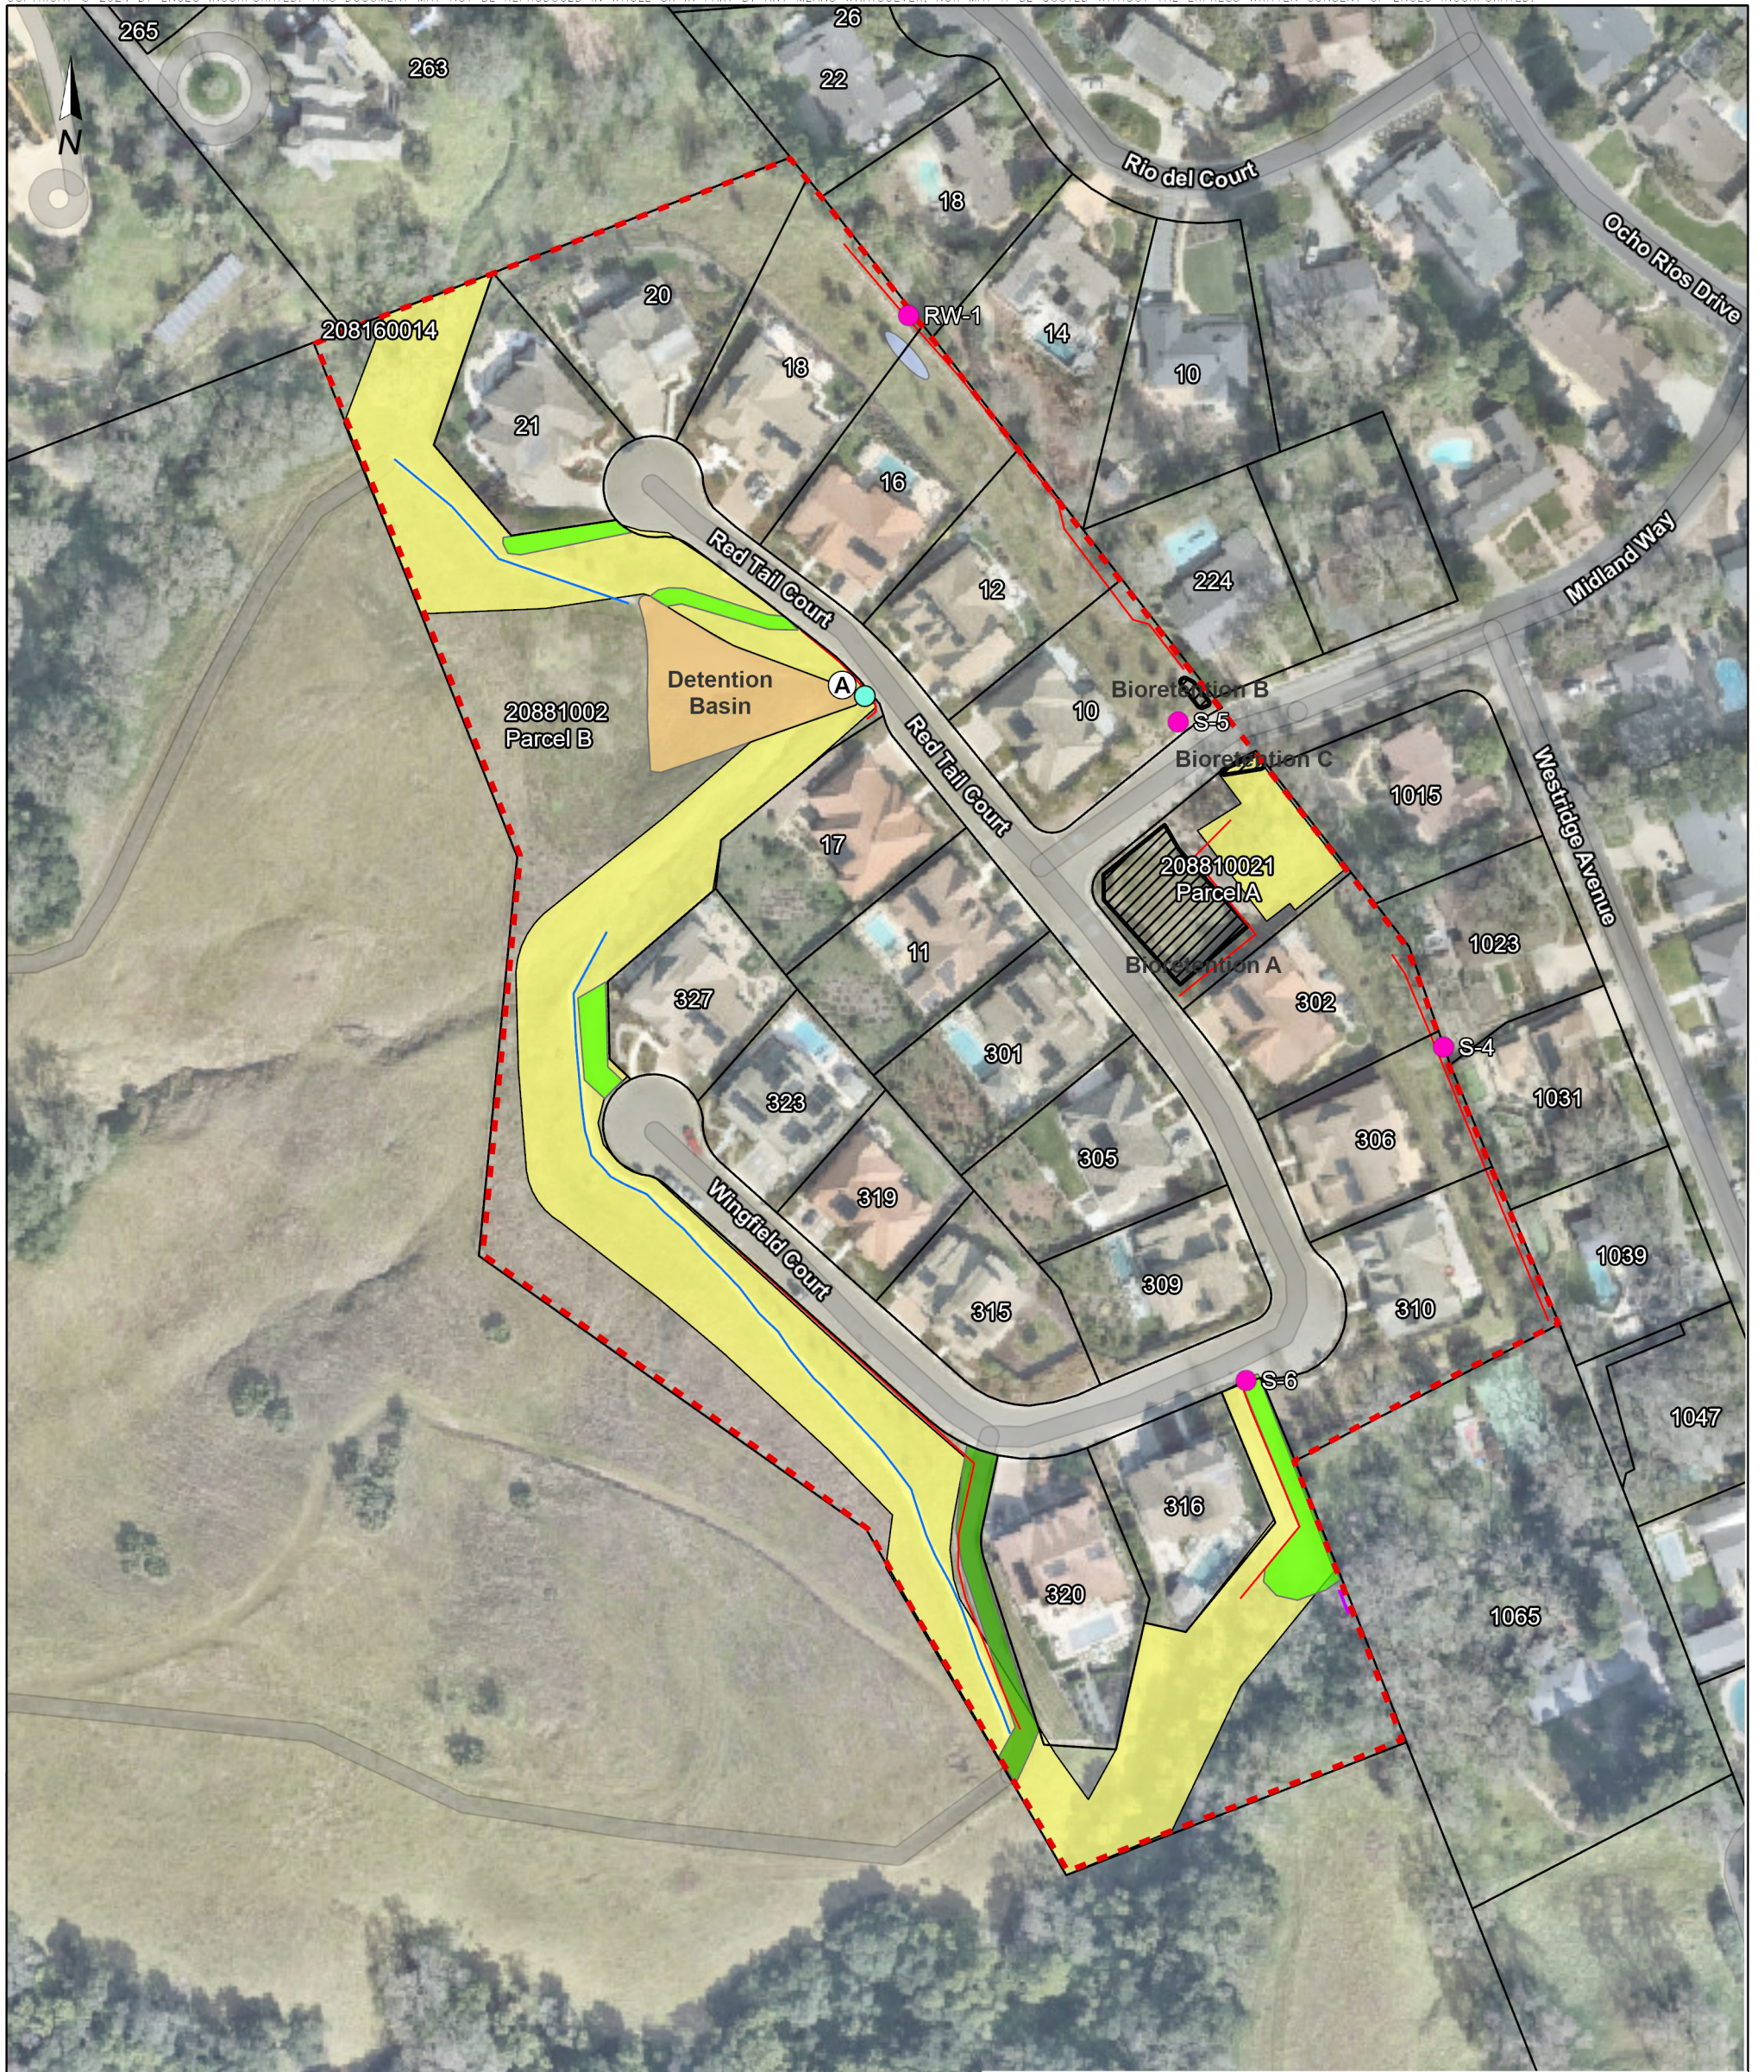
FIGURE 1

A detention basin (Figure 1) is located at the end of Red Tail Court. Monitoring of the detention basin was conducted as part of the open-space monitoring. The observed conditions for the detention basin are described in the attached Red Hawk Development Detention Basin Site Monitoring and Maintenance Form. Contracted ongoing routine maintenance within the detention basin currently includes roadway maintenance, weed abatement, and woody vegetation removal. At the time of our visit, the detention basin appeared to be functioning properly and was in good condition. We noted in our fall monitoring report significant accumulation of sediment adjacent to the basin outlet structure. During this monitoring event, we observed that the accumulated sediment was naturally migrating through the basin (Site Condition A, Appendix A, Figure 1). The GHAD will continue to monitor and will remove the sediment, if needed.

We observed the condition of three bioretention areas adjacent to Midland Way (Figure 1). During our monitoring, the bioretention areas appeared to be free of accumulated standing water or debris and were functioning properly.
