Project No.
3586.002.023

May 8, 2024

Subject: Henry Ranch
San Ramon, California

**GEOLOGIC HAZARD ABATEMENT DISTRICT
MONITORING – SPRING 2024**

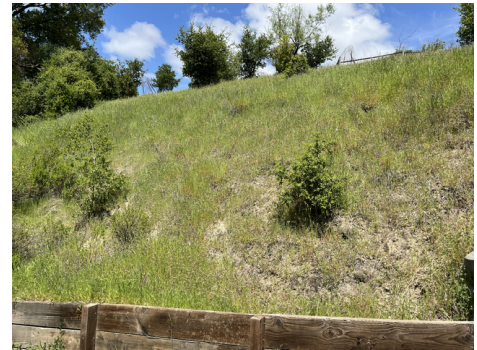
We previously noted that the slopes adjacent to the gravel-surfaced access road within the easement area were in an oversteepened condition and subject to shallow slope instability. Retaining walls and debris walls were constructed to protect the road from unstable materials from the uphill slope. During past monitoring events, we have observed and noted surface erosion on portions of the uphill slope. During this monitoring event, we observed that the areas of slope erosion appeared unchanged from our last monitoring event and were partially revegetated (Site Conditions A.1 and A.2, Appendix A, Figure 1). We also observed debris wall distress (Site Condition B, Appendix A, Figure 1). The GHAD will continue to monitor the slope and wall conditions and remove, as needed, soil materials that collect behind the debris walls to maintain the catchment capacity.

Site Condition: A.1
Observation Date: 04/24/2024
Description: Oversteepened slope with erosion and sloughing on slope above debris wall.
Recommendation: Continue to monitor.
Field Representative: GH

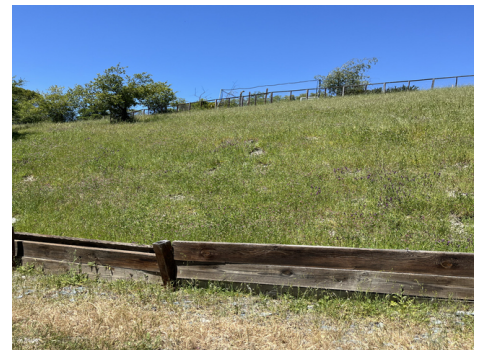
Site Condition: A.2
Observation Date: 04/24/2024
Description: Oversteepened slope with erosion and sloughing on slope above debris wall.
Recommendation: Continue to monitor.
Field Representative: GH

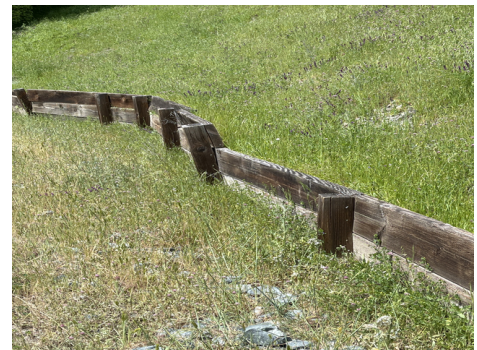
Site Condition: B
Observation Date: 04/24/2024
Description: Debris wall distress.
Recommendation: Continue to monitor.
Field Representative: GH

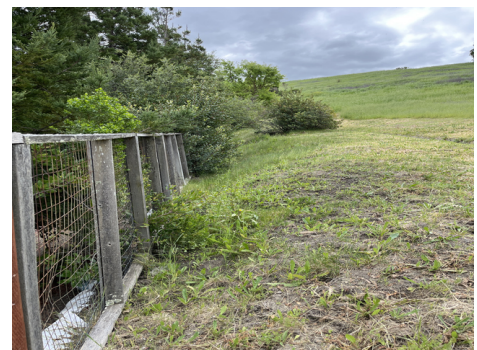
We noted in spring 2020 that the rear fence at 6025 Westside Drive was tilted in the downslope direction, which is an indication of soil creep. Fluctuations in moisture regimes of expansive soil may result in movement of soil related to shrinkage and swelling, which may result in an adverse impact to overlying improvements. Soil creep involves the downslope movement of expansive soil due to wetting and drying of the soil. At the time of this site visit, the condition of the fence appeared to be in a similar condition as observed during our last monitoring event

(Site Condition C, Appendix A, Figure 1). We observed the soil creep to be localized directly adjacent to and along the fence alignment and common area irrigation/sprinkler line. Fences are not a GHAD-maintained improvement. The GHAD will continue to monitor this condition.

Site Condition: C
Observation Date: 04/24/2024
Description: Tilted/leaning fence and localized soil creep due to irrigation.
Recommendation: Continue to monitor.
Field Representative: GH

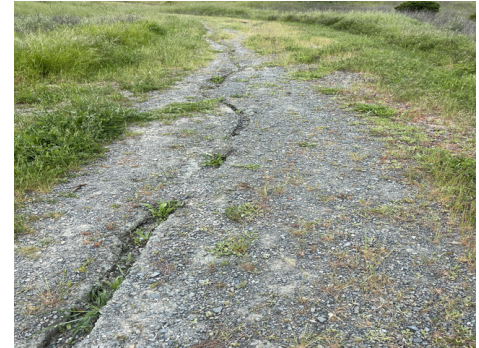
Site Condition: D.1
Observation Date: 04/24/2024
Description: Erosional rill within gravel maintenance road.
Recommendation: Continue to monitor.
Field Representative: GH

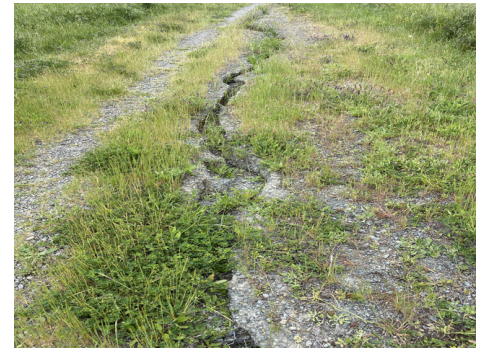
Site Condition: D.2
Observation Date: 04/24/2024
Description: Erosional rill within gravel maintenance road.
Recommendation: Continue to monitor.
Field Representative: GH

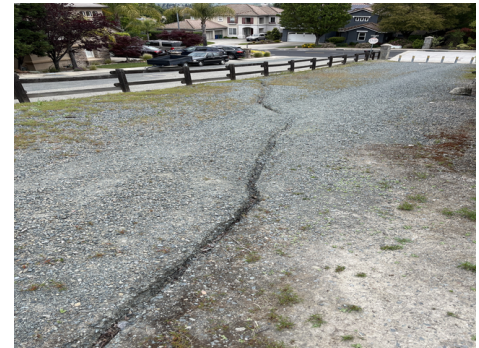
Site Condition: D.3
Observation Date: 04/24/2024
Description: Erosional rill within gravel maintenance road.
Recommendation: Continue to monitor.
Field Representative: GH

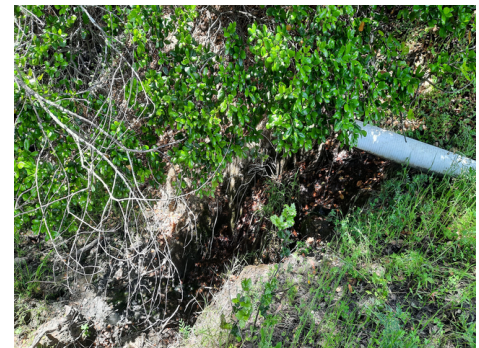
Site Condition: E
Observation Date: 04/24/2024
Description: Slope erosion below subdrain outlet.
Recommendation: Continue to monitor.
Field Representative: GH

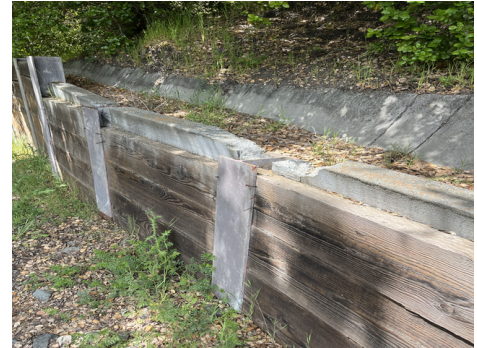
As noted in our previous monitoring reports, we observed significant damage to the top of the concrete-lined drainage ditch within the easement area (Site Condition F, Appendix A, Figure 1). The damaged concrete appeared to be unchanged from our last monitoring event. The drainage ditch will continue to be monitored and will be repaired, as needed, to allow for proper function of the drainage ditch.

Site Condition: F
Observation Date: 04/24/2024
Description: Damaged concrete-lined drainage ditch within Easement Area
Recommendation: Continue to monitor.
Field Representative: GH

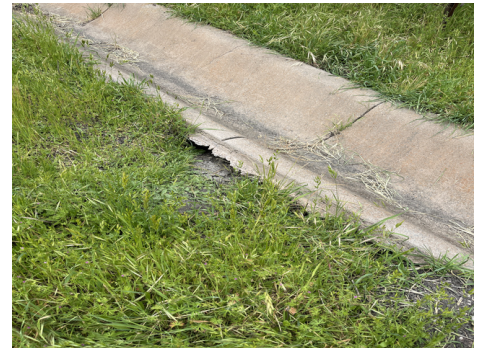
During our fall 2019 monitoring event, we noted that there is a significant void underneath a portion of drainage ditch at the northern end of Lone Tree Lane (Site Condition G, Appendix A, Figure 1). During this monitoring event, we were able to observe the condition of the void to be unchanged, and the drainage ditch did not appear to show significant distress. The GHAD will have the maintenance contractor backfill the void, if needed, to prevent the void from continued enlargement. This area will continue to be monitored in future monitoring events.

Site Condition: G
Observation Date: 04/24/2024
Description: Void beneath concrete-lined drainage ditch.
Recommendation: Continue to monitor.
Field Representative: GH
