Project No.  
**3586.002.024**

November 18, 2024

Subject: Elworthy Ranch  
Danville, California

**GEOLOGIC HAZARD ABATEMENT DISTRICT  
MONITORING – FALL 2024**

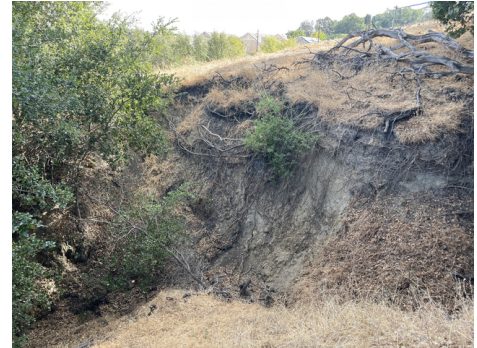
The common area and open-space slopes were observed for evidence of slope instability, including landslides, earthflows, erosion, diverted drainage, or standing water. In general, we observed the open space and slopes to be in satisfactory condition. We noted an oversteepened condition with erosion exposing portions of the creek channel side wall on Parcel P in our fall 2022 monitoring. During this monitoring event, we observed that the condition remained relatively unchanged since our last site visit (Site Condition A.1, Appendix A, Figure 1, attached). We also observed significant erosion exposing creek channel side walls at other locations within Parcel P (Site Condition A.2 through A.3, Appendix A, Figure 1) and shallow landslide/earthflows along slopes adjacent to the creek channel (Site Conditions B.1 and B.2, Appendix A, Figure 1). The GHAD will continue to monitor and, if needed, mitigate these conditions to prevent the eroding soil from obstructing drainage at the outfall and creek channel.

Site Condition: A.1  
Observation Date: 10/25/2024  
Description: Creek channel erosion.  
Recommendation: Continue to monitor.  
Field Representative: GH

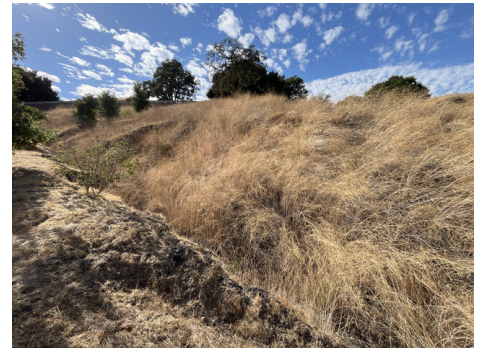
Site Condition: A.2  
Observation Date: 10/25/2024  
Description: Creek channel erosion.  
Recommendation: Continue to monitor.  
Field Representative: GH

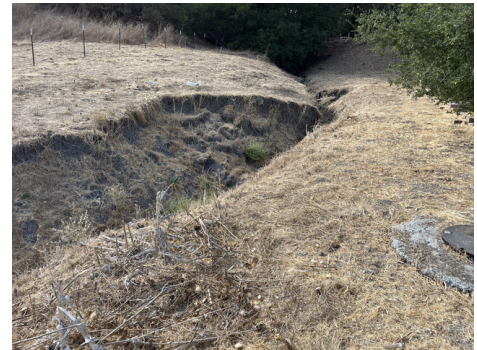
Site Condition: A.3  
Observation Date: 10/25/2024  
Description: Creek channel erosion.  
Recommendation: Continue to monitor.  
Field Representative: GH

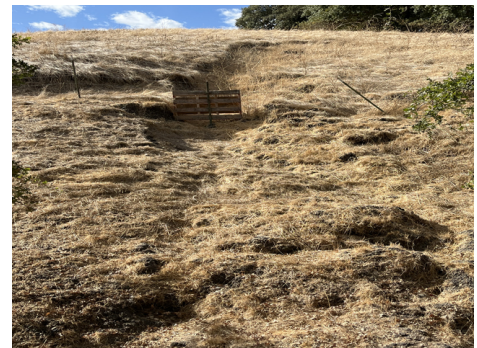
Site Condition: B.1  
Observation Date: 10/25/2024  
Description: Shallow landslide/earthflow.  
Recommendation: Continue to monitor.  
Field Representative: GH

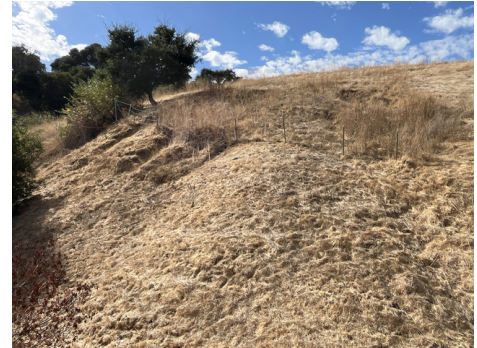
Site Condition: B.2  
Observation Date: 10/25/2024  
Description: Shallow landslide/earthflow.

Recommendation: Continue to monitor.

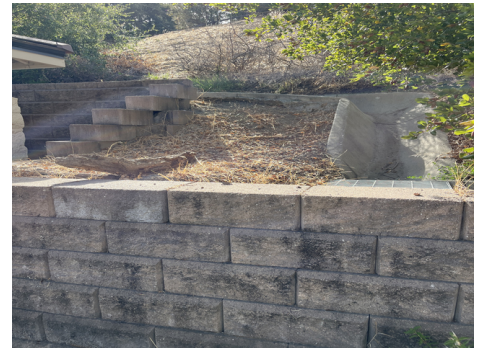
The concrete-lined drainage ditches were checked for accumulation of debris/sediment and for obvious distress, such as cracking or shifting of the concrete. During this monitoring event, we observed minor soil and vegetation within the drainage ditches. Soil and vegetation will be cleaned as part of the routine GHAD maintenance. We observed minor cracks and voids in the concrete ditches; however, the minor cracks do not appear to compromise the integrity of the concrete-lined drainage ditches. The GHAD will continue to monitor, and as needed, the minor cracks and voids will be resealed to maintain ditch integrity. Since our fall 2021 monitoring, we have noted that erosion between the MSE retaining wall and the concrete-lined drainage ditch at the southern end of Elworthy Ranch Circle created a void below the drainage ditch. During this monitoring, we observed that the erosion and void remained the same since our last monitoring (Site Condition C, Appendix A, Figure 1). We will continue to monitor the condition of the void and the stability of the ditch during future monitoring.

Site Condition: C  
Observation Date: 10/25/2024  
Description: Erosion below concrete-lined drainage ditch.

Recommendation: Continue to monitor.

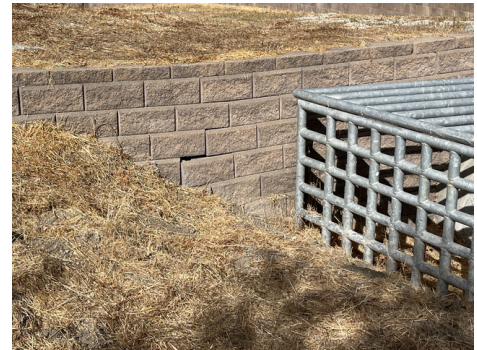
Retaining walls were inspected for significant cracking and damage. Since our fall 2020 monitoring, we have observed broken/distressed blocks on the MSE retaining wall next to the trash rack between Elworthy Ranch Circle and Elworthy Ranch Lane. During this monitoring event, we observed that the broken/distressed blocks remained unchanged since our last monitoring (Site Condition D, Appendix A, Figure 1). The GHAD will continue to monitor and, if needed, will repair or replace the blocks to maintain the integrity of the wall.

Site Condition: D  
Observation Date: 10/25/2024  
Description: Distressed MSE retaining wall block.

Recommendation: Continue to monitor.
