Project No.
3586.002.024

November 18, 2024

Subject: Norris Canyon Estates
Contra Costa County, California

**GEOLOGIC HAZARD ABATEMENT DISTRICT
MONITORING – FALL 2024**

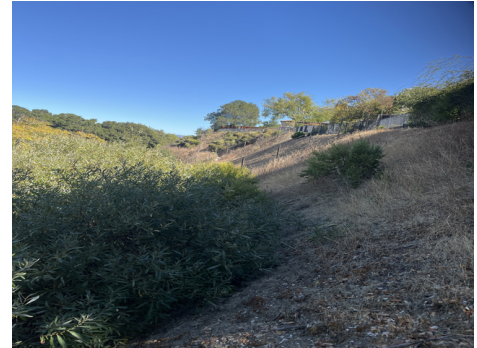
Since 2018, several minor landslides/earthflows have been observed along the 1:1 (horizontal:vertical) engineered fill slope, north of Lyndhurst Place, downhill from the nearby residences. These shallow landslides were not of immediate concern, but have been monitored during subsequent scheduled monitoring events. During this monitoring event, the landslides did not show any significant movement (Site Condition A, Appendix A, Figure 2A). We did observe a new earthflow and damaged fence at the rear of 149 Lyndhurst Place during the spring 2023 monitoring event. During this monitoring event, the earthflow appeared to have stabilized and did not appear to be impacting the house pad or mid-slope drainage ditch. The GHAD will continue monitoring these areas for slope stability.

Site Condition: A
Observation Date: 10/14/2024
Description: Surficial earthflow along 1:1 slope.
Recommendation: Continue to monitor.
Field Representative: GH

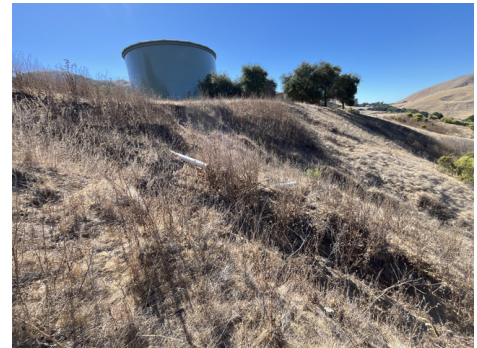
- Shallow earthflow northeast of Bishop Tank Site pad: Earthflow is stabilized with partial revegetation on affected slope (Site Condition B.1, Appendix A, Figure 2A).

Site Condition: B.1
Observation Date: 10/14/2024
Description: Shallow earthflow (18 feet wide by 25 feet long with an estimated depth of 1 to 2 feet).
Recommendation: Continue to monitor.
Field Representative: GH

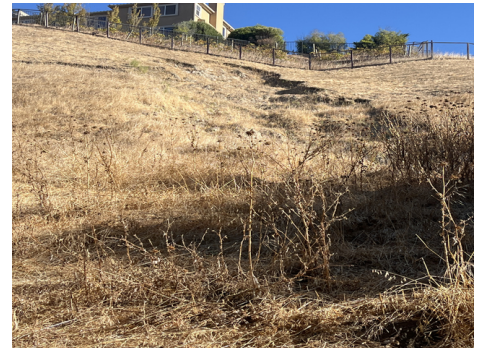
- Shallow earthflow southwest of 539 Wycombe Court rear yard: Earthflow is stabilized with partial revegetation on affected slope (Site Condition B.2, Appendix A, Figure 2B).

Site Condition: B.2
Observation Date: 10/15/2024
Description: Shallow earthflow (25 feet wide by 35 feet long with an estimated depth of 2 to 3 feet).
Recommendation: Continue to monitor.
Field Representative: GH

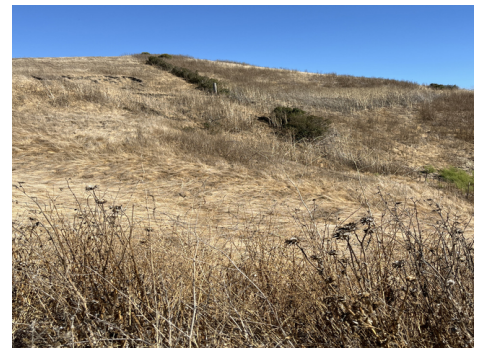
- Slope erosion rills northeast of Whitcliffe Court (outside of the GHAD boundary): Condition unchanged with partial revegetation on affected slope. (Site Condition C.1, Appendix A, Figure 2B).

Site Condition: C.1
Observation Date: 10/14/2024
Description: Off-site slope erosion adjacent to GHAD boundary
Recommendation: Continue to monitor.
Field Representative: GH

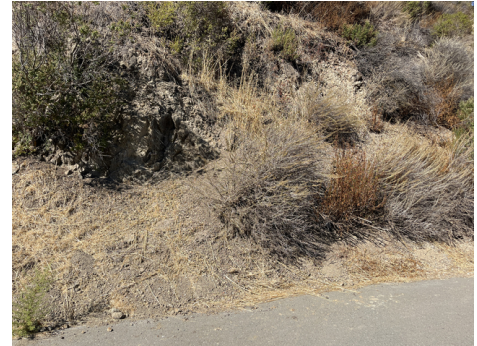
During this monitoring event, we observed significant erosion on portions of the naturally oversteepened slope along the western side of the EVA road (Site Condition C.2, Appendix A, Figure 2C). We also observed erosion directly upslope of a creek channel resulting from yard drainage along the rear of 2293 Ashbourne Drive (Site Condition C.3, Appendix A, Figure 2A). The GHAD will inform the HOA of the yard drainage erosion and will continue monitoring these areas for slope stability.

Site Condition: C.2
Observation Date: 10/15/2024
Description: Slope erosion on naturally oversteepened slopes.
Recommendation: Continue to monitor.
Field Representative: GH

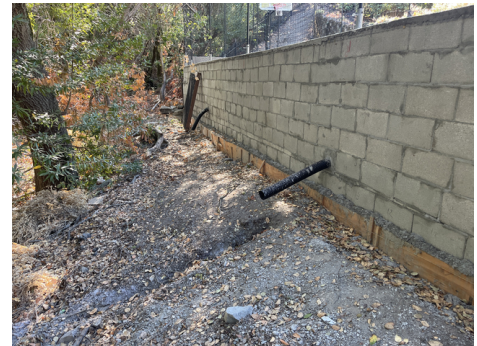
Site Condition: C.3
Observation Date: 10/14/2024
Description: Drain pipe erosion upslope of creek channel.
Recommendation: Continue to monitor.
Field Representative: GH

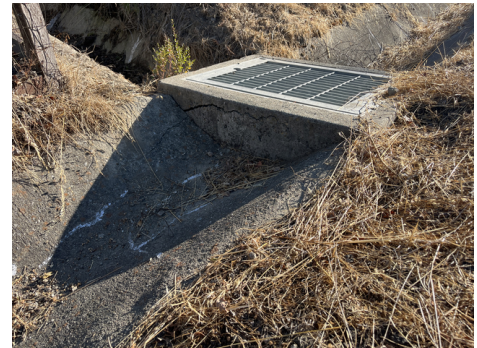
During the spring 2020 monitoring event, the top of the storm drain inlet box at the concrete-lined drainage ditch, located southwest of 3057 Ashbourne Circle, showed cracking and significant separation from the inlet box structure. At the time of this monitoring event, the cracking had not progressed (Site Condition D, Appendix A, Figure 2B). The inlet box and cracks should continue to be monitored and, if needed, sealed or replaced to maintain the integrity and longevity of the drain inlet.

Site Condition: D
Observation Date: 10/14/2024
Description: Crack along top portion of DI box.
Recommendation: Continue to monitor.
Field Representative: GH

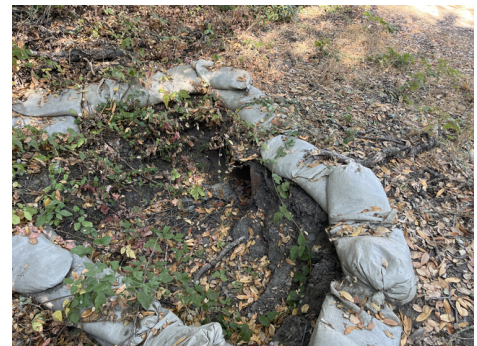
A series of pre-development culvert pipe inlets along the upslope side of an access road west of Ashbourne Drive (APN 211210045) were obstructed during the rains of winter 2022/2023 and required maintenance. We noted during our spring 2023 monitoring that performed maintenance of the pipe inlets allowed for proper drainage. During this monitoring event, we observed the pipe inlets to be functioning properly (Site Condition E.1-E.3, Appendix A, Figure 2A). The GHAD will continue to monitor the culvert pipes during future monitoring and will provide maintenance, as needed.

Site Condition: E.1
Observation Date: 10/14/2024
Description: Maintained drainage culvert.
Recommendation: Continue to monitor.
Field Representative: GH

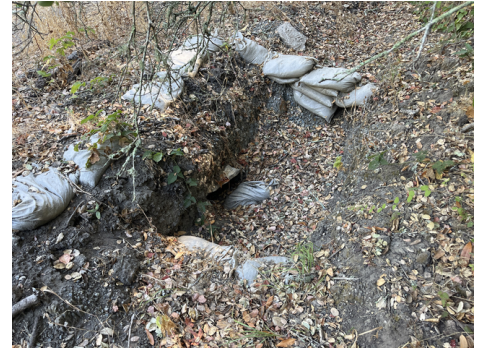
Site Condition: E.2
Observation Date: 10/14/2024
Description: Maintained drainage culvert.

Recommendation: Continue to monitor.

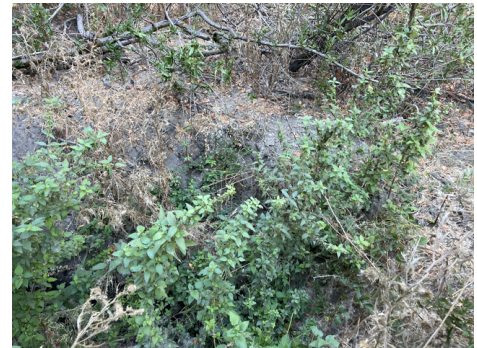
Site Condition: E.3
Observation Date: 10/14/2024
Description: Maintained drainage culvert.

Recommendation: Continue to monitor.
