Project No.
3586.002.024

November 18, 2024

Subject: Red Hawk Development
Danville, California

**GEOLOGIC HAZARD ABATEMENT DISTRICT
MONITORING – FALL 2024**

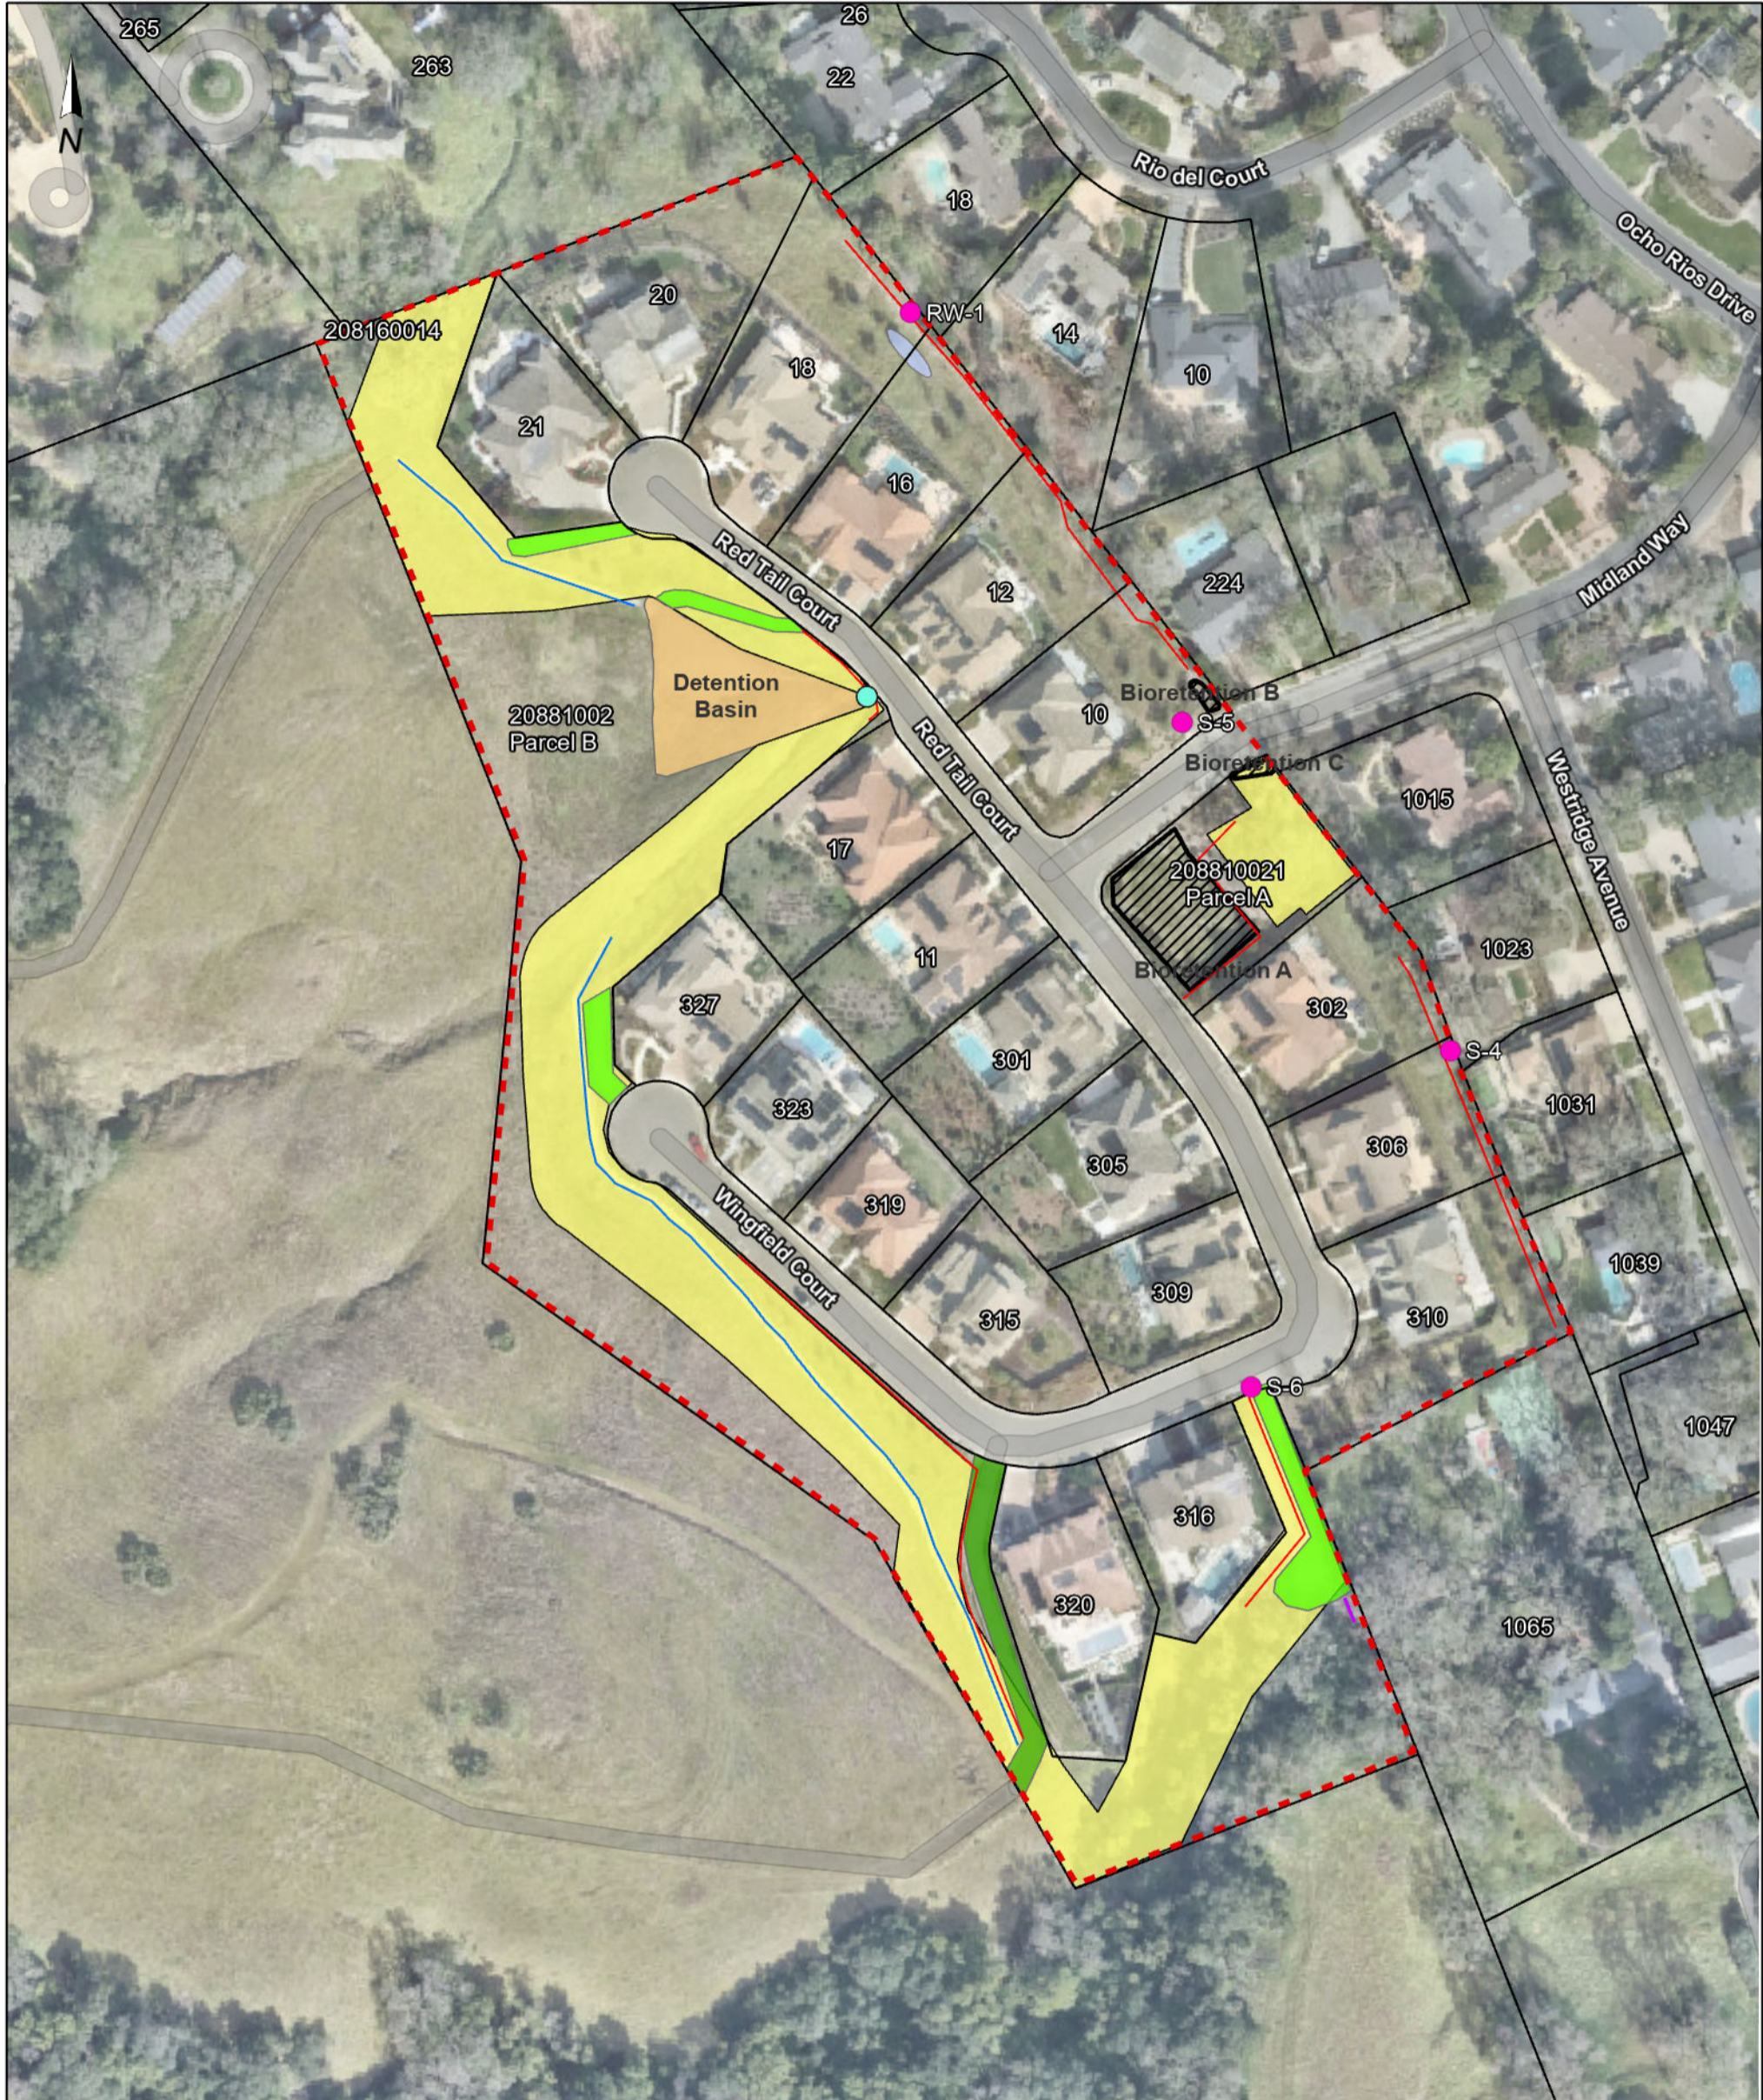
FIGURE 1

A detention basin (Figure 1) is located at the end of Red Tail Court. Monitoring of the detention basin was conducted as part of the open-space monitoring. The observed conditions for the detention basin are described in the attached Red Hawk Development Detention Basin Site Monitoring and Maintenance Form. Contracted ongoing routine maintenance within the detention basin currently includes roadway maintenance, weed abatement, and woody vegetation removal. At the time of our visit, the detention basin appeared to be functioning properly and was in good condition. We noted in our fall monitoring report significant accumulation of sediment adjacent to the basin outlet structure. During this monitoring event, we observed that the accumulated sediment has naturally migrated through the basin.

We observed the condition of three bioretention basins adjacent to Midland Way (Figure 1). During our monitoring, the bioretention basins appeared to be free of accumulated standing water or debris and were functioning properly.
