Project No.
3586.002.024

November 21, 2024

Subject: Henry Ranch
 San Ramon, California

**GEOLOGIC HAZARD ABATEMENT DISTRICT
 MONITORING – FALL 2024**

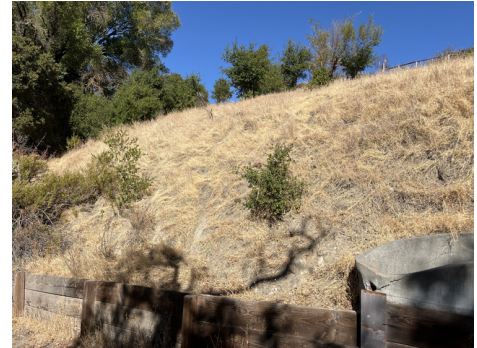
We previously noted that the slopes adjacent to the gravel-surfaced access road within the easement area were in an oversteepened condition and subject to shallow slope instability. Retaining walls and debris walls were constructed to protect the road from unstable materials from the uphill slope. During past monitoring events, we have observed and noted surface erosion on portions of the uphill slope. During this monitoring event, we observed that the areas of slope erosion appeared unchanged from our last monitoring event and were partially revegetated (Site Conditions A.1 and A.2, Appendix A, Figure 1). We also observed debris wall distress (Site Condition B, Appendix A, Figure 1). The GHAD will continue to monitor the slope and wall conditions and remove, as needed, soil materials that collect behind the debris walls to maintain the catchment capacity.

Site Condition: A.1
Observation Date: 10/29/2024
Description: Oversteepened slope with erosion and sloughing on slope above debris wall.
Recommendation: Continue to monitor.
Field Representative: GH

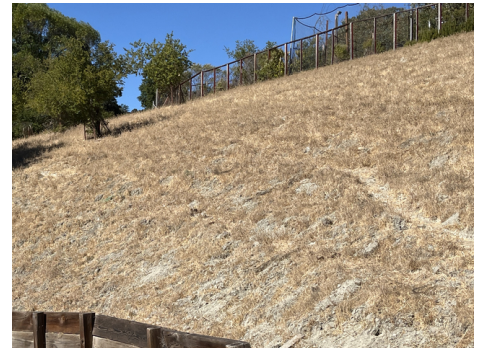
Site Condition: A.2
Observation Date: 10/29/2024
Description: Oversteepened slope with erosion and sloughing on slope above debris wall.
Recommendation: Continue to monitor.
Field Representative: GH

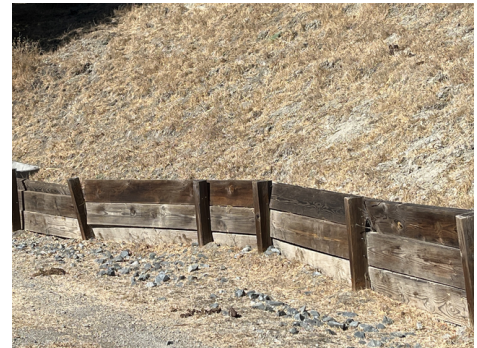
Site Condition: B
Observation Date: 10/29/2024
Description: Debris wall distress.
Recommendation: Continue to monitor.
Field Representative: GH

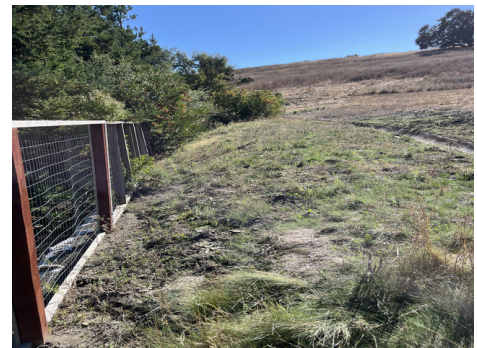
We noted in spring 2020 that the rear fence at 6025 Westside Drive was tilted in the downslope direction, which is an indication of soil creep. Fluctuations in moisture regimes of expansive soil may result in movement of soil related to shrinkage and swelling, which may result in an adverse impact to overlying improvements. Soil creep involves the downslope movement of expansive soil due to wetting and drying of the soil. At the time of this site visit, the condition of the fence appeared to be in a similar condition as observed during our last monitoring event

(Site Condition C, Appendix A, Figure 1). We observed the soil creep to be localized directly adjacent to and along the fence alignment and common area irrigation/sprinkler line. Fences are not a GHAD-maintained improvement. The GHAD will continue to monitor this condition.

Site Condition: C
Observation Date: 10/29/2024
Description: Tilted/leaning fence and localized soil creep due to irrigation.
Recommendation: Continue to monitor.
Field Representative: GH

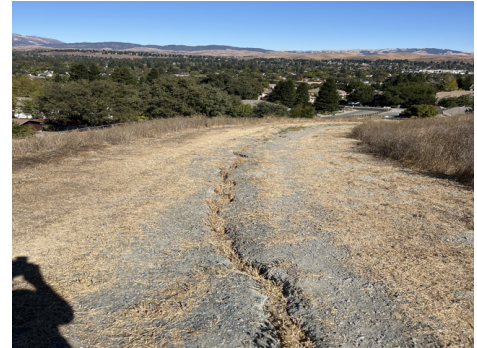
Site Condition: D.1
Observation Date: 10/29/2024
Description: Erosional rill within gravel maintenance road.
Recommendation: Continue to monitor.
Field Representative: GH

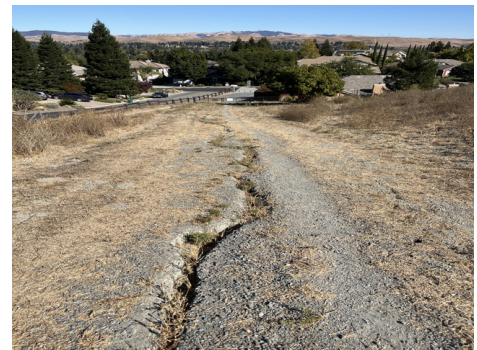
Site Condition: D.2
Observation Date: 10/29/2024
Description: Erosional rill within gravel maintenance road.
Recommendation: Continue to monitor.
Field Representative: GH

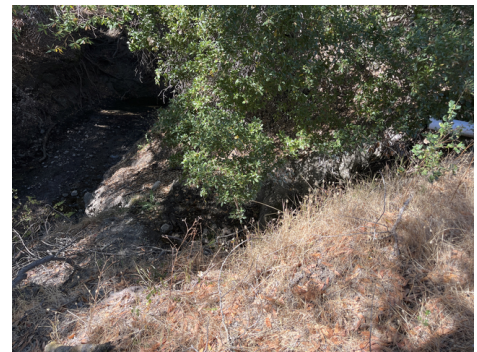
Site Condition: E
Observation Date: 10/29/2024
Description: Slope erosion below subdrain outlet.
Recommendation: Continue to monitor.
Field Representative: GH

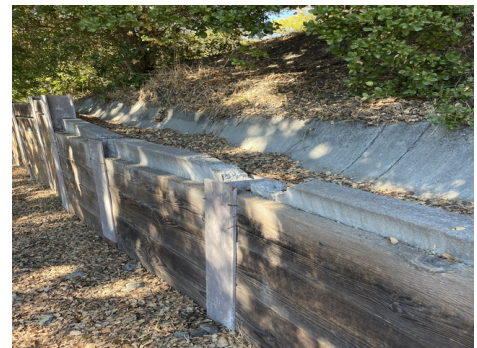
As noted in our previous monitoring reports, we observed significant damage to the top of the concrete-lined drainage ditch within the easement area (Site Condition F, Appendix A, Figure 1). The damaged concrete appeared to be unchanged from our last monitoring event. The drainage ditch will continue to be monitored and will be repaired, as needed, to allow for proper function of the drainage ditch.

Site Condition: F
Observation Date: 10/29/2024
Description: Damaged concrete-lined drainage ditch within Easement Area
Recommendation: Continue to monitor.
Field Representative: GH

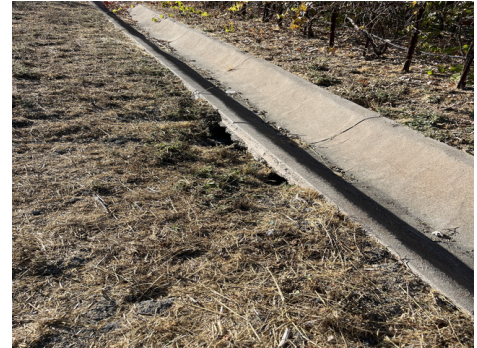
During our fall 2019 monitoring event, we noted that there is a significant void underneath a portion of drainage ditch at the northern end of Lone Tree Lane (Site Condition G, Appendix A, Figure 1). The void appears to be the result of animal burrowing activity. During this monitoring event, we were able to observe the condition of the void to be unchanged, and the drainage ditch did not appear to show significant distress. This area will continue to be monitored and noted, as needed, in future monitoring reports.

Site Condition: G
Observation Date: 10/29/2024
Description: Void beneath concrete-lined drainage ditch.

Recommendation: Continue to monitor.
