Project No. 3586.002.022

June 7, 2023

Subject: Norris Canyon Estates Contra Costa County, California

## GEOLOGIC HAZARD ABATEMENT DISTRICT MONITORING – SPRING 2023

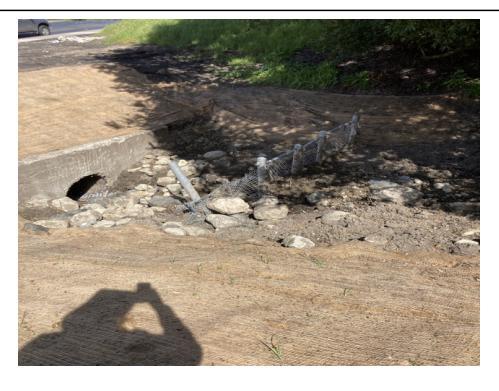
During the winter of 2022-2023, the culvert inlets at 2380 Ashbourne Drive and 3221 Ashbourne Circle were obstructed by debris. Woody vegetation became lodged within the culvert adjacent to 3221 Ashbourne Circle and damaged the trash rack upstream of the culvert. We observed during this monitoring event that the woody vegetation had been removed from the culvert pipe (Site Condition A, Appendix A, Figure 2). The GHAD will continue to monitor the damaged trash rack and will perform repairs in the future. We also observed that the culvert at 2380 Ashbourne Drive is still obstructed by sediment and debris (Site Condition B, Appendix A, Figure 2). The GHAD will remove the sediment and debris from the culvert inlet to allow for proper drainage.

Site Condition: Observation Date:	A 04/24/2023				
Description:	Damaged trash rack.				
Recommendation:	Continue to monitor. replace/repaired.	Trash	rack	to	be
Field Representative:	GH

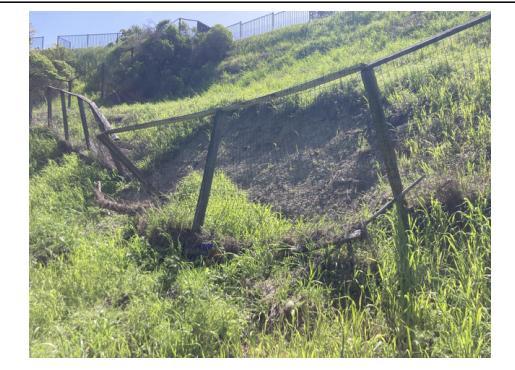
Site Condition:	С
Observation Date:	04/24/2023
Description:	Surficial mudslide along 1:1 slope.
Recommendation:	Continue to monitor.

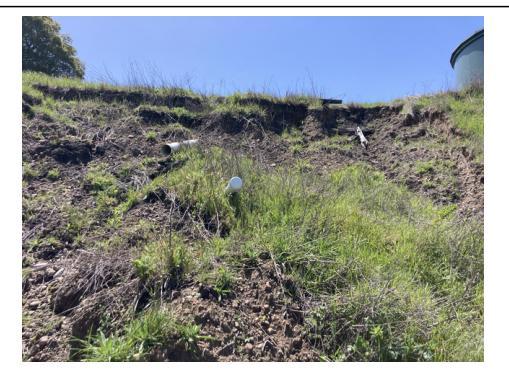
- Shallow earthflow northeast of Bishop Tank Site pad measuring 18 feet wide by 25 feet long with an estimated depth of 1 to 2 feet (Site Condition D.1, Appendix A, Figure 1).

Site Condition: Observation Date:	D.1 04/24/2023
Description:	Shallow earthflow (18 feet wide by 25 feet long with an estimated depth of 1 to 2 feet).
Recommendation:	Continue to monitor. Mitigate/repair as needed.

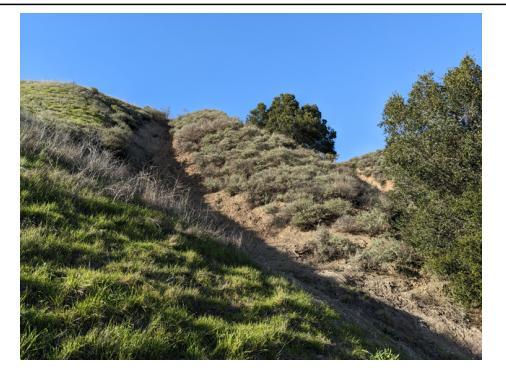
- Shallow earthflow northwest of 3581 Ashbourne Circle rear yard (west) measuring 10 to 15 feet wide by 185 feet long with an estimated depth of 1 to 5 feet (Site Condition D.2, Appendix A, Figure 1).

Site Condition: Observation Date:	D.2 04/25/2023
Description:	Shallow earthflow (10 to 15 feet wide by 185 feet long with an estimated depth of 1 to 2 feet).
Recommendation:	Continue to monitor. Mitigate/repair as needed.
Field Representative:	GH

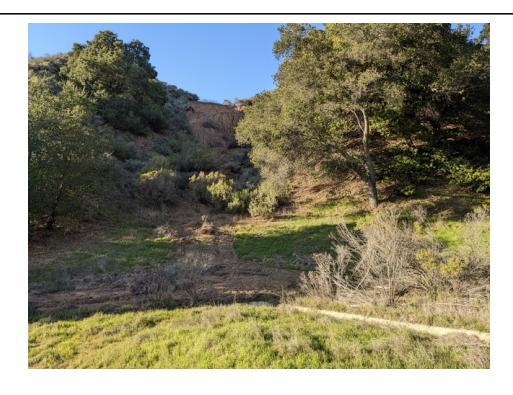
D.3

- Shallow earthflow northwest of 3581 Ashbourne Circle rear yard (east) measuring 40 feet wide by 150 feet long with an estimated depth of 2 to 3 feet (Site Condition D.3, Appendix A, Figure 1).

Shallow earthflow (40 feet wide by 150 feet long

with an estimated depth of 2 to 3 feet).

Continue to monitor. Mitigate/repair as needed.

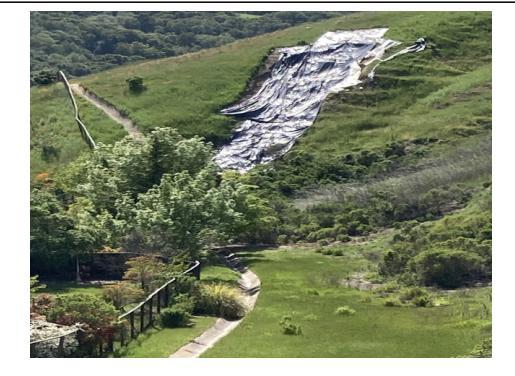
- Shallow earthflow northwest of 3551 Ashbourne Circle rear yard measuring 10 to 30 feet wide by 75 feet long with an estimated depth of 3 to 4 feet (Site Condition D.4, Appendix A, Figure 1).

Site Condition:	D.4
Observation Date:	04/25/2023
Description:	Shallow earthflow (10 to 30 feet wide by 75 feet long with an estimated depth of 3 to 4 feet).
Recommendation:	Continue to monitor. Mitigate/repair as needed.

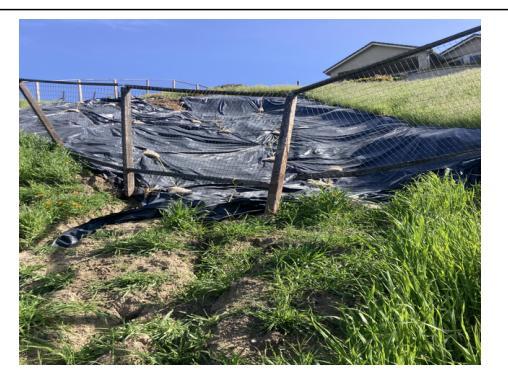
- Shallow earthflow within natural rear slope of 547 Wycombe Court measuring 10 to 15 feet wide by 60 feet long with an estimated depth of 2 to 3 feet (Site Condition D.5, Appendix A, Figure 2).

Site Condition: Observation Date:	D.5 04/25/2023
Description:	Shallow earthflow (10 to 15 feet wide by 60 feet long with an estimated depth of 2 to 3 feet).
Recommendation:	Continue to monitor. Mitigate/repair as needed.

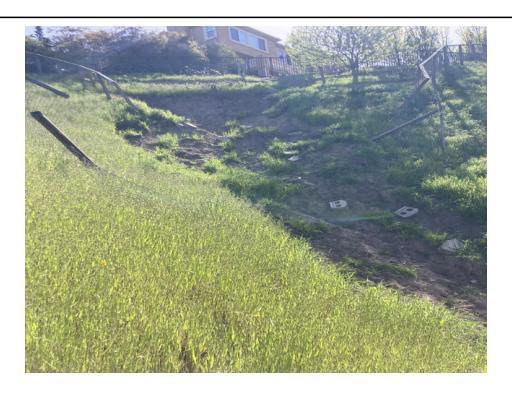
- Shallow earthflow within natural rear slope of 539 Wycombe Court measuring 10 feet wide by 25 feet long with an estimated depth of 1 to 2 feet (Site Condition D.6, Appendix A, Figure 2).

Site Condition: Observation Date:	D.6 04/25/2023
Description:	Shallow earthflow (10 feet wide by 25 feet long with an estimated depth of 1 to 2 feet).
Recommendation:	Continue to monitor. Mitigate/repair as needed.
Field Representative:	GH

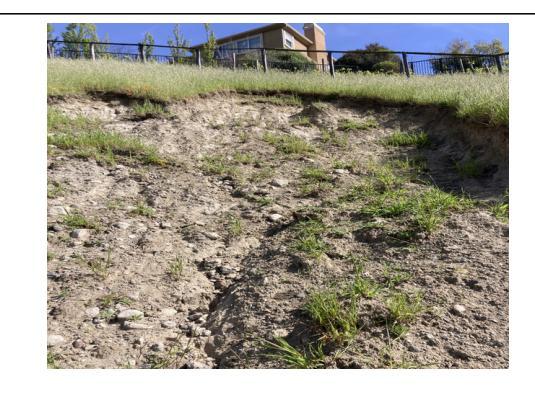
D.7

- Shallow earthflow southwest of 539 Wycombe Court rear yard measuring 10 to 15 feet wide by 185 feet long with an estimated depth of 1 to 5 feet (Site Condition D.7, Appendix A, Figure 2).

Shallow earthflow (25 feet wide by 35 feet long

with an estimated depth of 2 to 3 feet).

Continue to monitor. Mitigate/repair as needed.

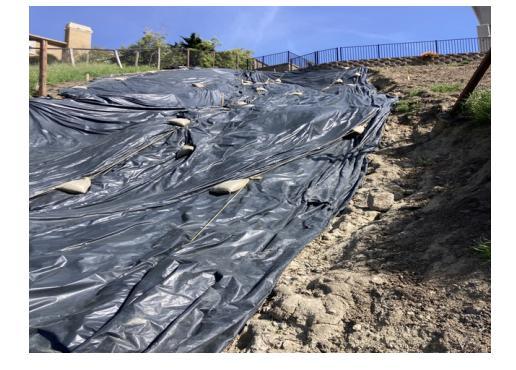
- Shallow earthflow within natural rear slope of 533 Wycombe Court measuring 15 to 20 feet wide by 60 feet long with an estimated depth of 12 to 4 feet (Site Condition D.8, Appendix A, Figure 2).

Site Condition: Observation Date:	D.8 04/25/2023
Description:	Shallow earthflow (15-20 feet wide by 60 feet long with an estimated depth of 2 to 4 feet).
Recommendation:	Continue to monitor. Mitigate/repair as needed.

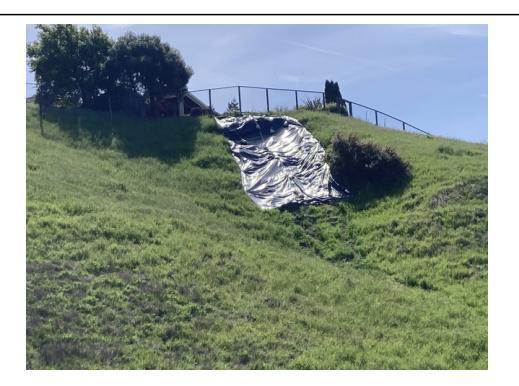
- Shallow earthflow west of 3340 Ashbourne Circle rear yard measuring 15 feet wide by 20 feet long with an estimated depth of 2 to 3 feet (Site Condition D.9, Appendix A, Figure 2).

Site Condition: Observation Date:	D.9 04/25/2023
Description:	Shallow earthflow (15 feet wide by 20 feet long with an estimated depth of 2 to 3 feet).
Recommendation:	Continue to monitor. Mitigate/repair as needed.

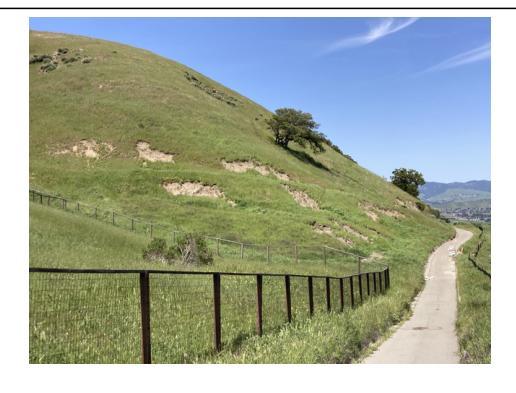
- Multiple shallow earthflows along northwestern side of EVA Road. (Site Condition D.10, Appendix A, Figure 2).

Site Condition:	D.10
Observation Date:	04/25/2023
Description:	Multiple shallow earthflows along northwest side of EVA Road.
Recommendation:	Continue to monitor.
Field Representative:	GH

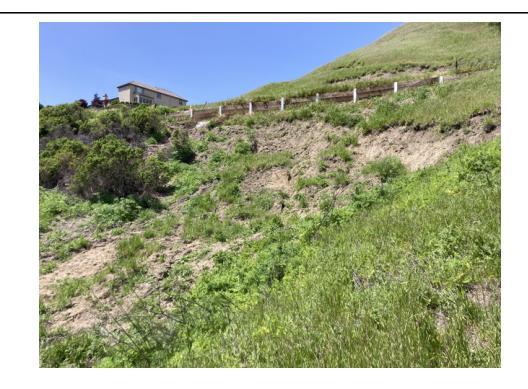
D.11

- Shallow earthflow west of EVA Road and retaining wall measuring 50 to 60 feet wide by 40 feet long with an estimated depth of 2 to 3 feet (Site Condition D.11, Appendix A, Figure 2).

Shallow earthflow (50 to 60 feet wide by 40 feet long with an estimated depth of 2 to 3 feet).

Continue to monitor. Mitigate/repair as needed.

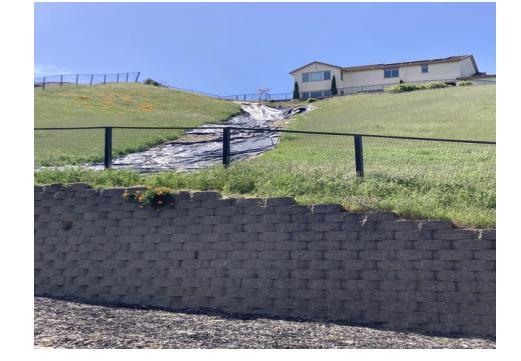
- Shallow earthflow within natural rear slope of 231 Cliffecastle Court measuring 15 wide by 30 feet long with an estimated depth of 4 to 5 feet (Site Condition D.12, Appendix A, Figure 2).

Site Condition:	D.12
Observation Date:	04/25/2023
Description:	Shallow earthflow (15 feet wide by 30 feet long with an estimated depth of 4 to 5 feet).
Recommendation:	Continue to monitor. Mitigate/repair as needed.

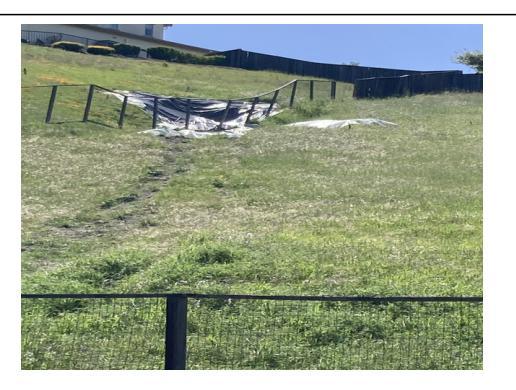
- Shallow earthflow within natural rear slope of 223 and 231 Cliffecastle Court measuring 15 feet wide by 30 to 40 feet long with an estimated depth of 2 to 3 feet (Site Condition D.13, Appendix A, Figure 2).

Site Condition: Observation Date:	D.13 04/25/2023
Description:	Shallow earthflow (15 feet wide by 30 to 40 feet long with an estimated depth of 2 to 3 feet).
Recommendation:	Continue to monitor. Mitigate/repair as needed.

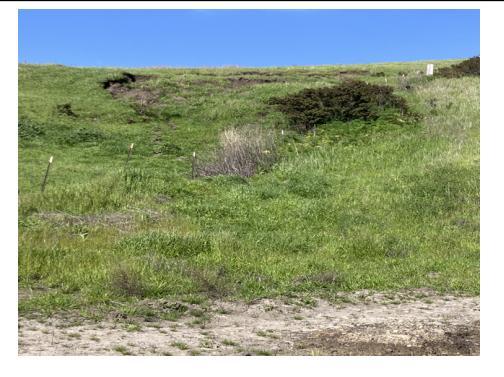
- Slope erosion rills northeast of Whitcliffe Court measuring 1 to 2 feet wide by 35 feet long with an estimated depth of 1 to 2 feet (Site Condition E, Appendix A, Figure 1). Erosional rills are outside of the GHAD boundary.

Site Condition: Observation Date:	E 04/24/2023	
Description:	Off-site slope erosion adjacent to boundary	GHAD
Recommendation:	Continue to monitor.	
Field Representative:	GH

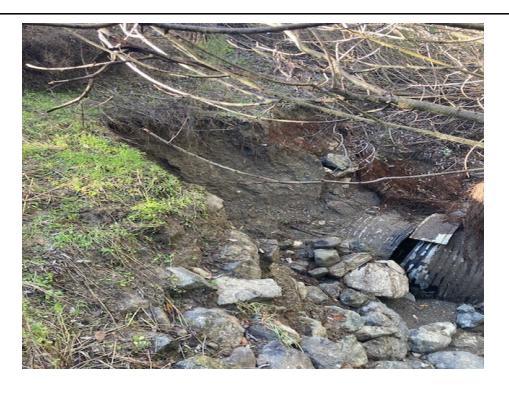
Site Condition: Observation Date:	F.1 04/24/2023
Description:	Eroded and displaced backfill above culvert pipe.
Recommendation:	Repair culvert pipe and slope above pipe.

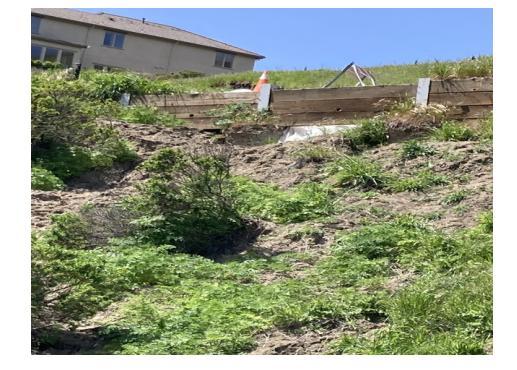
Site Condition: Observation Date:	F.2 04/25/2023
Description:	Eroded and displaced backfill behind retaining wall and below wall lagging.
Recommendation:	Replace backfill behind wall after reconstruction of fill in front of wall.

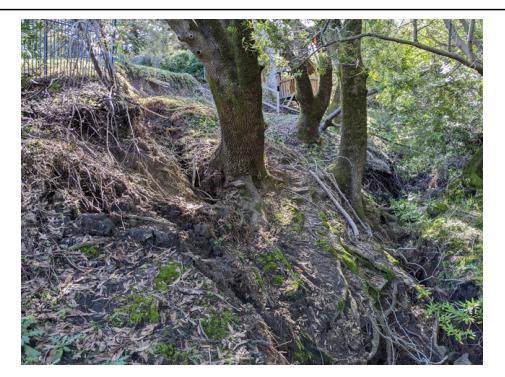
- Creek bank failure/slump within natural creek bank of 2380 Ashbourne Drive measuring 40 to 45 feet wide by 35 feet long with an estimated depth of 5 to 6 feet (Site Condition G, Appendix A, Figure 1).

Site Condition: Observation Date:	G 04/24/2023
Description:	Creek bank failure/slump measuring 40 to 45 feet wide by 35 feet long with an estimated depth of 5 to 6 feet.
Recommendation:	Continue to monitor. Mitigate/repair as needed.

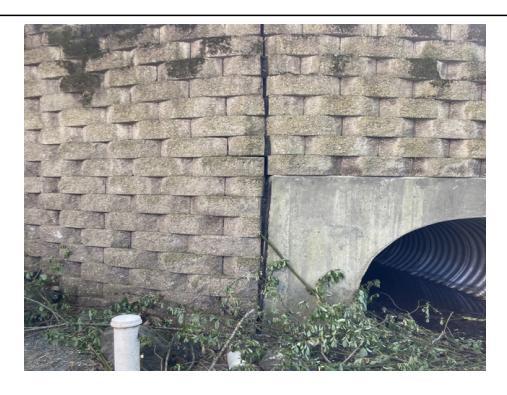
L

Retaining Wall L-5 subdrain outlet discharges directly over a separated drainage ditch expansion joint, and potential subdrain and/or surface water can seep through the separation and potentially saturate the soil of the slope (Site Condition I, Appendix A, Figure 1). During this monitoring event, the surrounding slope did not show significant saturation or movement. The expansion joint between segments of the concrete-lined drainage ditch should be sealed/patched, and the GHAD will continue monitoring the area for slope stability concerns.

Concrete-lined drainage ditch separated at expansion joint. Approximate 1-inch separation.

Continue to monitor.

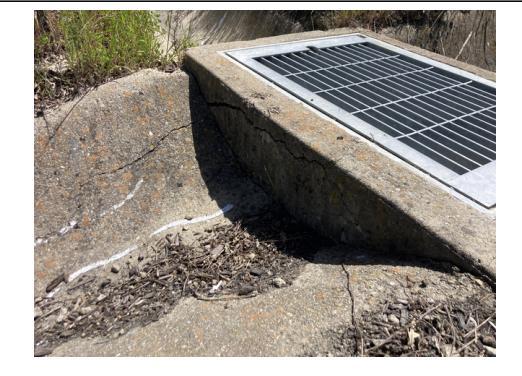
During the Spring 2020 monitoring event, the top of the storm drain inlet box at the concrete-lined drainage ditch, located southwest of 3057 Ashbourne Circle, showed cracking and significant separation from the inlet box structure. At the time of this monitoring event, the cracking had not progressed (Site Condition J, Appendix A, Figure 2). The inlet box and cracks should continue to be monitored and, if needed, sealed or replaced to maintain the integrity and longevity of the drain inlet.

Site Condition: Observation Date:	J 04/24/2023
Description:	Crack along top portion of DI box.
Recommendation:	Continue to monitor and replace if cracking affects DI function.
Field Representative:	GH

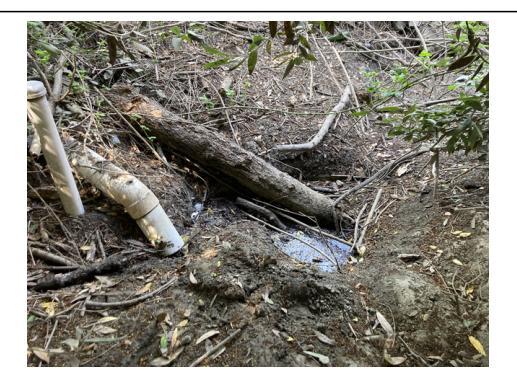
We observed that the storm drain inlet located at the southeastern corner of 101 Lyndhurst Place was obstructed by vegetation and sediment (Site Condition K, Appendix A, Figure 1). The drain inlet will be cleared during annual maintenance work.

Site Condition:	К
Observation Date:	04/24/2023
Description:	Storm drain inlet obstructedy by vegetation and sediment.
Recommendation:	Storm drain inlet should be cleared of vegetation and sediment.
Field Representative:	GH

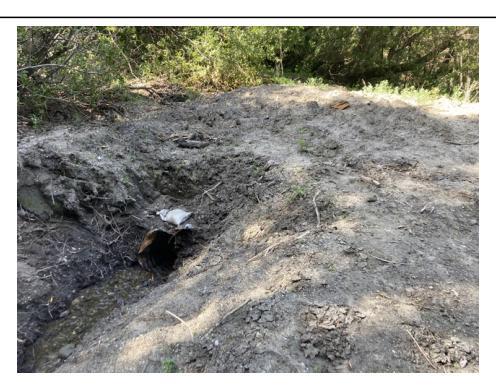
Site Condition: Observation Date:	L.1 04/25/2023
Description:	Maintained drainage culvert.
Recommendation:	Continue to monitor.
Field Representative:	GH

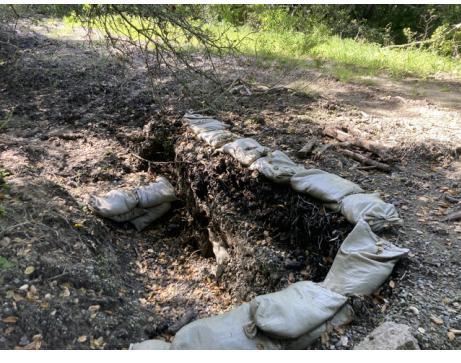
L.2

Maintained drainage culvert.

Continue to monitor.
