Project No.
3586.002.022

October 13, 2022

Subject: Elworthy Ranch
Danville, California

**GEOLOGIC HAZARD ABATEMENT DISTRICT MONITORING
FALL 2022**

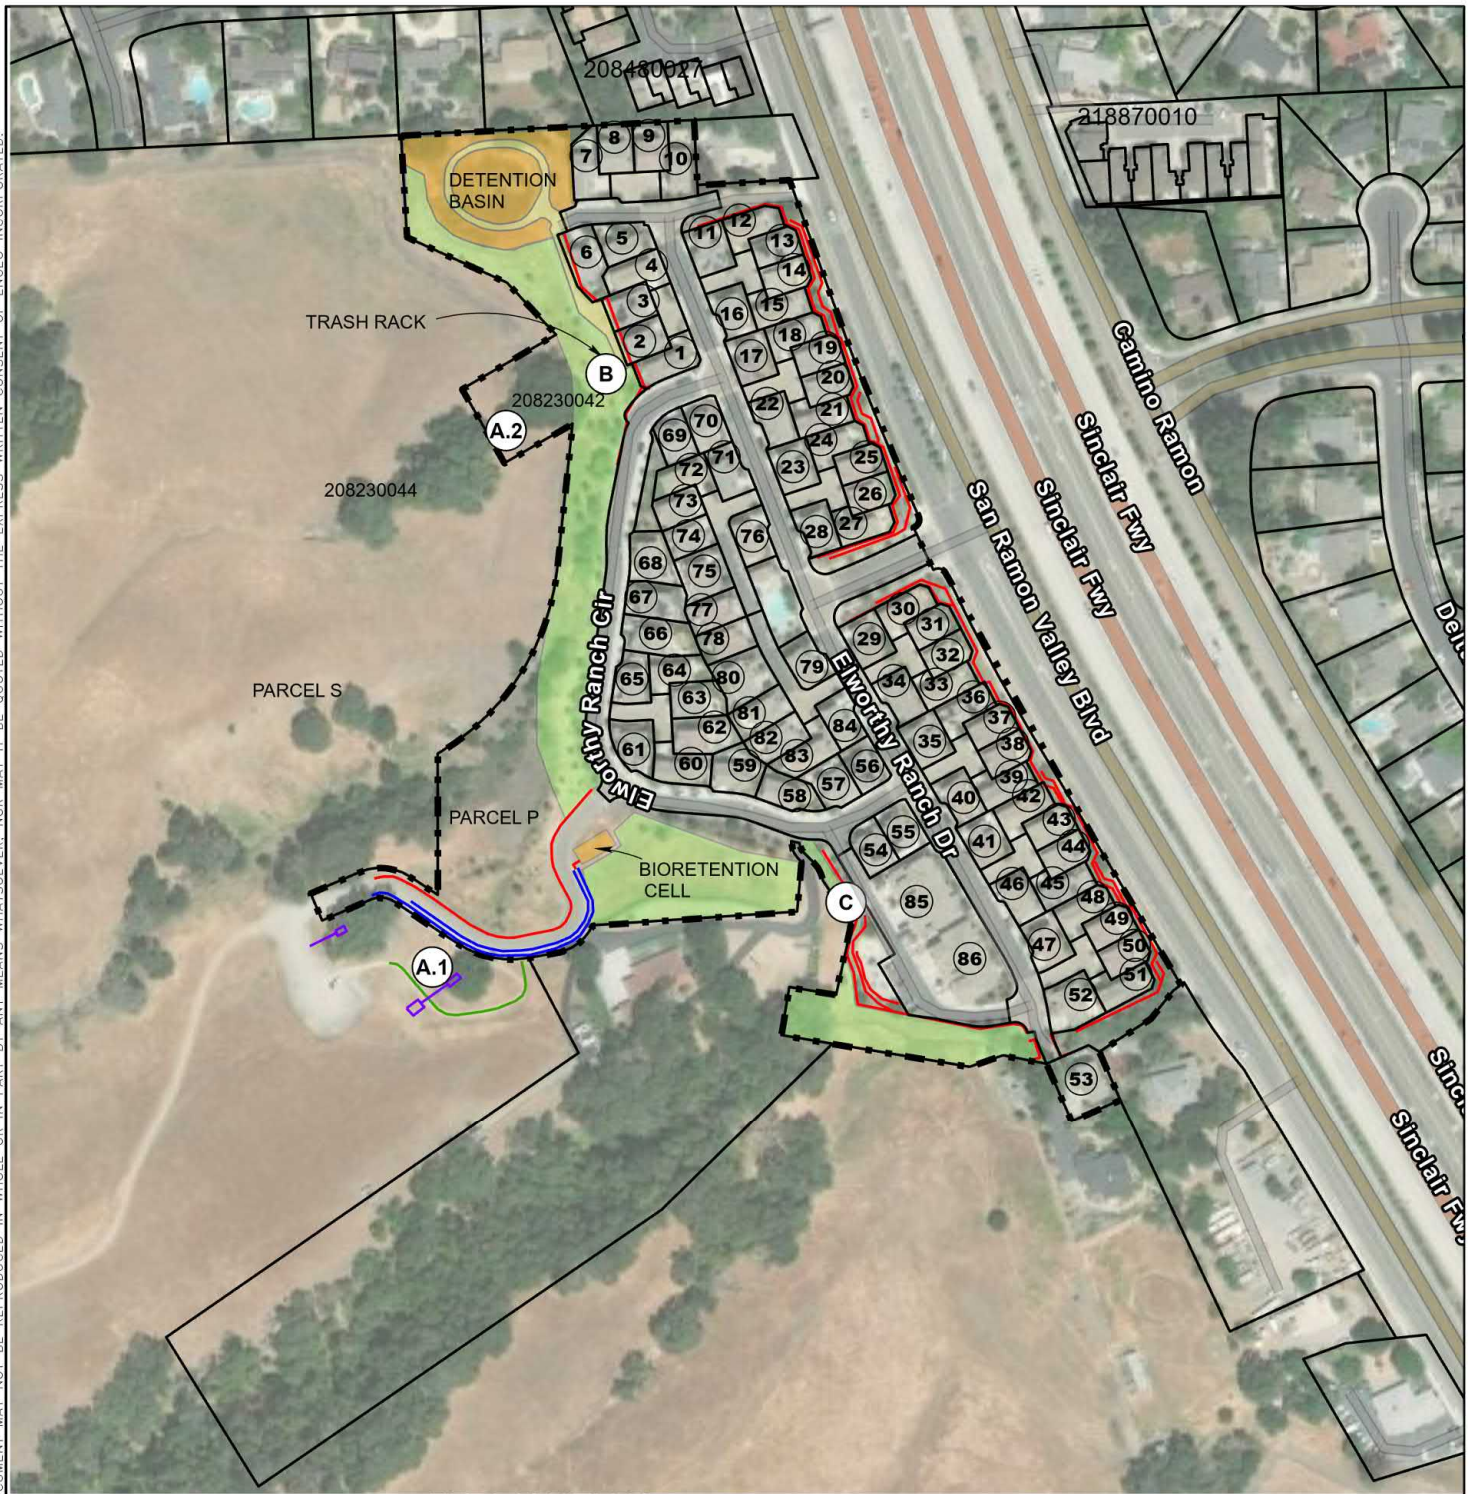
Figure 1 – Site Plan

A detention basin (Figure 1) is located at the end of Elworthy Ranch Lane. Monitoring of the detention basin was conducted as part of the Open Space monitoring. The observed conditions for the detention basin are described in the attached Elworthy Ranch Detention Basin Site Monitoring and Maintenance Form. Contracted ongoing routine maintenance within the water quality/detention basin currently includes roadway maintenance, weed abatement, and woody vegetation removal. At the time of our visit, the detention basin appeared to be functioning properly and was in good condition.
