Project No.  
**3586.002.022**

Subject: Norris Canyon Estates  
Contra Costa County, California

**GEOLOGIC HAZARD ABATEMENT DISTRICT  
MONITORING – Fall 2022**

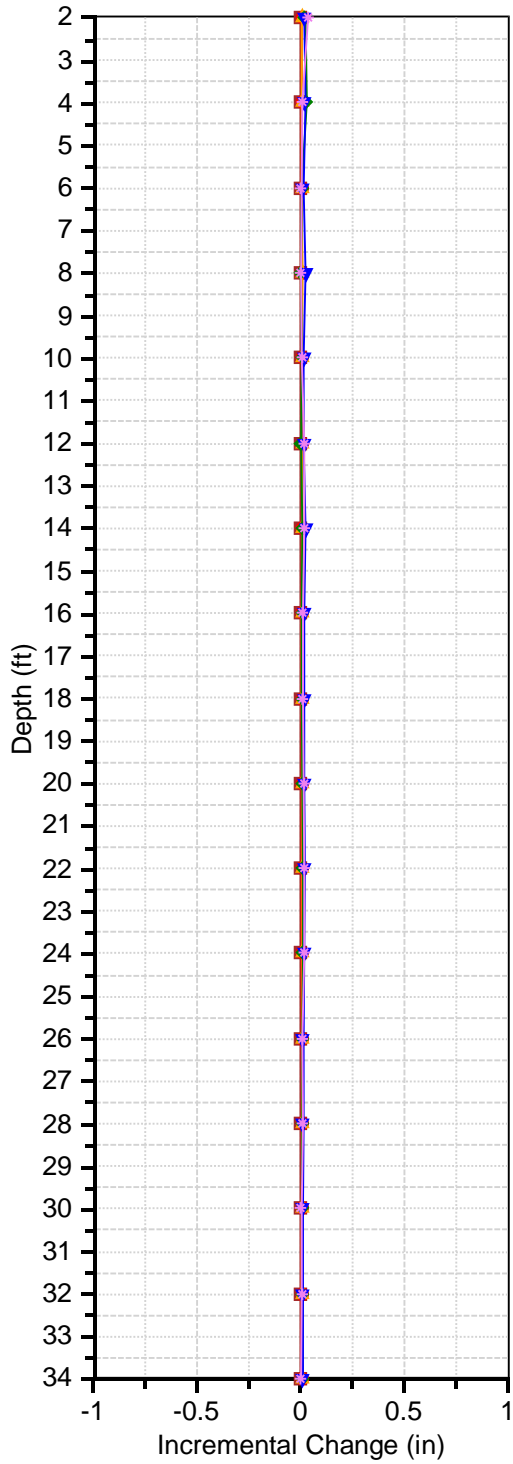
Norris SI-2 A

As previously mentioned in this report, The GHAD has an ongoing investigation in regard to AC cracking along Ashbourne Drive, which includes monitoring of two slope inclinometers installed between Ashbourne Drive and MSE Retaining Wall L2 (Figure 1). Test results of the inclinometer readings performed during this monitoring event are presented in Appendix B.
