Project No.
3586.002.022

April 20, 2023

Subject: Red Hawk Development
Danville, California

**GEOLOGIC HAZARD ABATEMENT DISTRICT MONITORING
SPRING 2023**

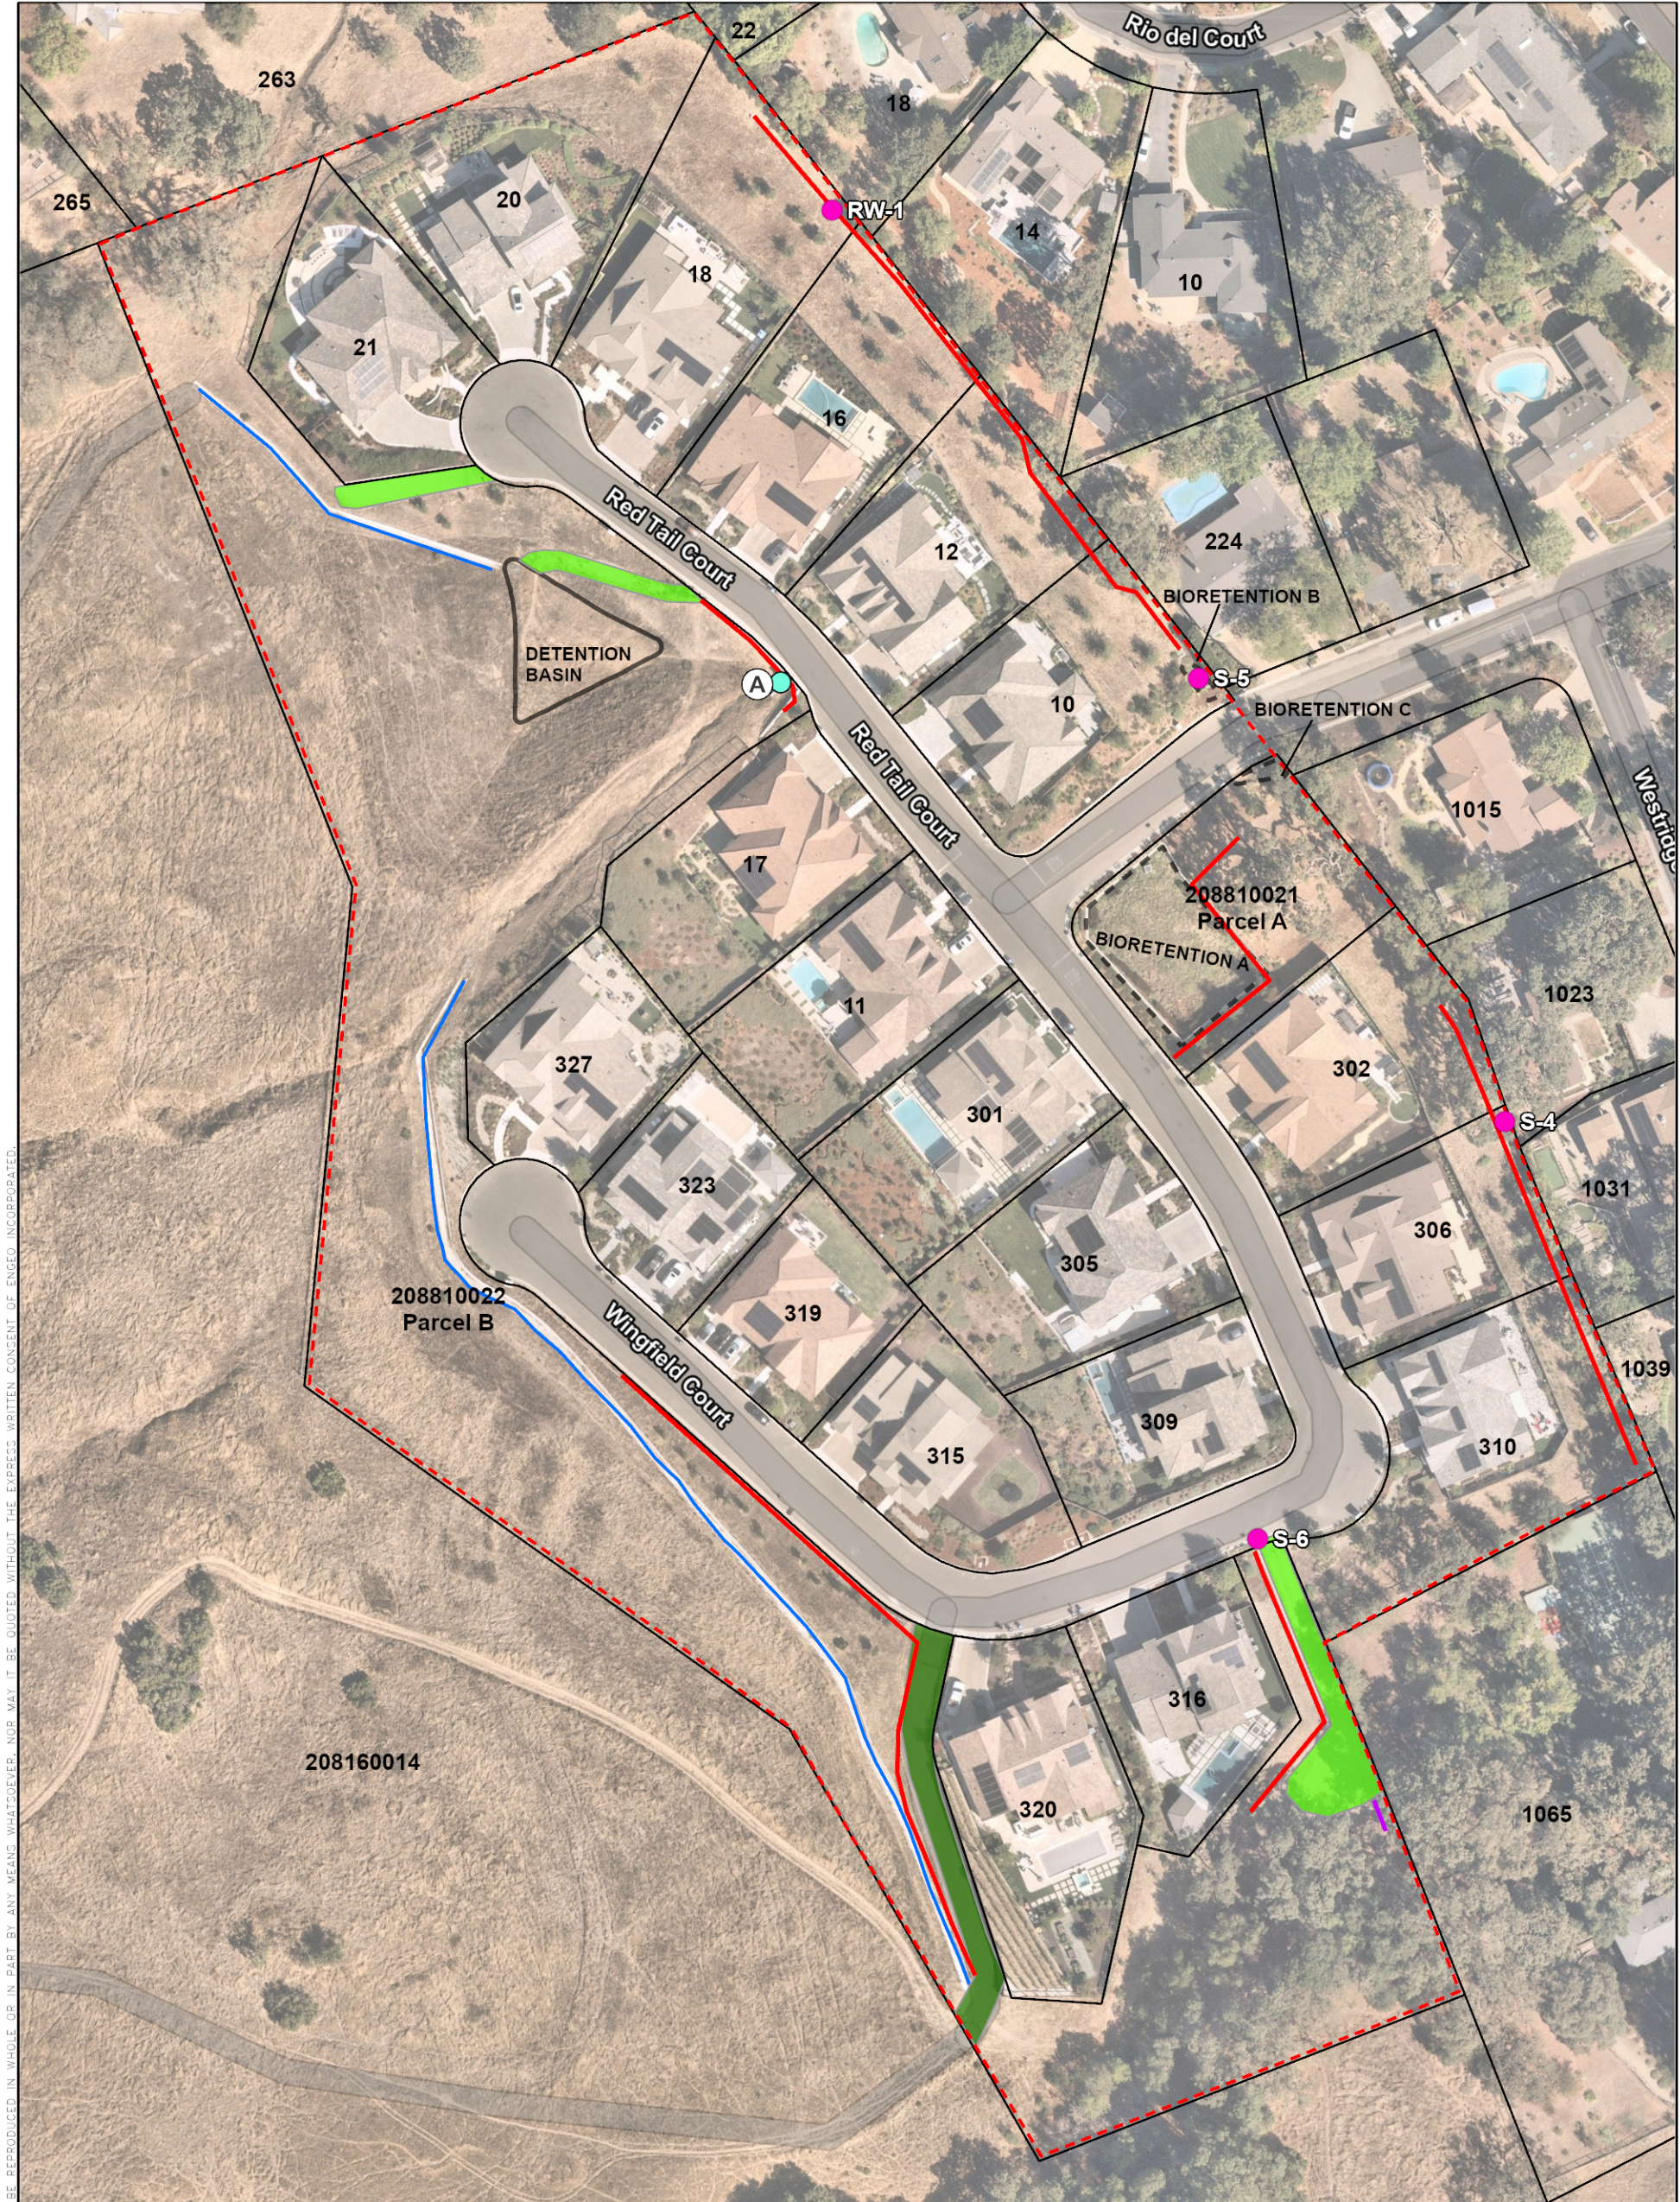
FIGURE 1 – SITE PLAN

A detention basin (Figure 1) is located at the end of Red Tail Court. Monitoring of the detention basin was conducted as part of the open-space monitoring. The observed conditions for the detention basin are described in the attached Red Hawk Development Detention Basin Site Monitoring and Maintenance Form. Contracted ongoing routine maintenance within the detention basin currently includes roadway maintenance, weed abatement, and woody vegetation removal. At the time of our visit, the detention basin appeared to be functioning properly and was in good condition. We observe significant accumulation of sediment adjacent to the basin outlet structure (Site Condition A, Appendix A, Figure 1). The excess sediment will be removed by the GHAD during routine maintenance.

Site Condition: A
Observation Date: 04/04/2023
Description: Sediment accumulation adjacent to basin outlet structure.
Recommendation: Sediment should be removed during routine maintenance.
Field Representative: GH
