Project No.
3586.002.022

May 4, 2023

Subject: Elworthy Ranch
Danville, California

**GEOLOGIC HAZARD ABATEMENT DISTRICT MONITORING
SPRING 2023**

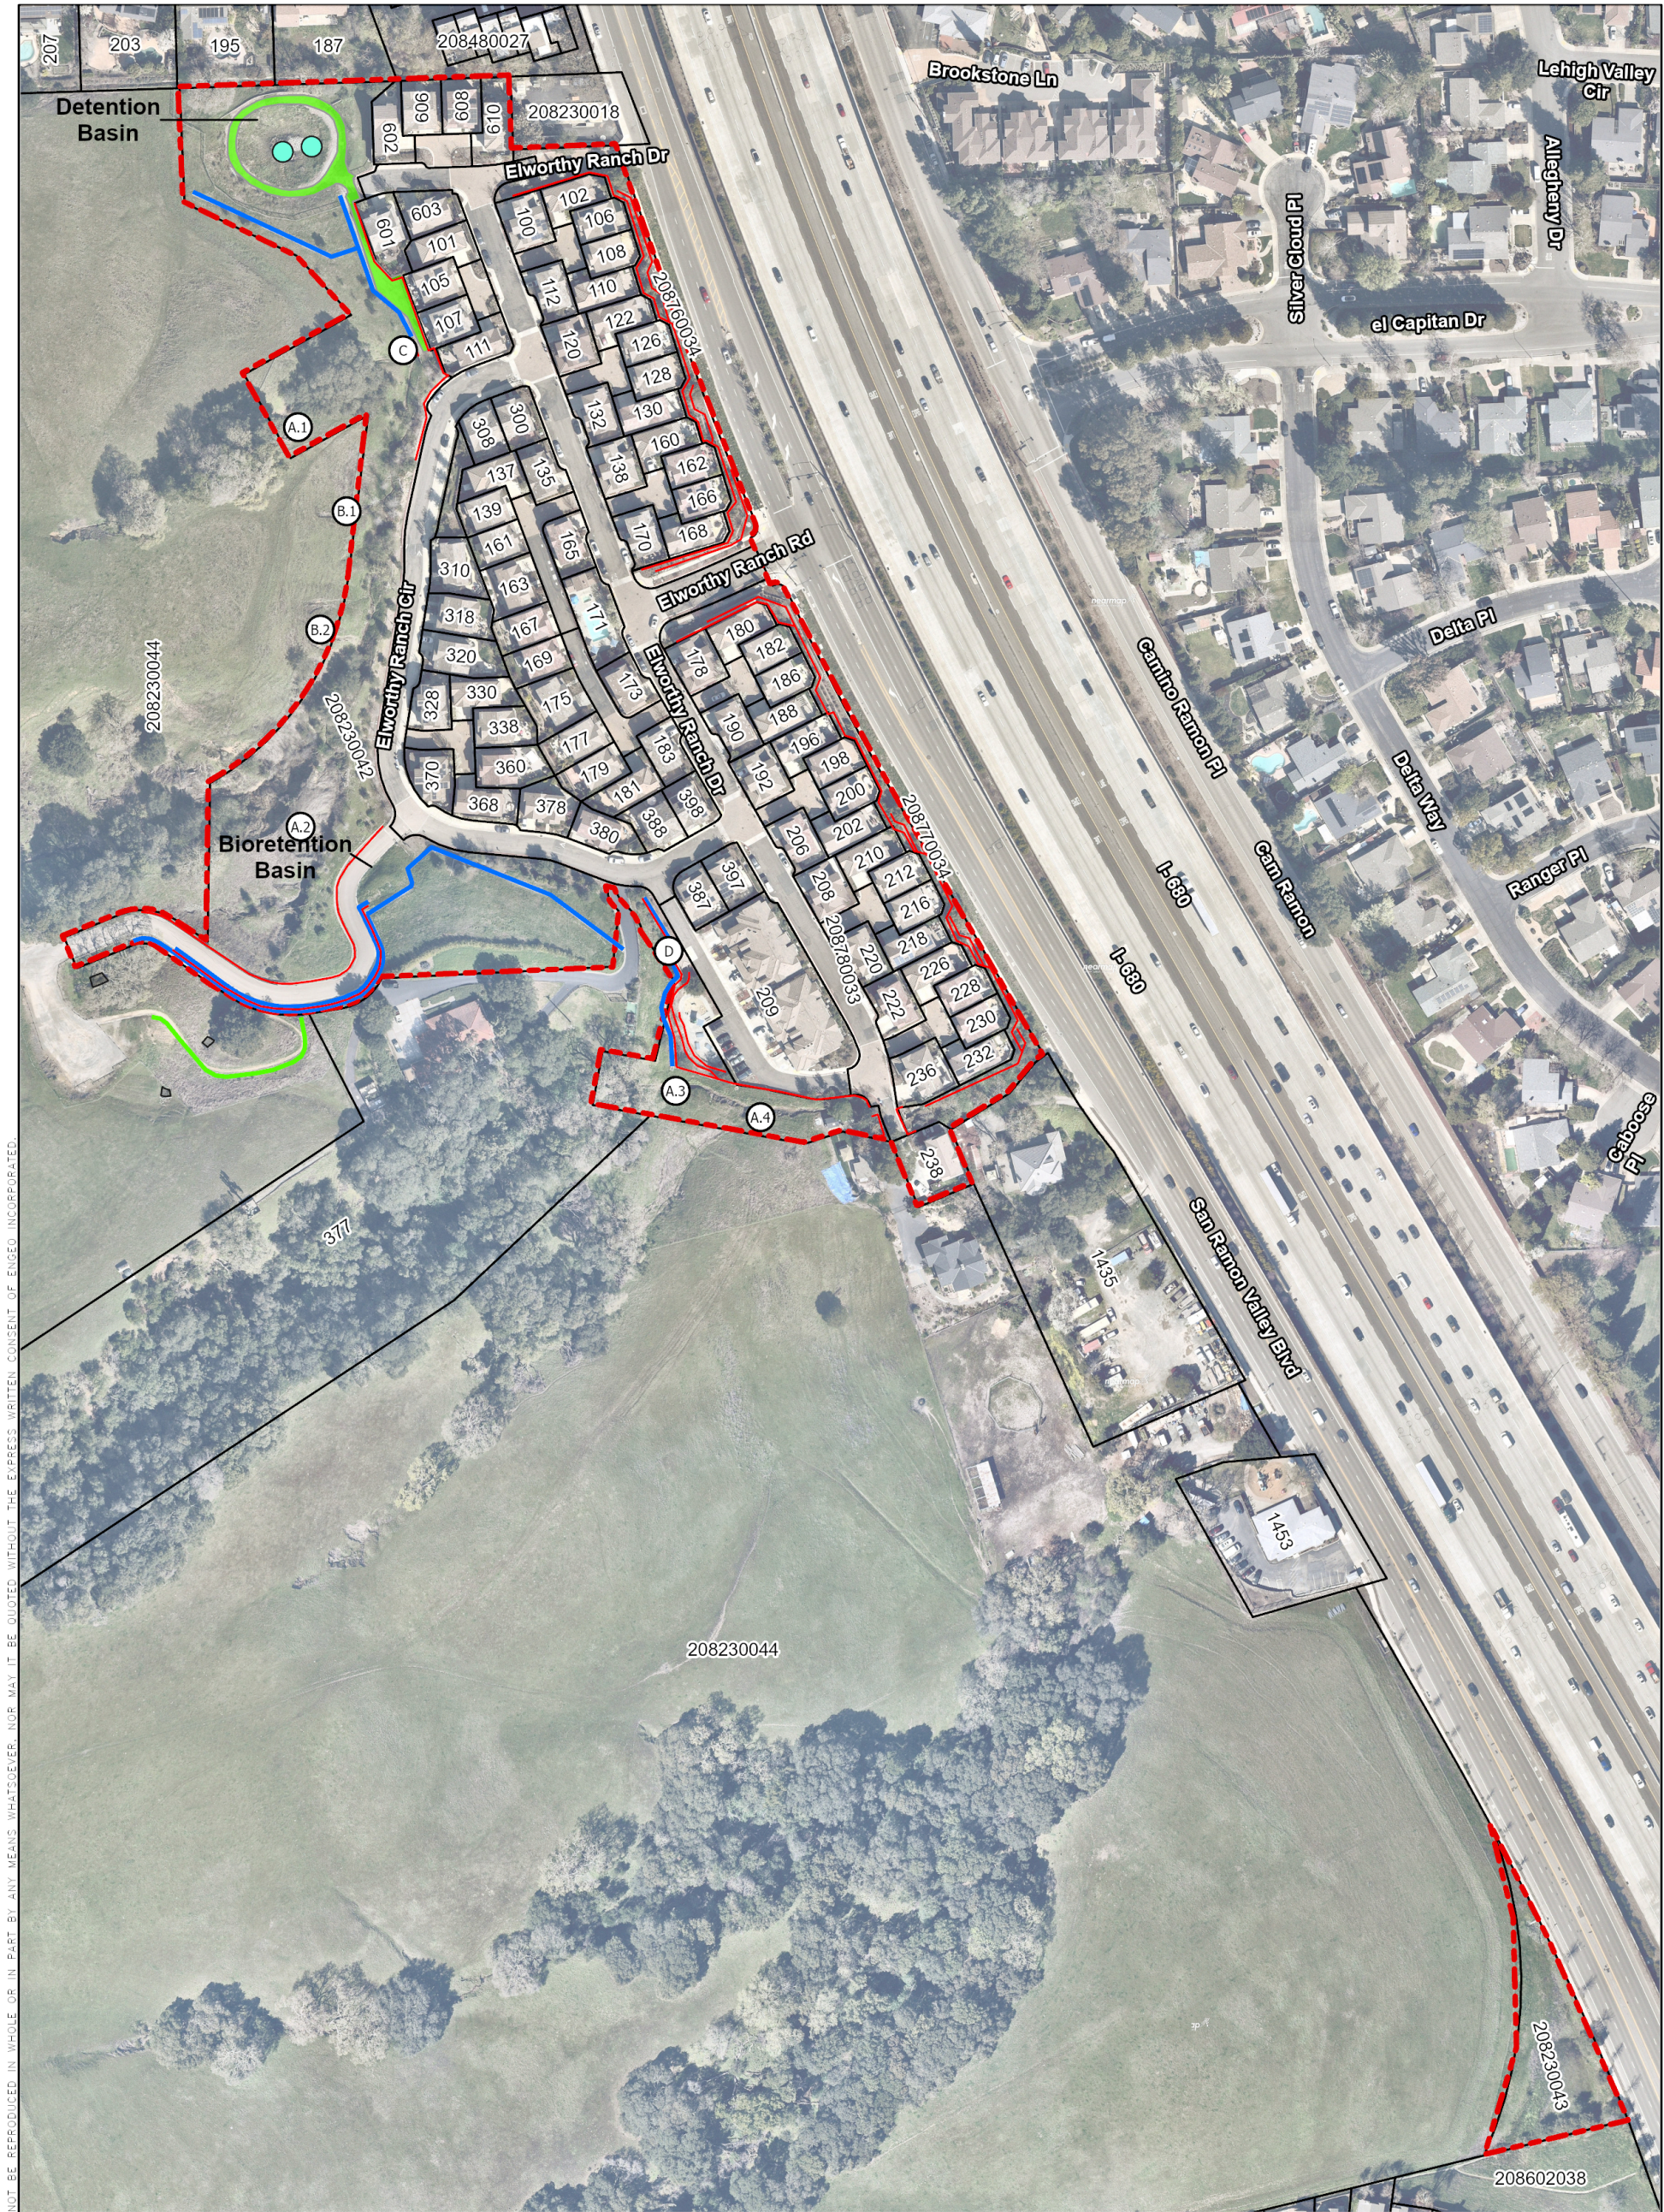
Figure 1 – Site Plan

A detention basin (Figure 1) is located at the end of Elworthy Ranch Lane. Monitoring of the detention basin was conducted as part of the Open Space monitoring. The observed conditions for the detention basin are described in the attached Elworthy Ranch Detention Basin Site Monitoring and Maintenance Form. Contracted ongoing routine maintenance within the water quality/detention basin currently includes roadway maintenance, weed abatement, and woody vegetation removal. At the time of our visit, the detention basin appeared to be functioning properly and was in good condition.
