Project No.  
**3586.002.023**

October 12, 2023

Subject: Red Hawk Development  
 Danville, California

**GEOLOGIC HAZARD ABATEMENT DISTRICT  
 MONITORING – FALL 2023**

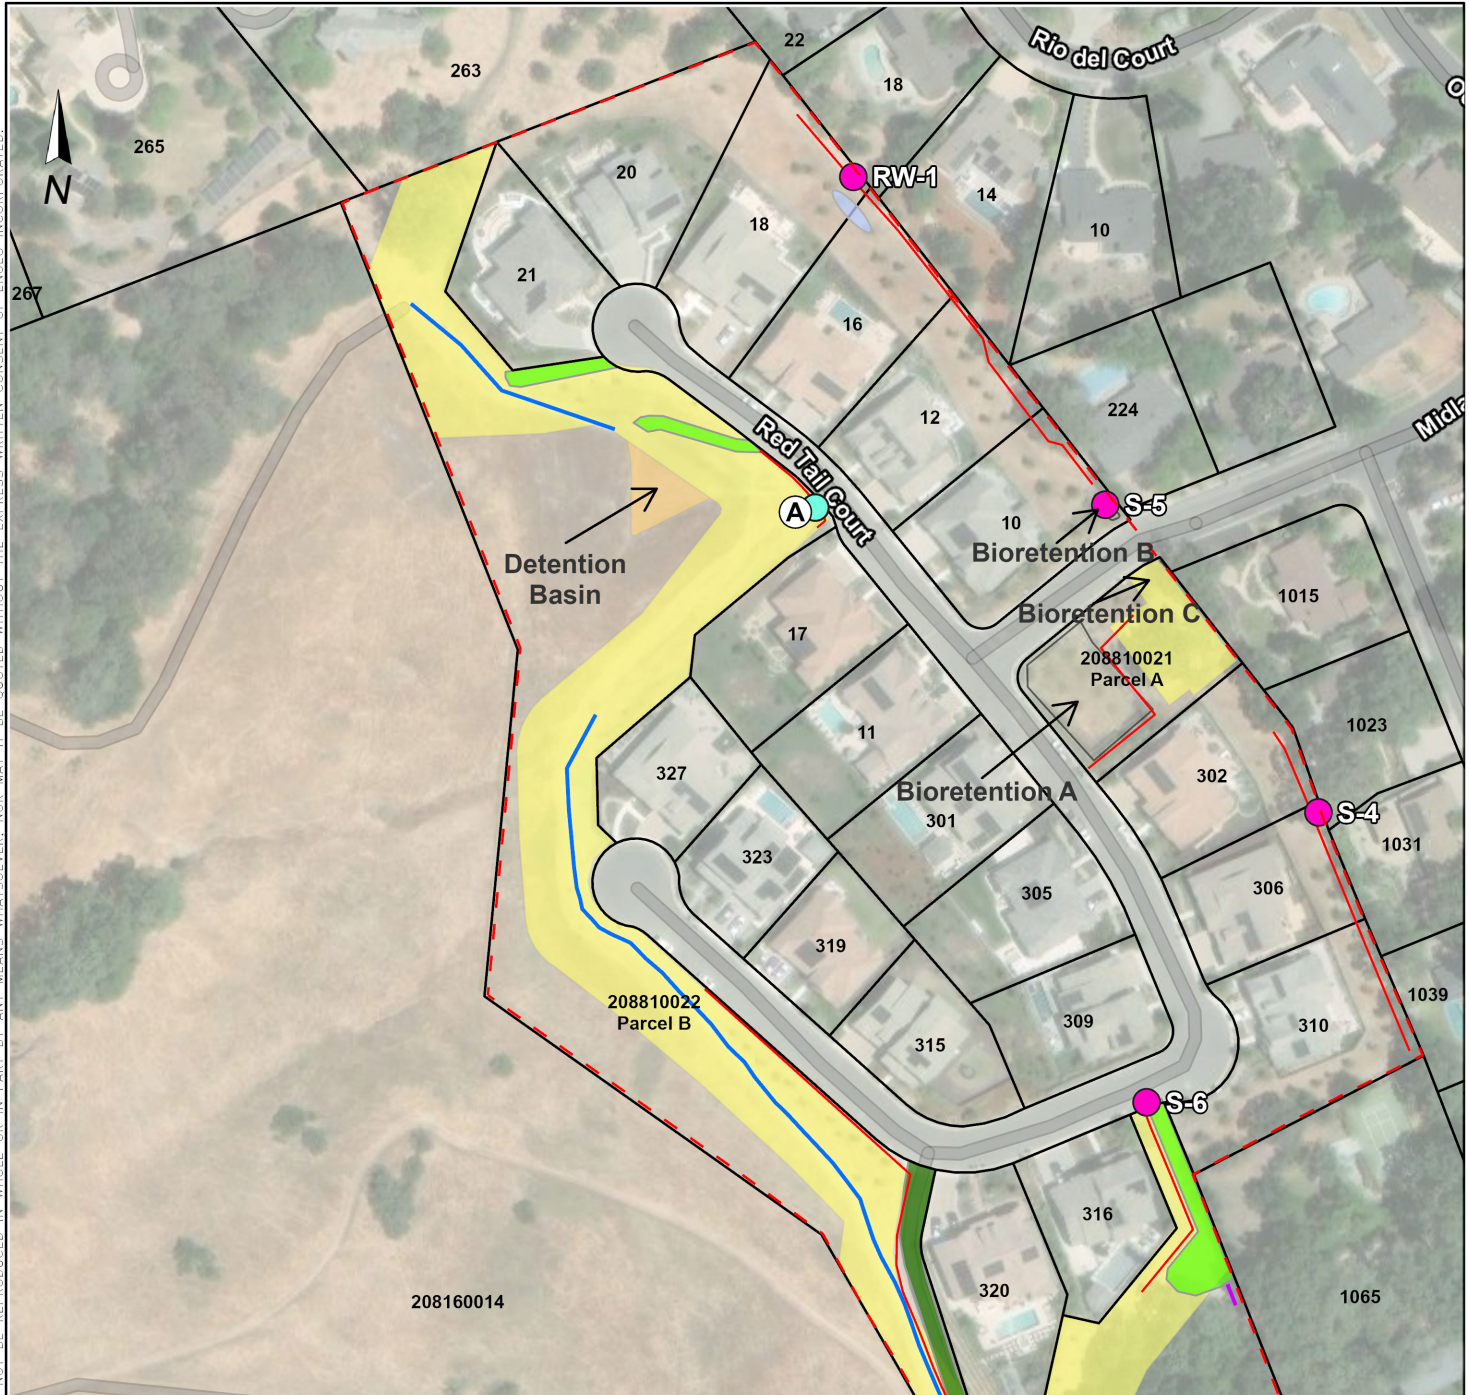
**FIGURE 1 – SITE PLAN**

A detention basin (Figure 1) is located at the end of Red Tail Court. Monitoring of the detention basin was conducted as part of the open-space monitoring. The observed conditions for the detention basin are described in the attached Red Hawk Development Detention Basin Site Monitoring and Maintenance Form. Contracted ongoing routine maintenance within the detention basin currently includes roadway maintenance, weed abatement, and woody vegetation removal. At the time of our visit, the detention basin appeared to be functioning properly and was in good condition. We observe significant accumulation of sediment adjacent to the basin outlet structure (Site Condition A, Appendix A, Figure 1). The excess sediment will be removed by the GHAD during routine maintenance.

Site Condition: A  
Observation Date: 09/28/2023  
Description: Sediment accumulation adjacent to basin outlet structure.  
Recommendation: Sediment should be removed during routine maintenance.  
Field Representative: GH
