Project No.
3586.002.023

Subject: Norris Canyon Estates
Contra Costa County, California

**GEOLOGIC HAZARD ABATEMENT DISTRICT
MONITORING – FALL 2023**

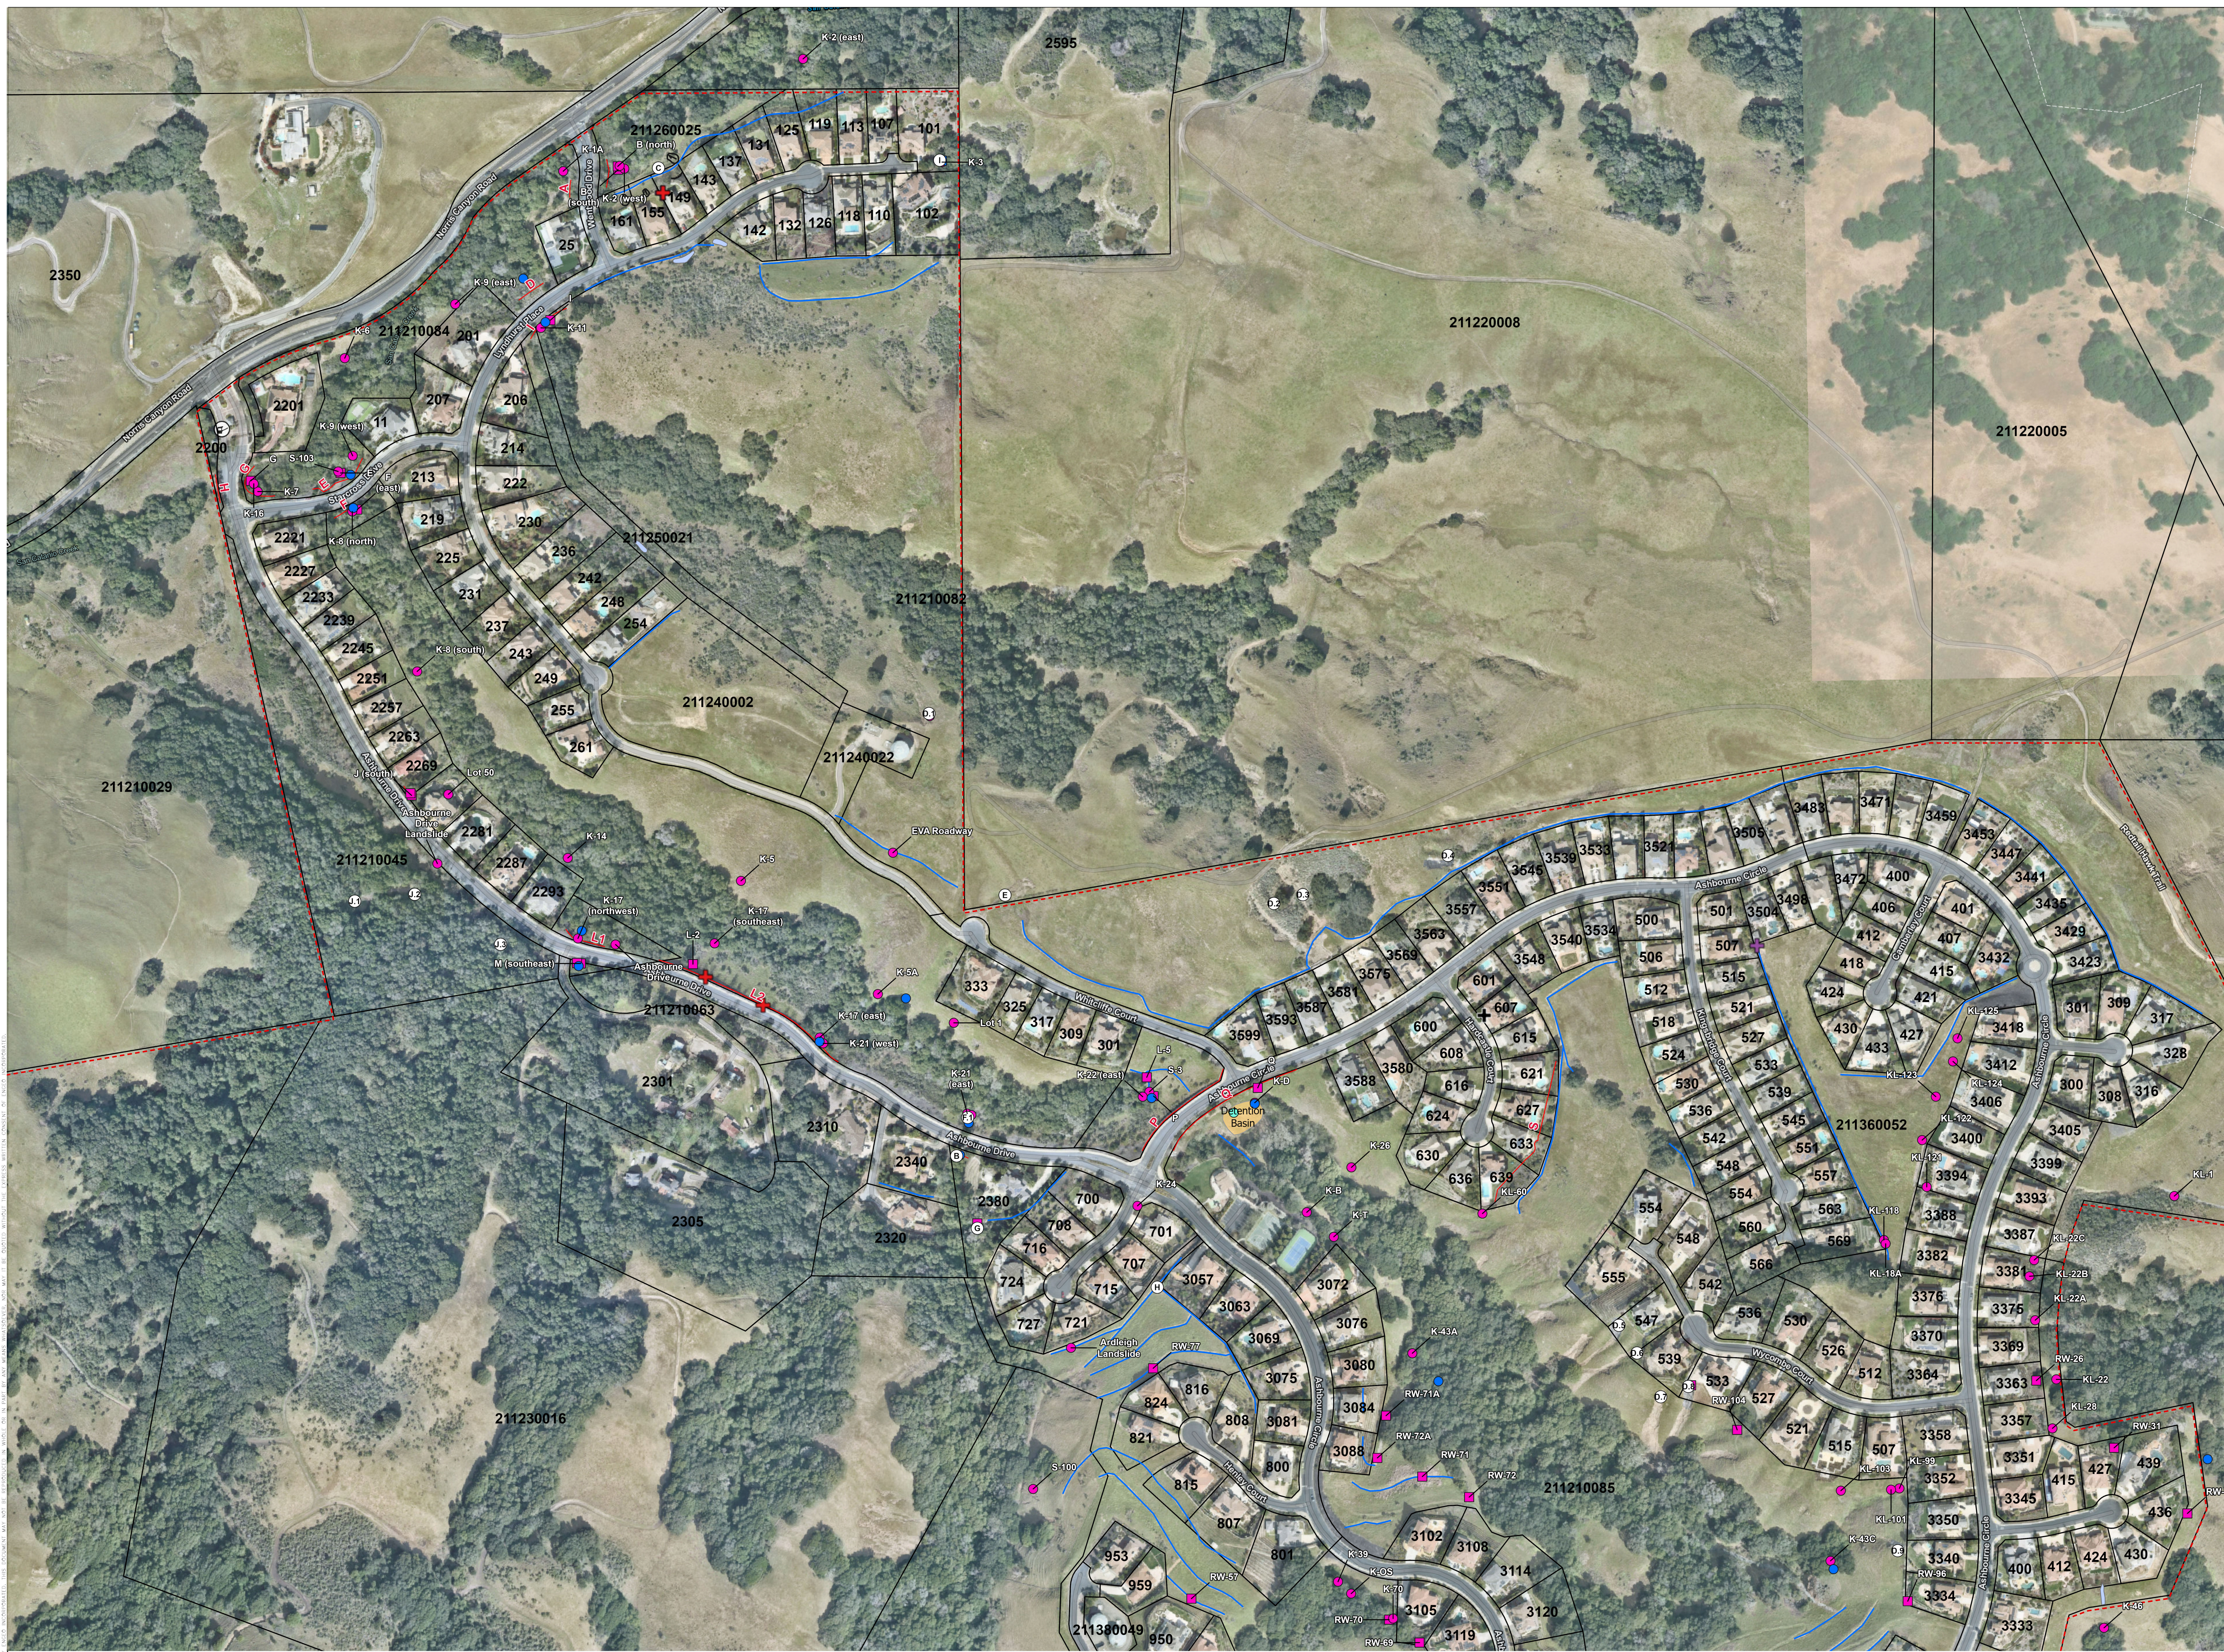
Figures 1 and 2 – Site Plan

- Shallow earthflow northeast of Bishop Tank Site pad measuring 18 feet wide by 25 feet long with an estimated depth of 1 to 2 feet. Condition unchanged (Site Condition D.1, Appendix A, Figure 1).
