Project No.  
**3586.002.023**

April 17, 2024

Subject: Norris Canyon Estates  
Contra Costa County, California

**GEOLOGIC HAZARD ABATEMENT DISTRICT  
MONITORING – SPRING 2024**

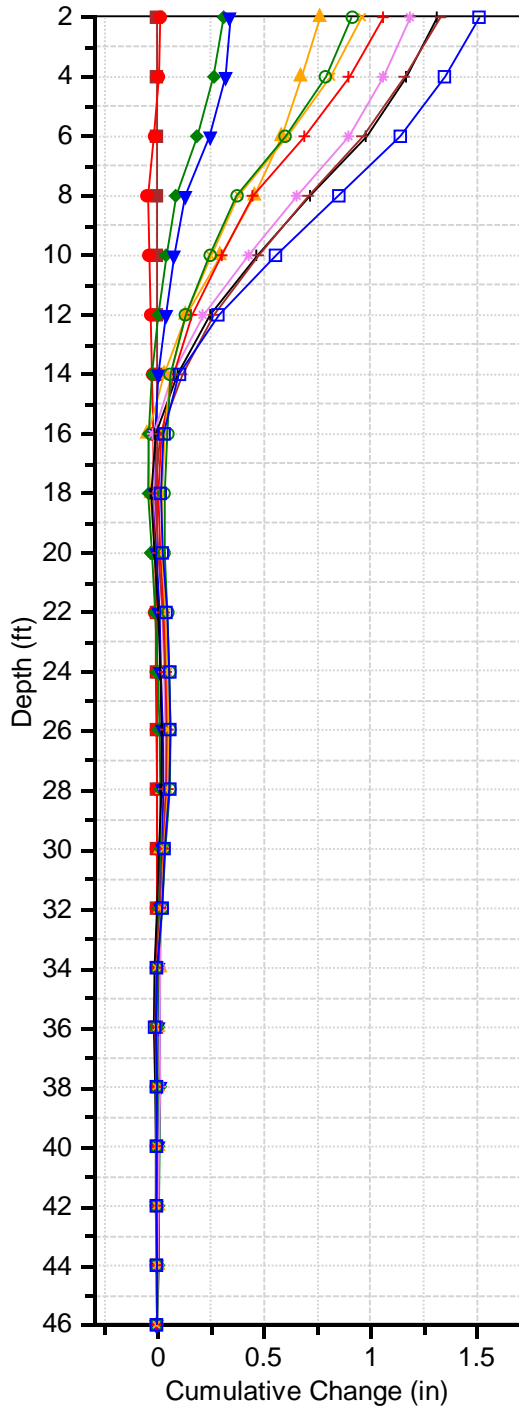
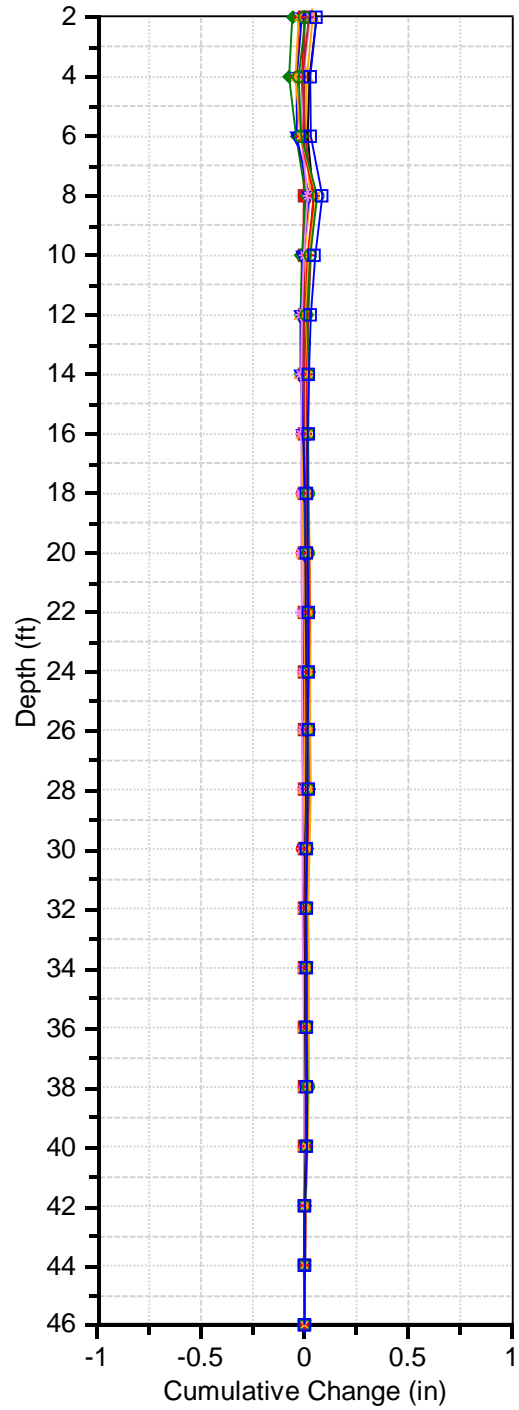
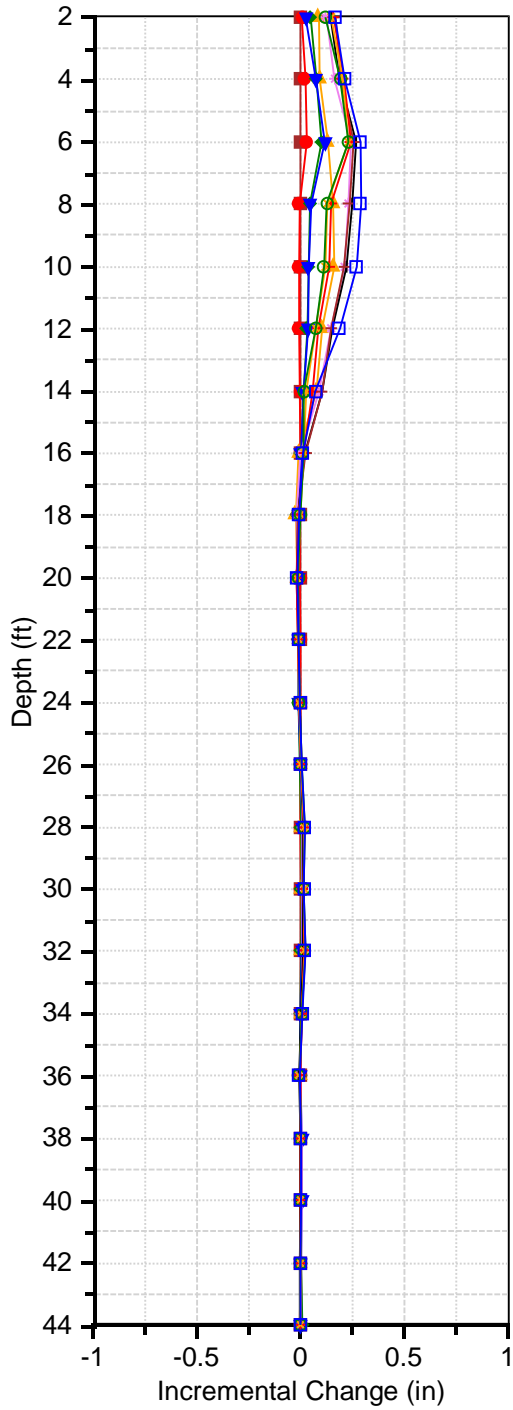
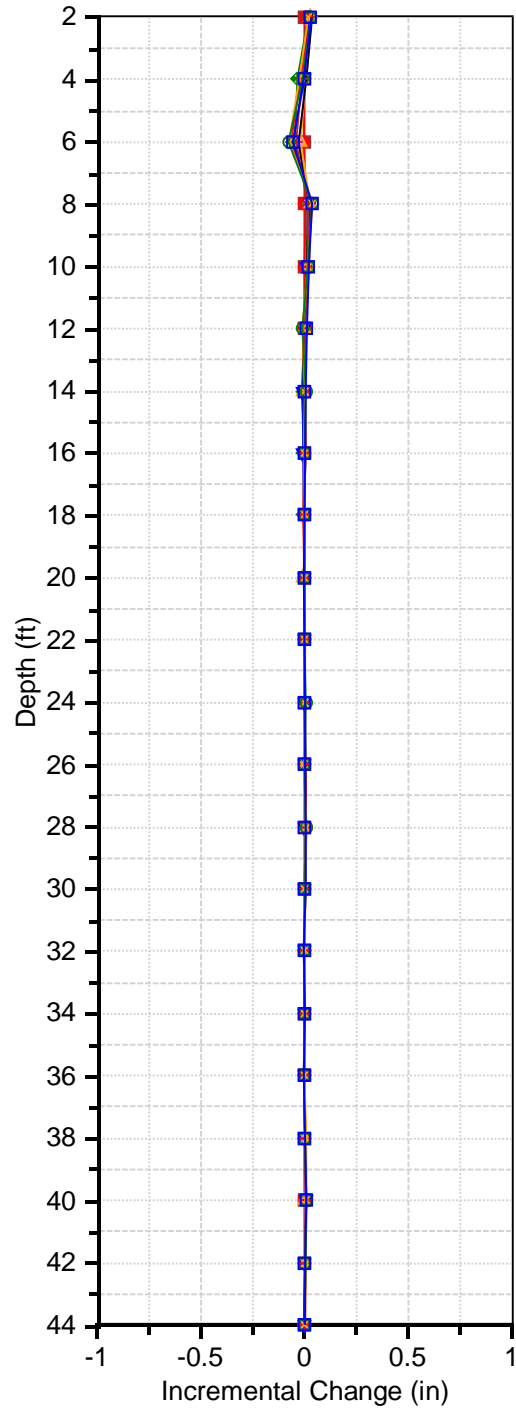
Norris SI-1 A

As previously mentioned in this report, the GHAD has completed an investigation in regard to AC cracking along Ashbourne Drive, which includes monitoring of two slope inclinometers installed between Ashbourne Drive and MSE Retaining Wall L2 (Figure 1C). Test results of the inclinometer readings performed through February 2024, are presented in Appendix B.

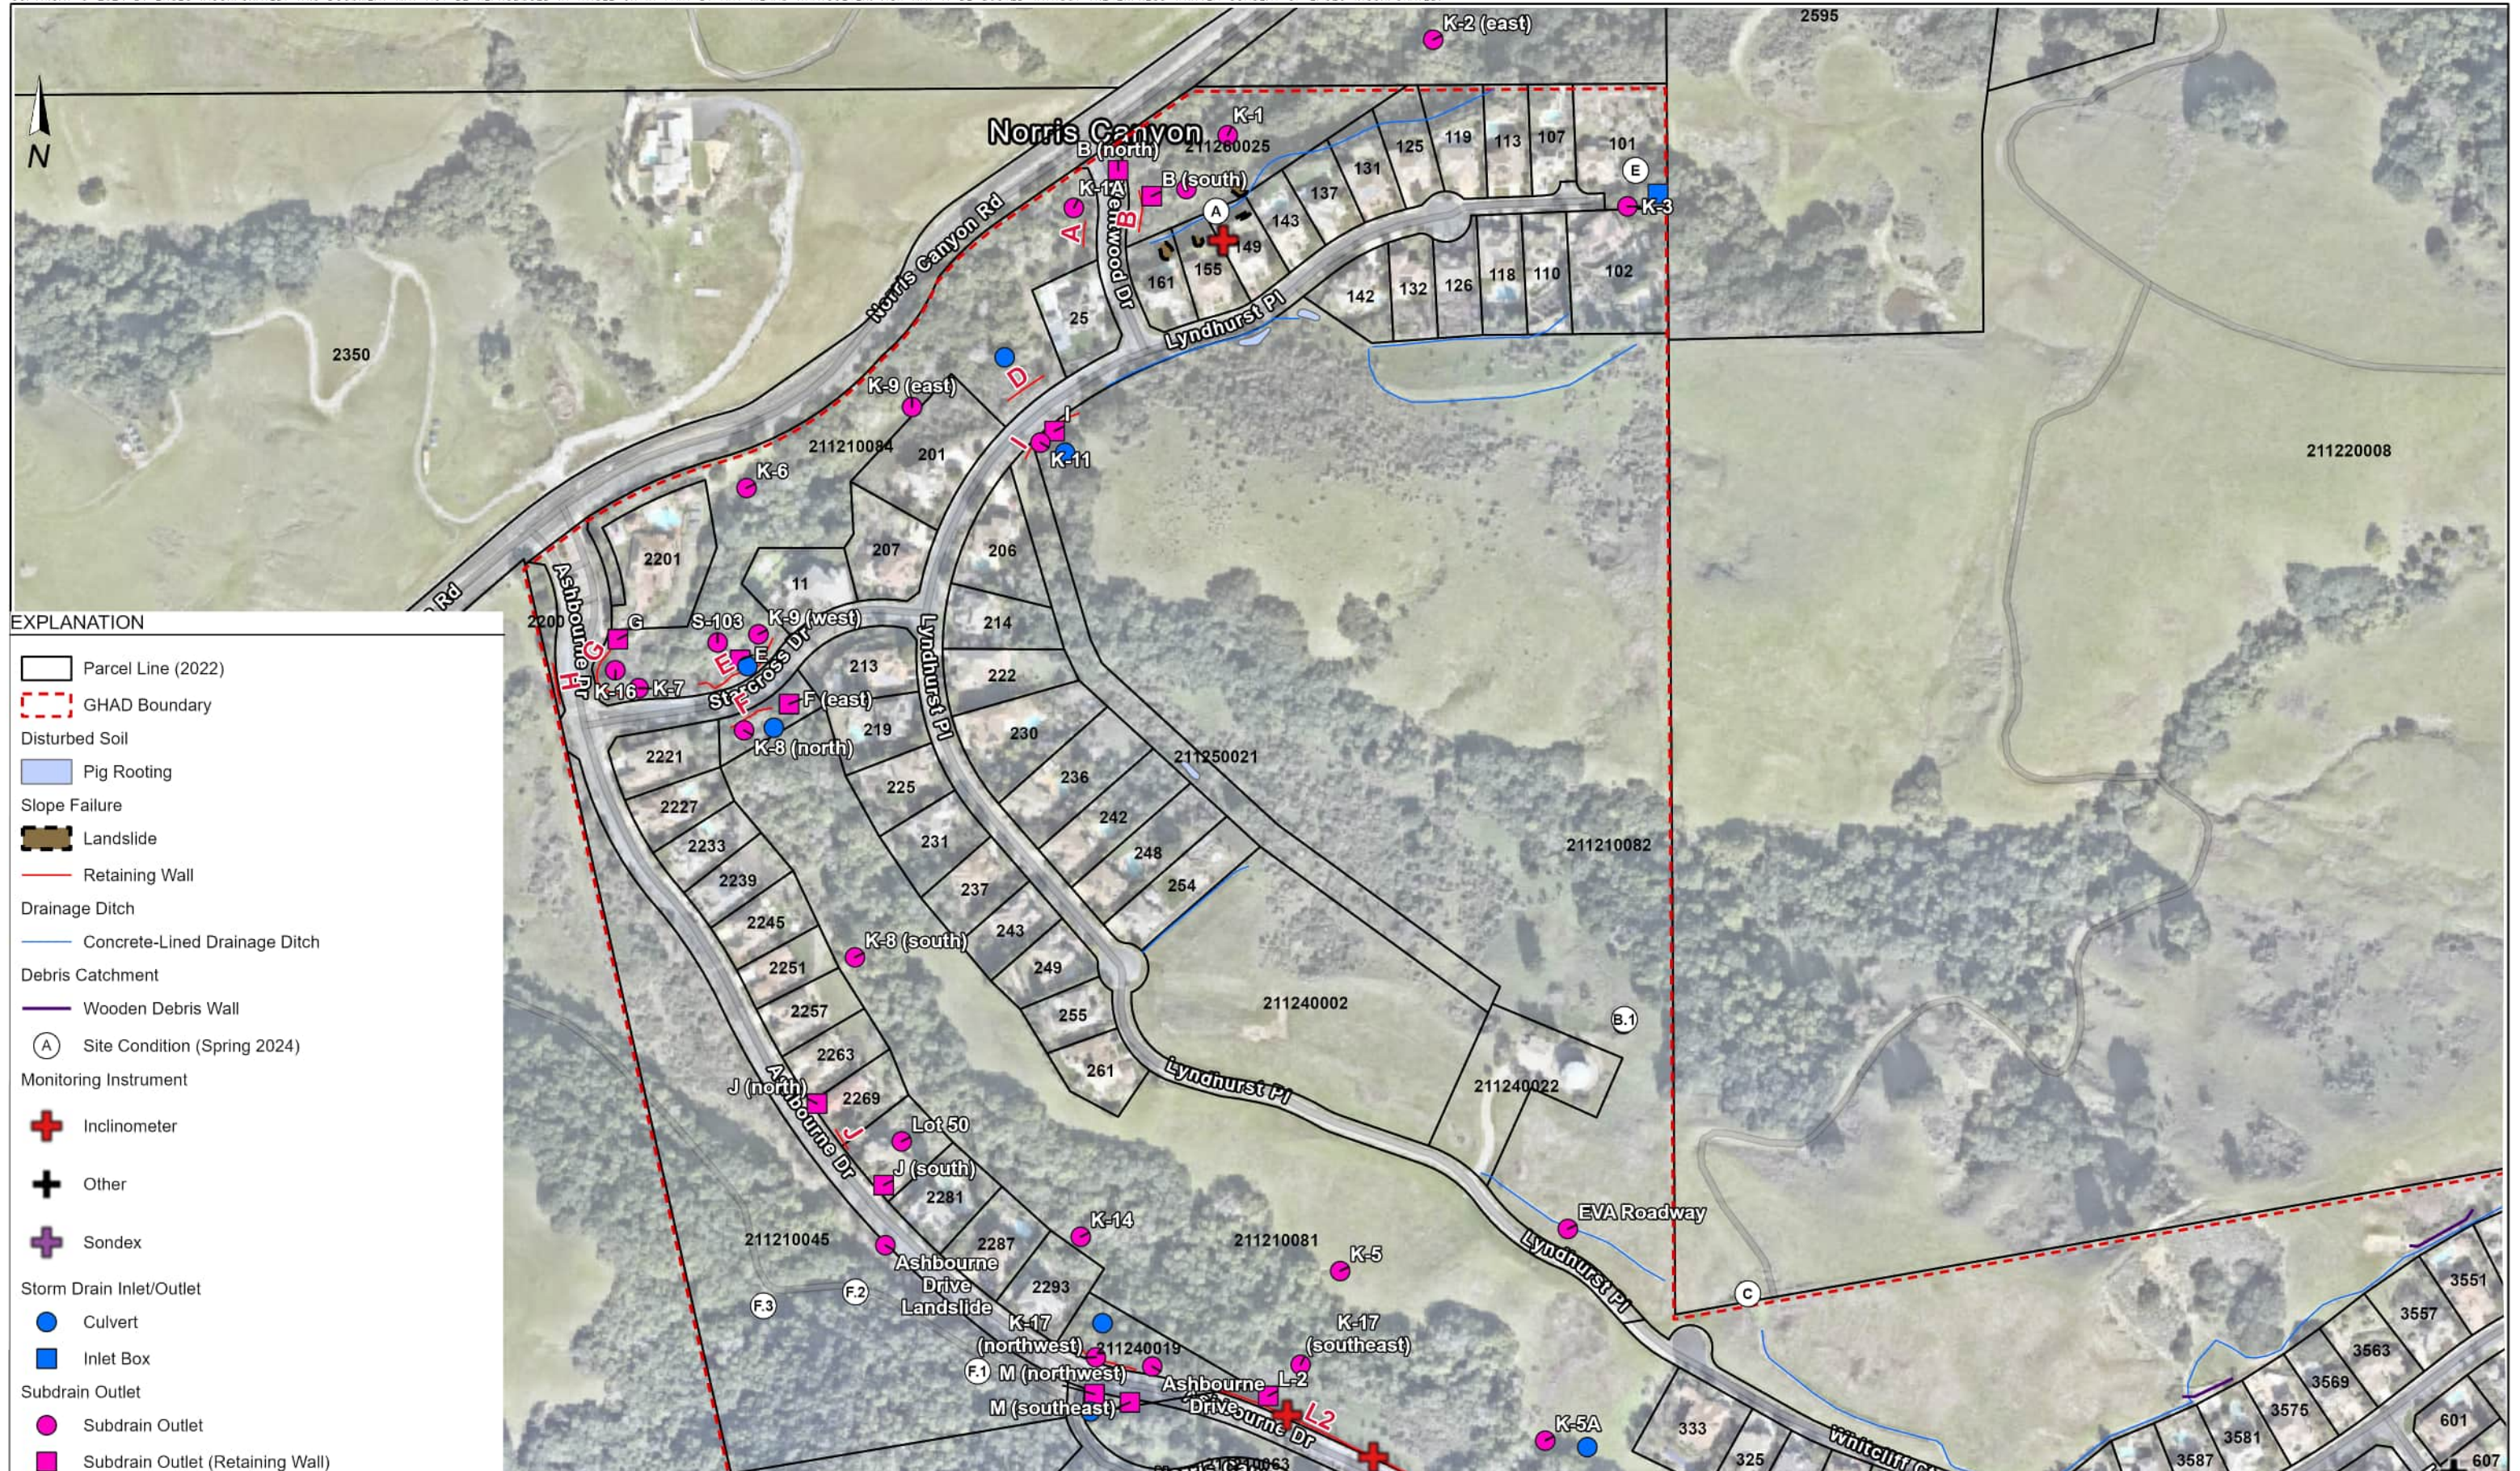
PROJECT NO. : 3586.002.023	FIGURE NO.
SCALE: AS SHOWN	<b>1B</b>
DRAWN BY: CMG

Since 2018, several minor landslides/earthflows have been observed along the 1:1 (horizontal:vertical) engineered fill slope, north of Lyndhurst Place, downhill from the nearby residences. These shallow landslides were not of immediate concern but have been monitored during subsequent scheduled monitoring events. During this monitoring event, the landslides did not show any significant movement. We did observe a new earthflow and damaged fence at the rear of 149 Lyndhurst Place during the spring 2023 monitoring event. During this monitoring event, the earthflow appeared to have stabilized and did not appear to be impacting the house pad or mid-slope drainage ditch (Site Condition A, Appendix A, Figure 1B). The GHAD will continue monitoring these areas for slope stability.

- Shallow earthflow northeast of Bishop Tank Site pad. Earthflow is stabilized with partial revegetation on affected slope (Site Condition B.1, Appendix A, Figure 1B).

We observed that the storm drain inlet located at the southeastern corner of 101 Lyndhurst Place was obstructed by vegetation and sediment (Site Condition E, Appendix A, Figure 1B). The drain inlet will be cleared during annual maintenance work.

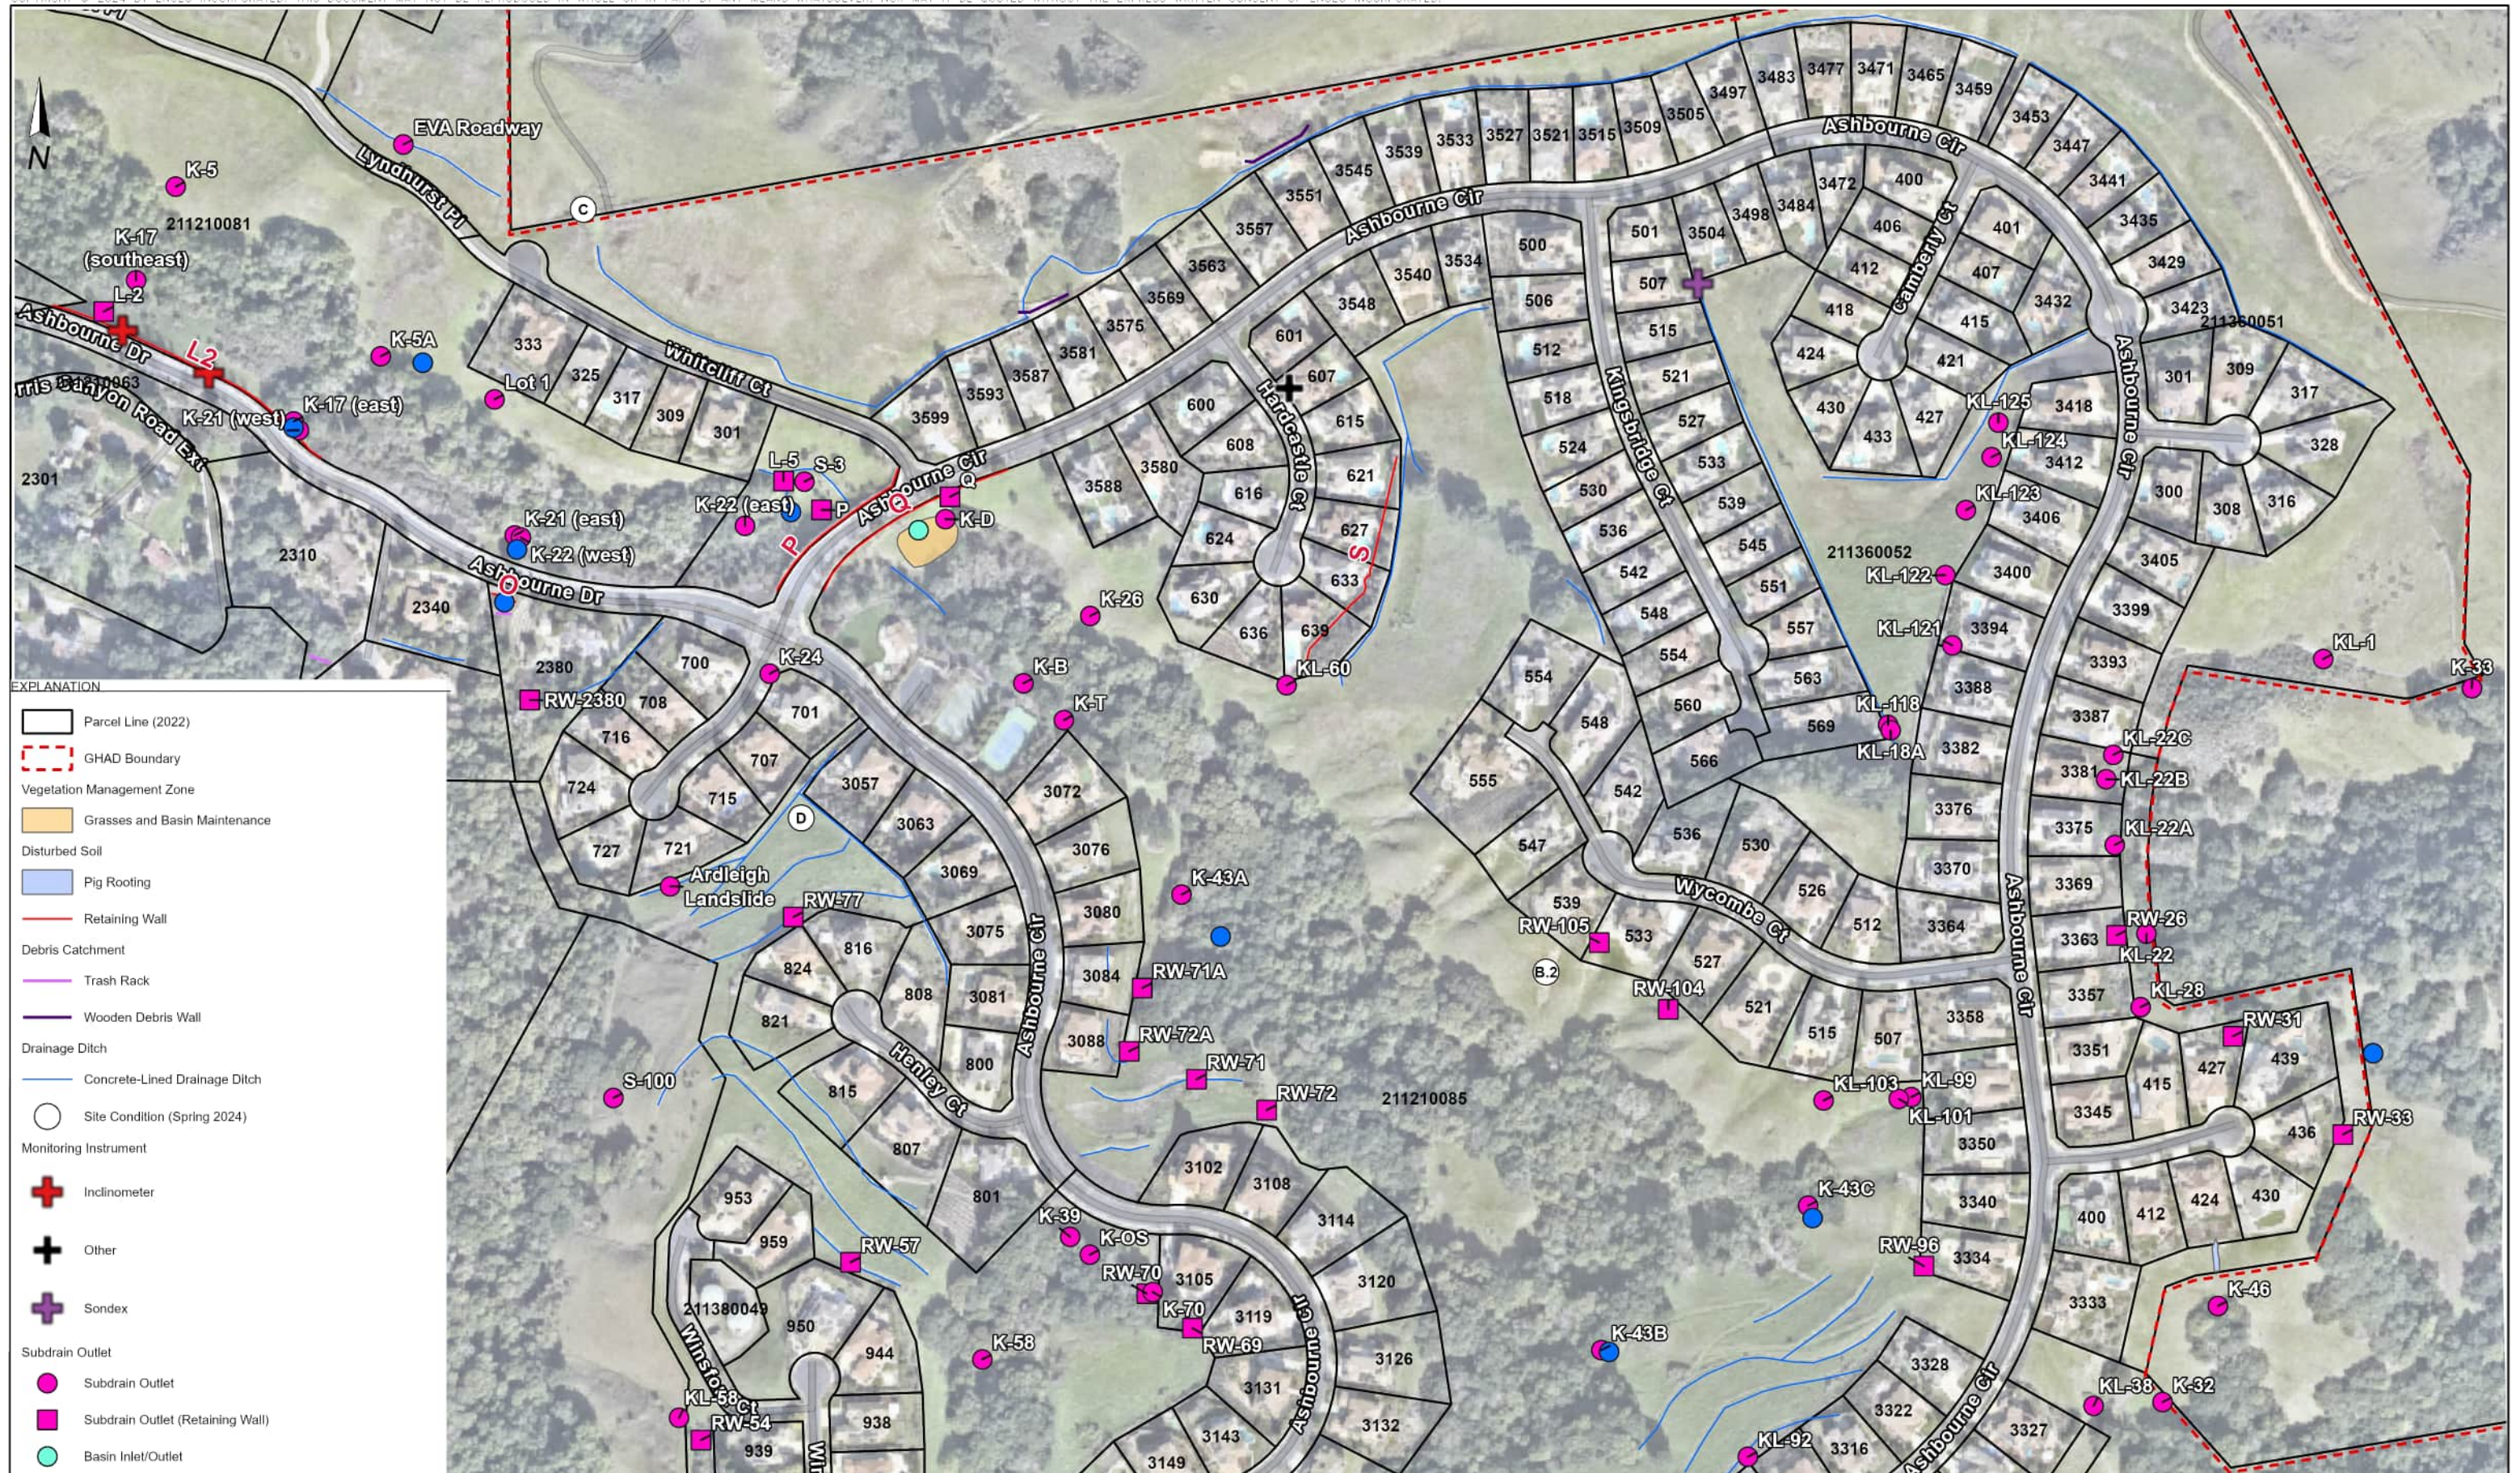
FIGURE NO.  
**1C**

- Shallow earthflow southwest of 539 Wycombe Court rear yard. Earthflow is stabilized with partial revegetation on affected slope (Site Condition B.2, Appendix A, Figure 1C).

- Slope erosion rills northeast of Whitcliffe Court (outside of the GHAD boundary). Condition unchanged with partial revegetation on affected slope. (Site Condition C, Appendix A, Figure 1C).

separation from the inlet box structure. At the time of this monitoring event, the cracking had not progressed (Site Condition D, Appendix A, Figure 1C). The inlet box and cracks should continue to be monitored and, if needed, sealed or replaced to maintain the integrity and longevity of the drain inlet.
