Project No.
3586.002.023

May 3, 2024

Subject: Elworthy Ranch
Danville, California

**GEOLOGIC HAZARD ABATEMENT DISTRICT
MONITORING – SPRING 2024**

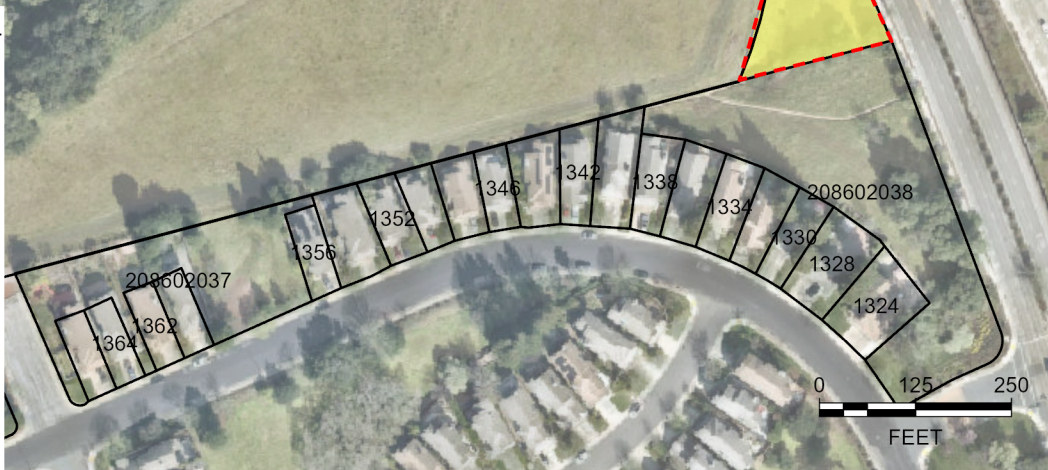
FIGURE 1

A detention basin (Figure 1) is located at the end of Elworthy Ranch Lane. Monitoring of the detention basin was conducted as part of the open-space monitoring. The observed conditions for the detention basin are described in the attached Elworthy Ranch Detention Basin Site Monitoring and Maintenance Form. Contracted ongoing routine maintenance within the detention basin currently includes roadway maintenance, weed abatement, and woody vegetation removal. At the time of our visit, the detention basin appeared to be functioning properly and was in good condition.
