Project No.  
**3586.002.024**

November 18, 2024

Subject: Elworthy Ranch  
Danville, California

**GEOLOGIC HAZARD ABATEMENT DISTRICT  
MONITORING – FALL 2024**

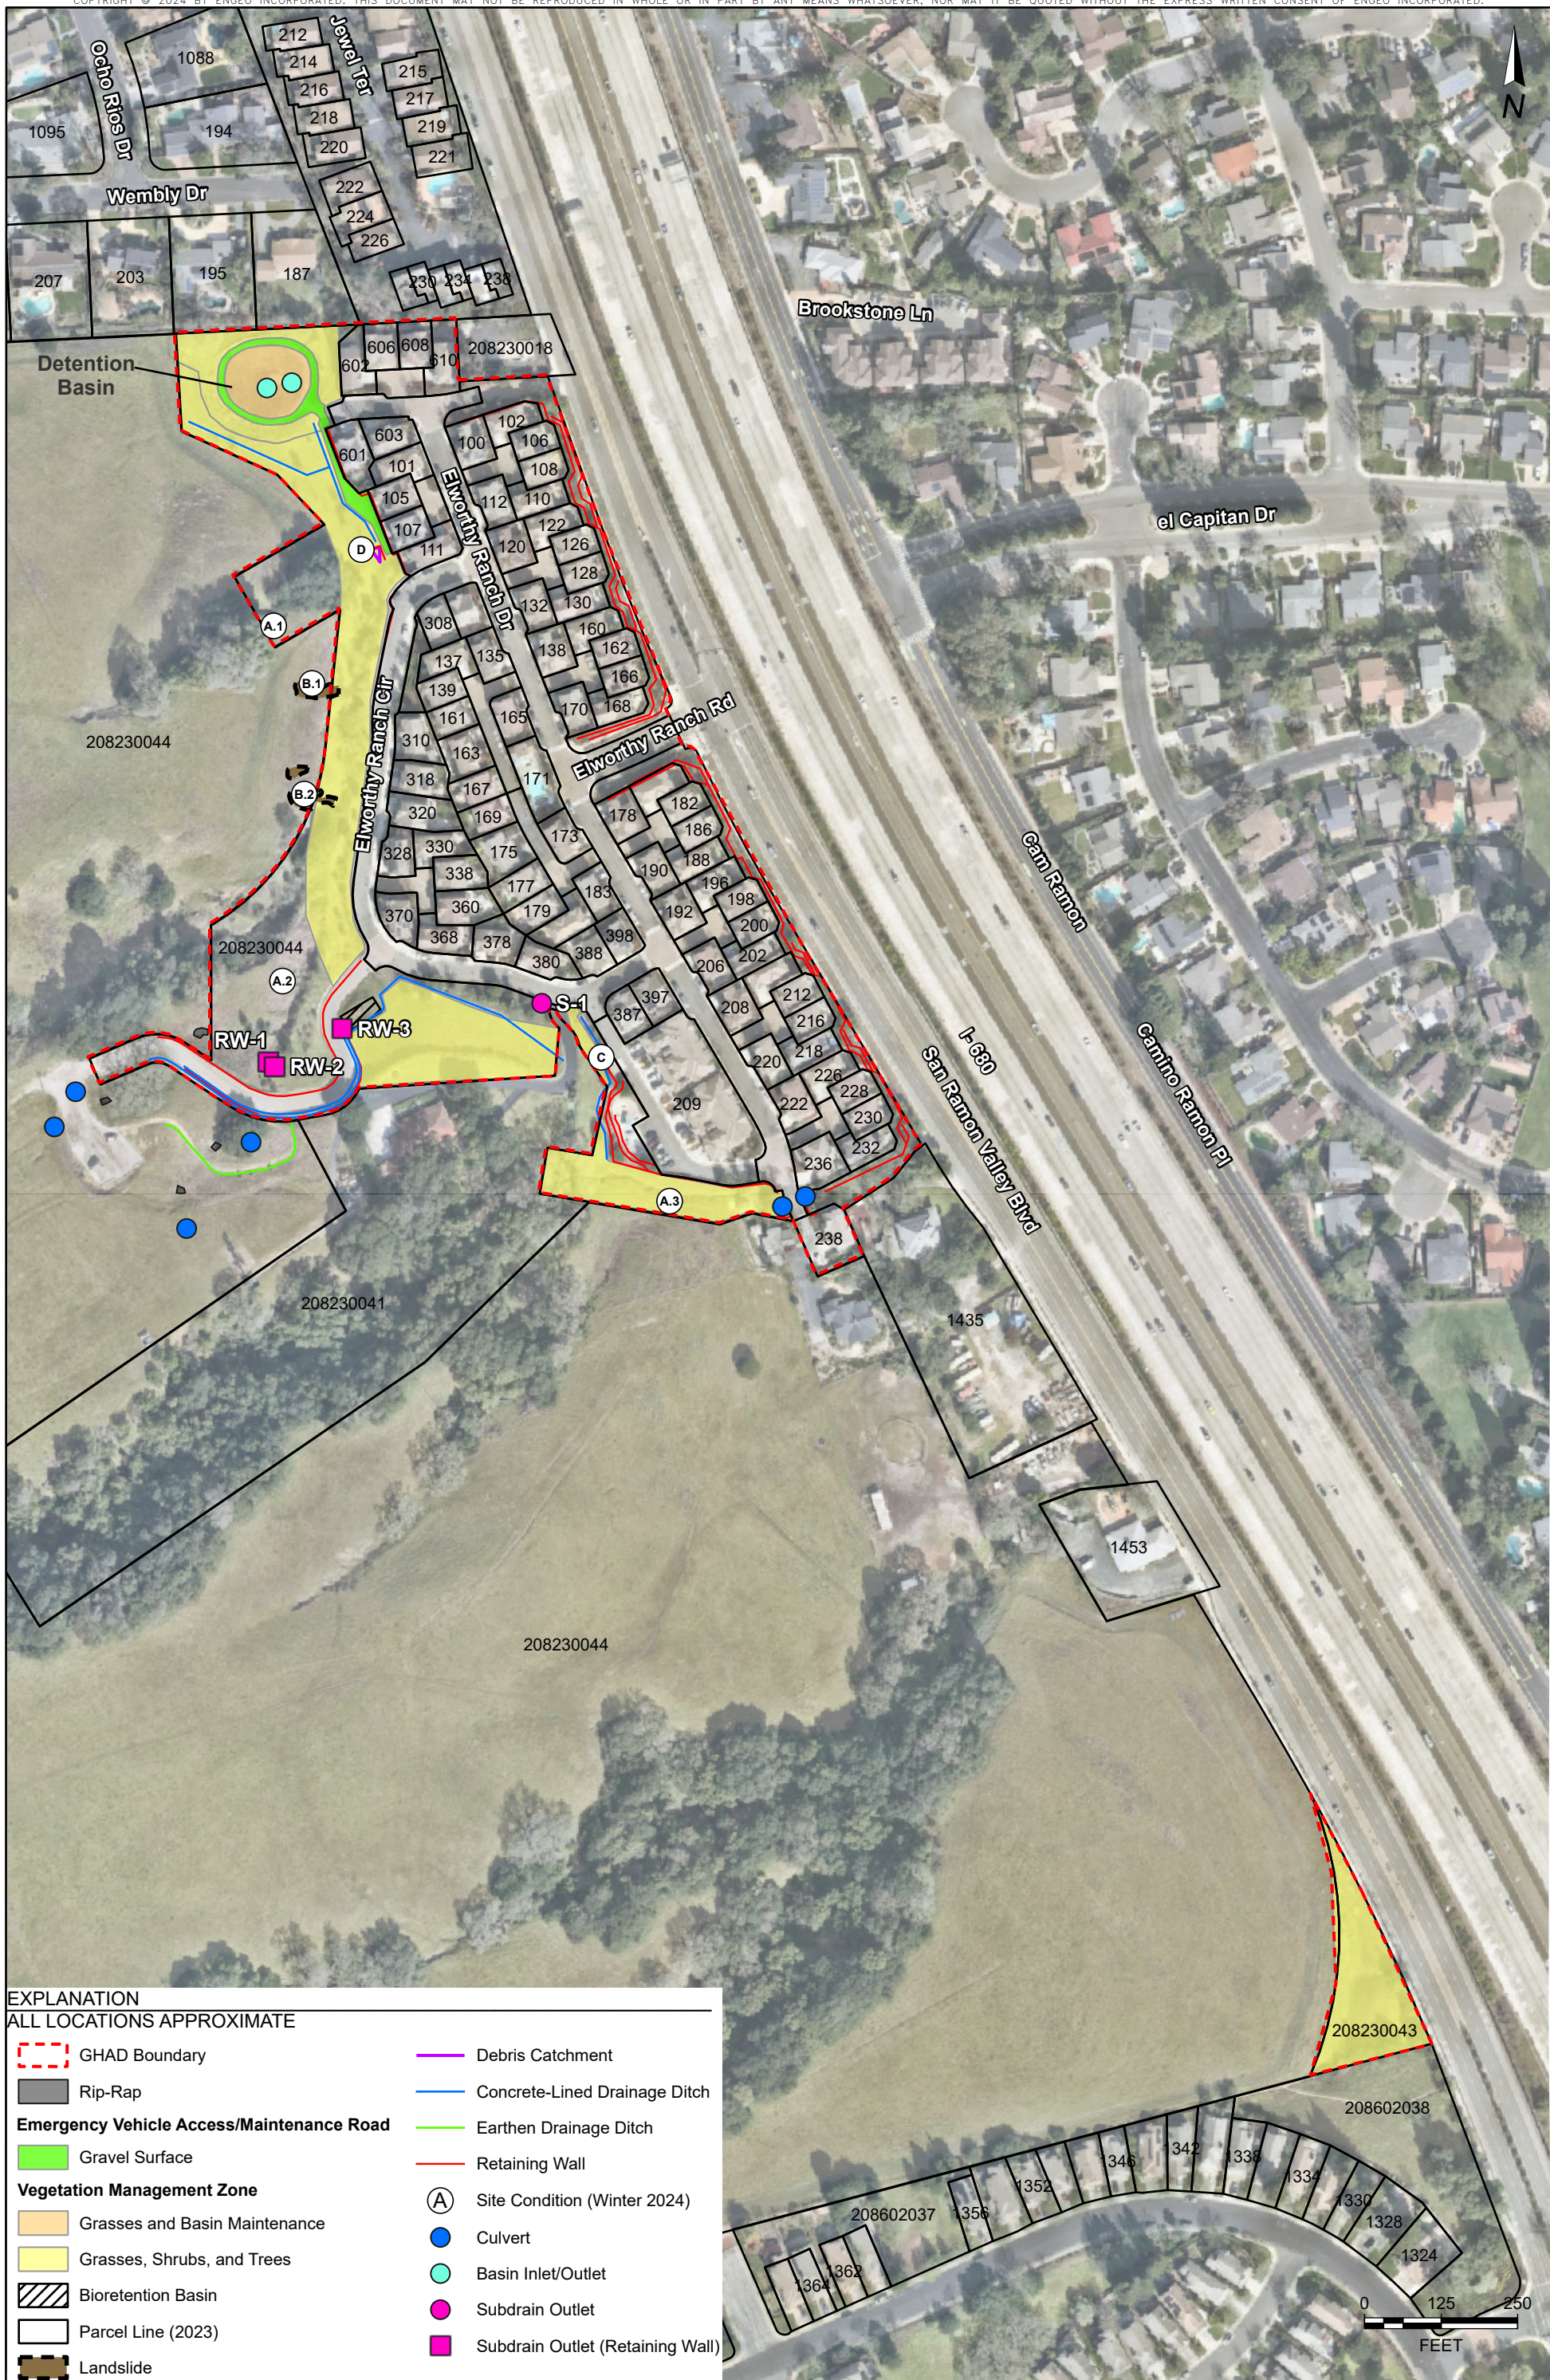
**FIGURE 1**  
**Site Plan**

A detention basin (Figure 1) is located at the end of Elworthy Ranch Lane. Monitoring of the detention basin was conducted as part of the open-space monitoring. The observed conditions for the detention basin are described in the attached Elworthy Ranch Detention Basin Site Monitoring and Maintenance Form. Contracted ongoing routine maintenance within the detention basin currently includes roadway maintenance, weed abatement, and woody vegetation removal. At the time of our visit, the detention basin appeared to be functioning properly and was in good condition.

We observed the condition of one bioretention basin adjacent to Elworthy Ranch Circle (Figure 1). During our monitoring, the bioretention basin appeared to be free of accumulated standing water or debris and was functioning properly.
