Project No.
3586.002.024

November 18, 2024

Subject: Norris Canyon Estates
Contra Costa County, California

**GEOLOGIC HAZARD ABATEMENT DISTRICT
MONITORING – FALL 2024**

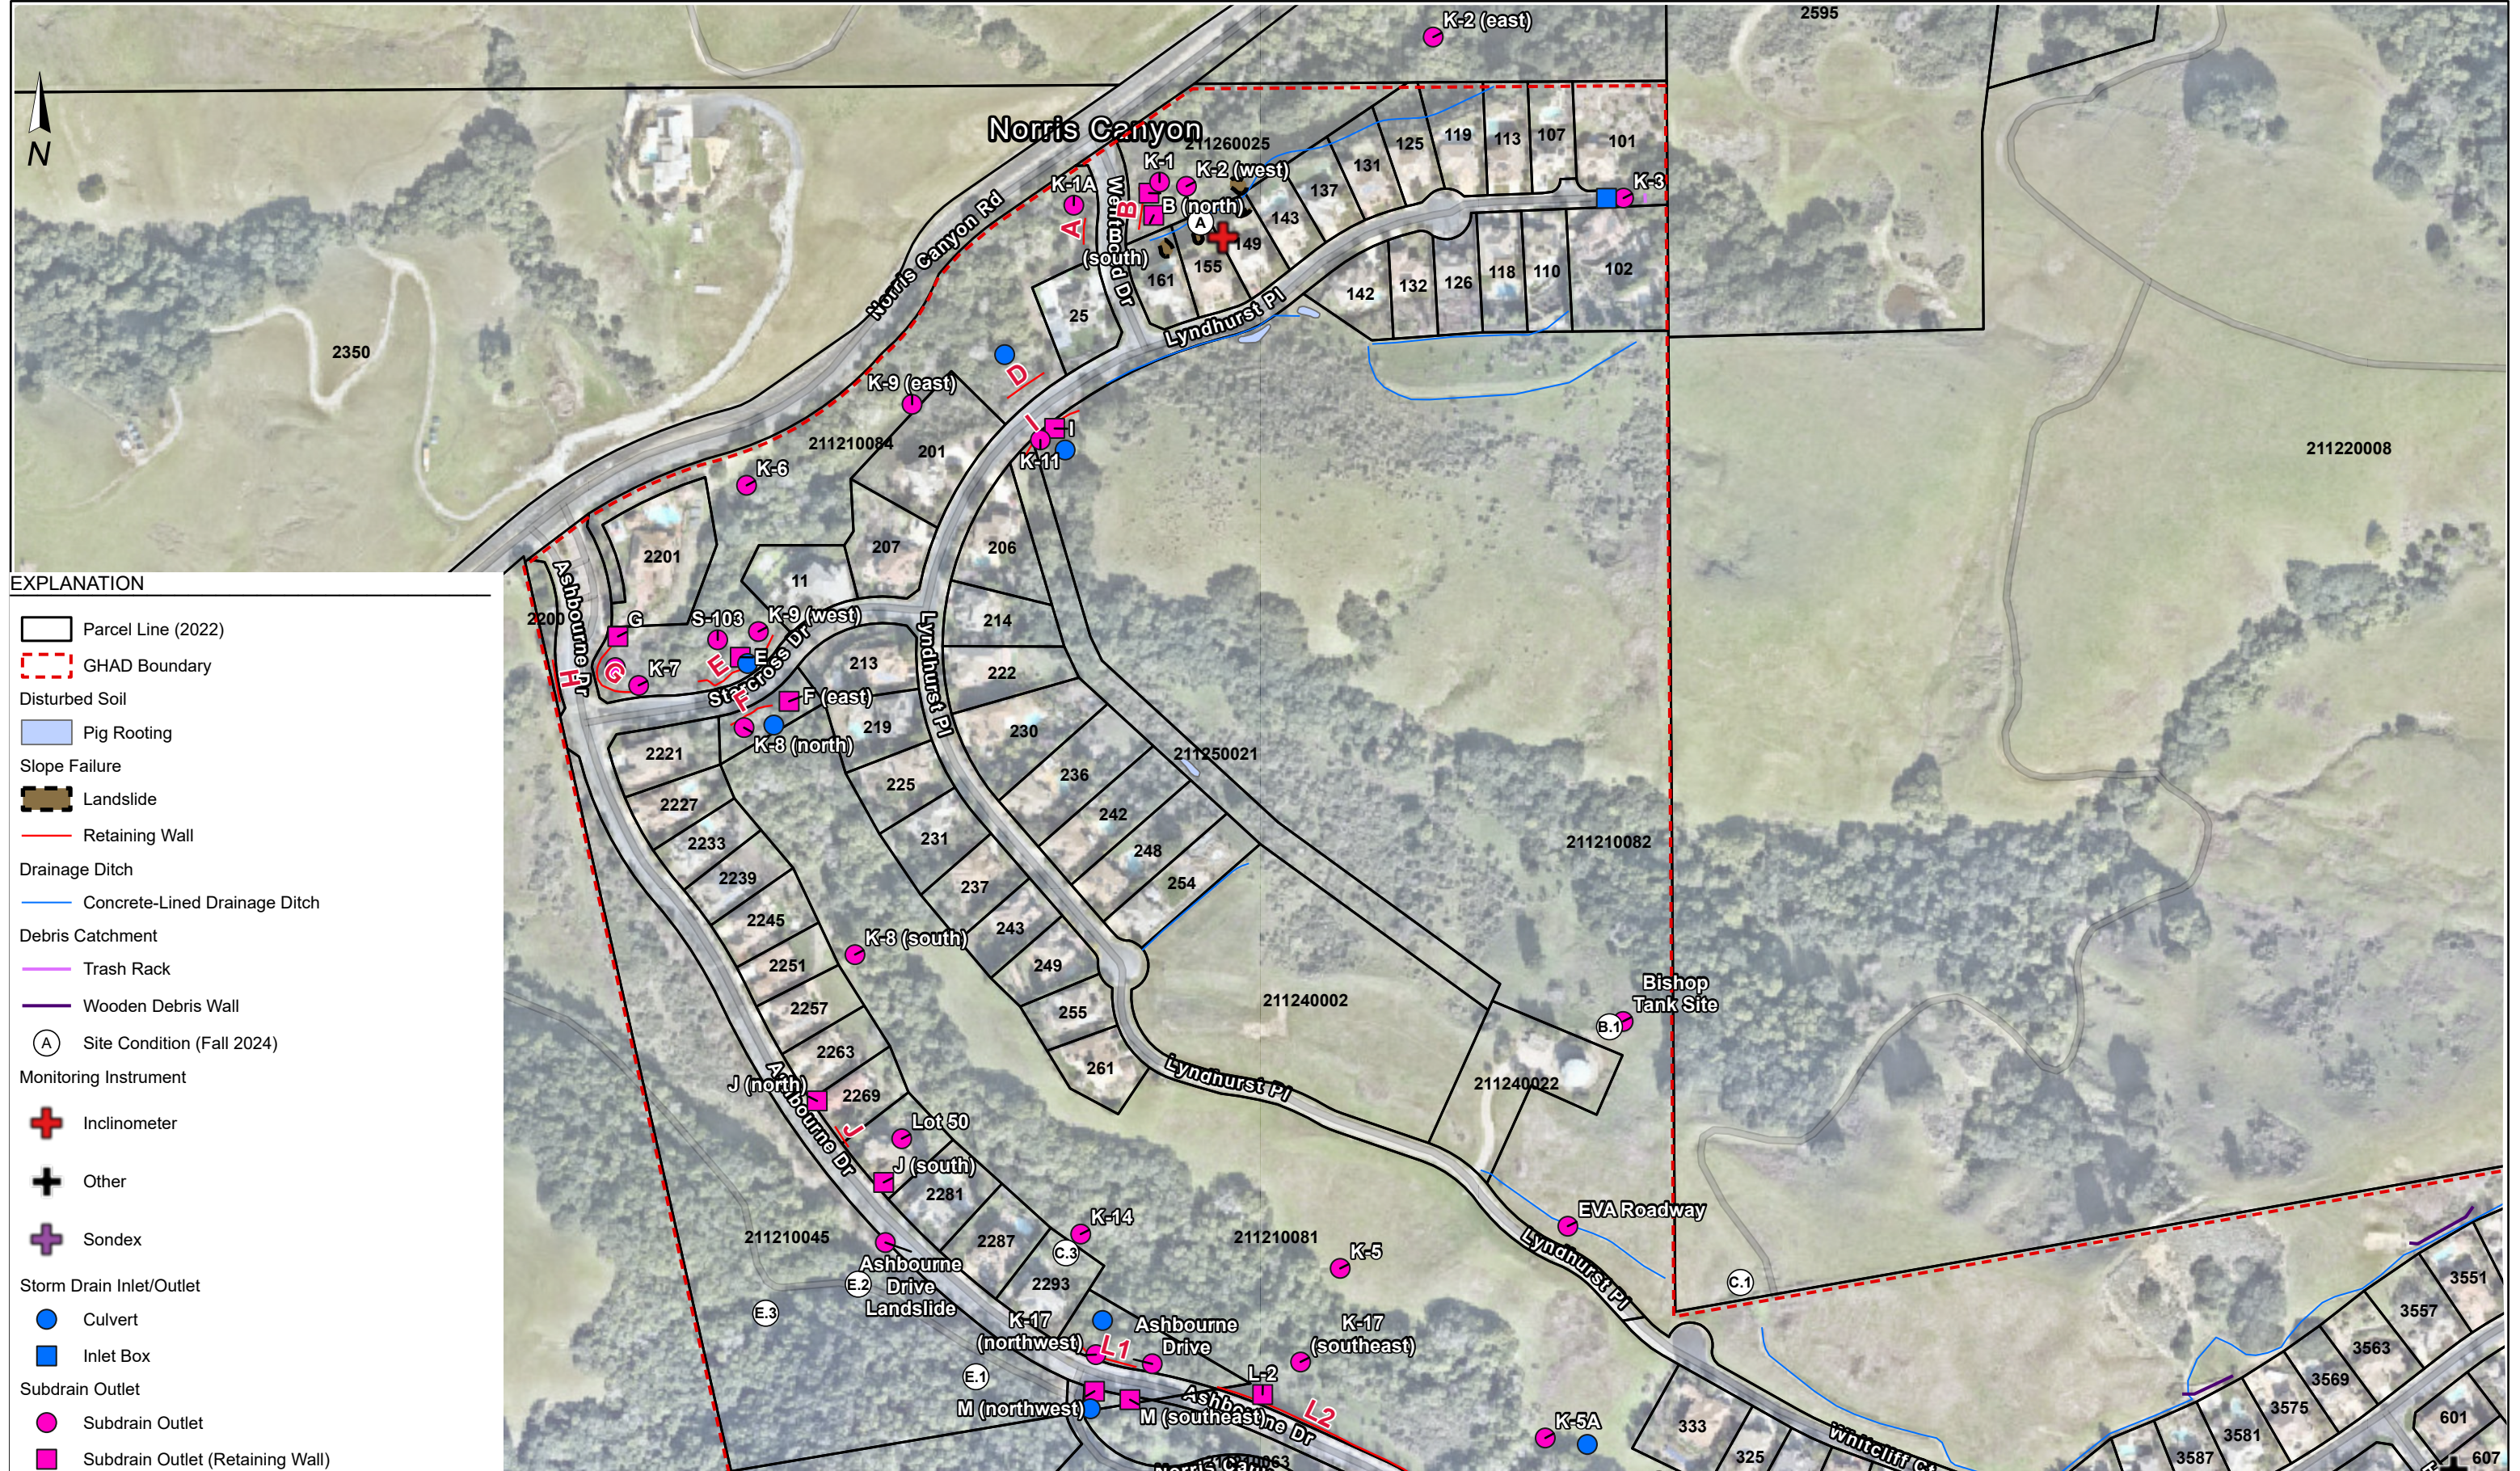
PROJECT NO. : 3586.002.024	FIGURE NO.
SCALE: AS SHOWN	2A
DRAWN BY: NWC	CHECKED BY: RHB

- Shallow earthflow northeast of Bishop Tank Site pad: Earthflow is stabilized with partial revegetation on affected slope (Site Condition B.1, Appendix A, Figure 2A).
