WIEDEMANN RANCH GEOLOGIC HAZARD  
ABATEMENT DISTRICT (GHAD)

PLAN OF CONTROL  
PODVA PROPERTY DEVELOPMENT ANNEXATION

Prepared by  
ENGEO Incorporated

June 18, 2015  
Revised January 7, 2016

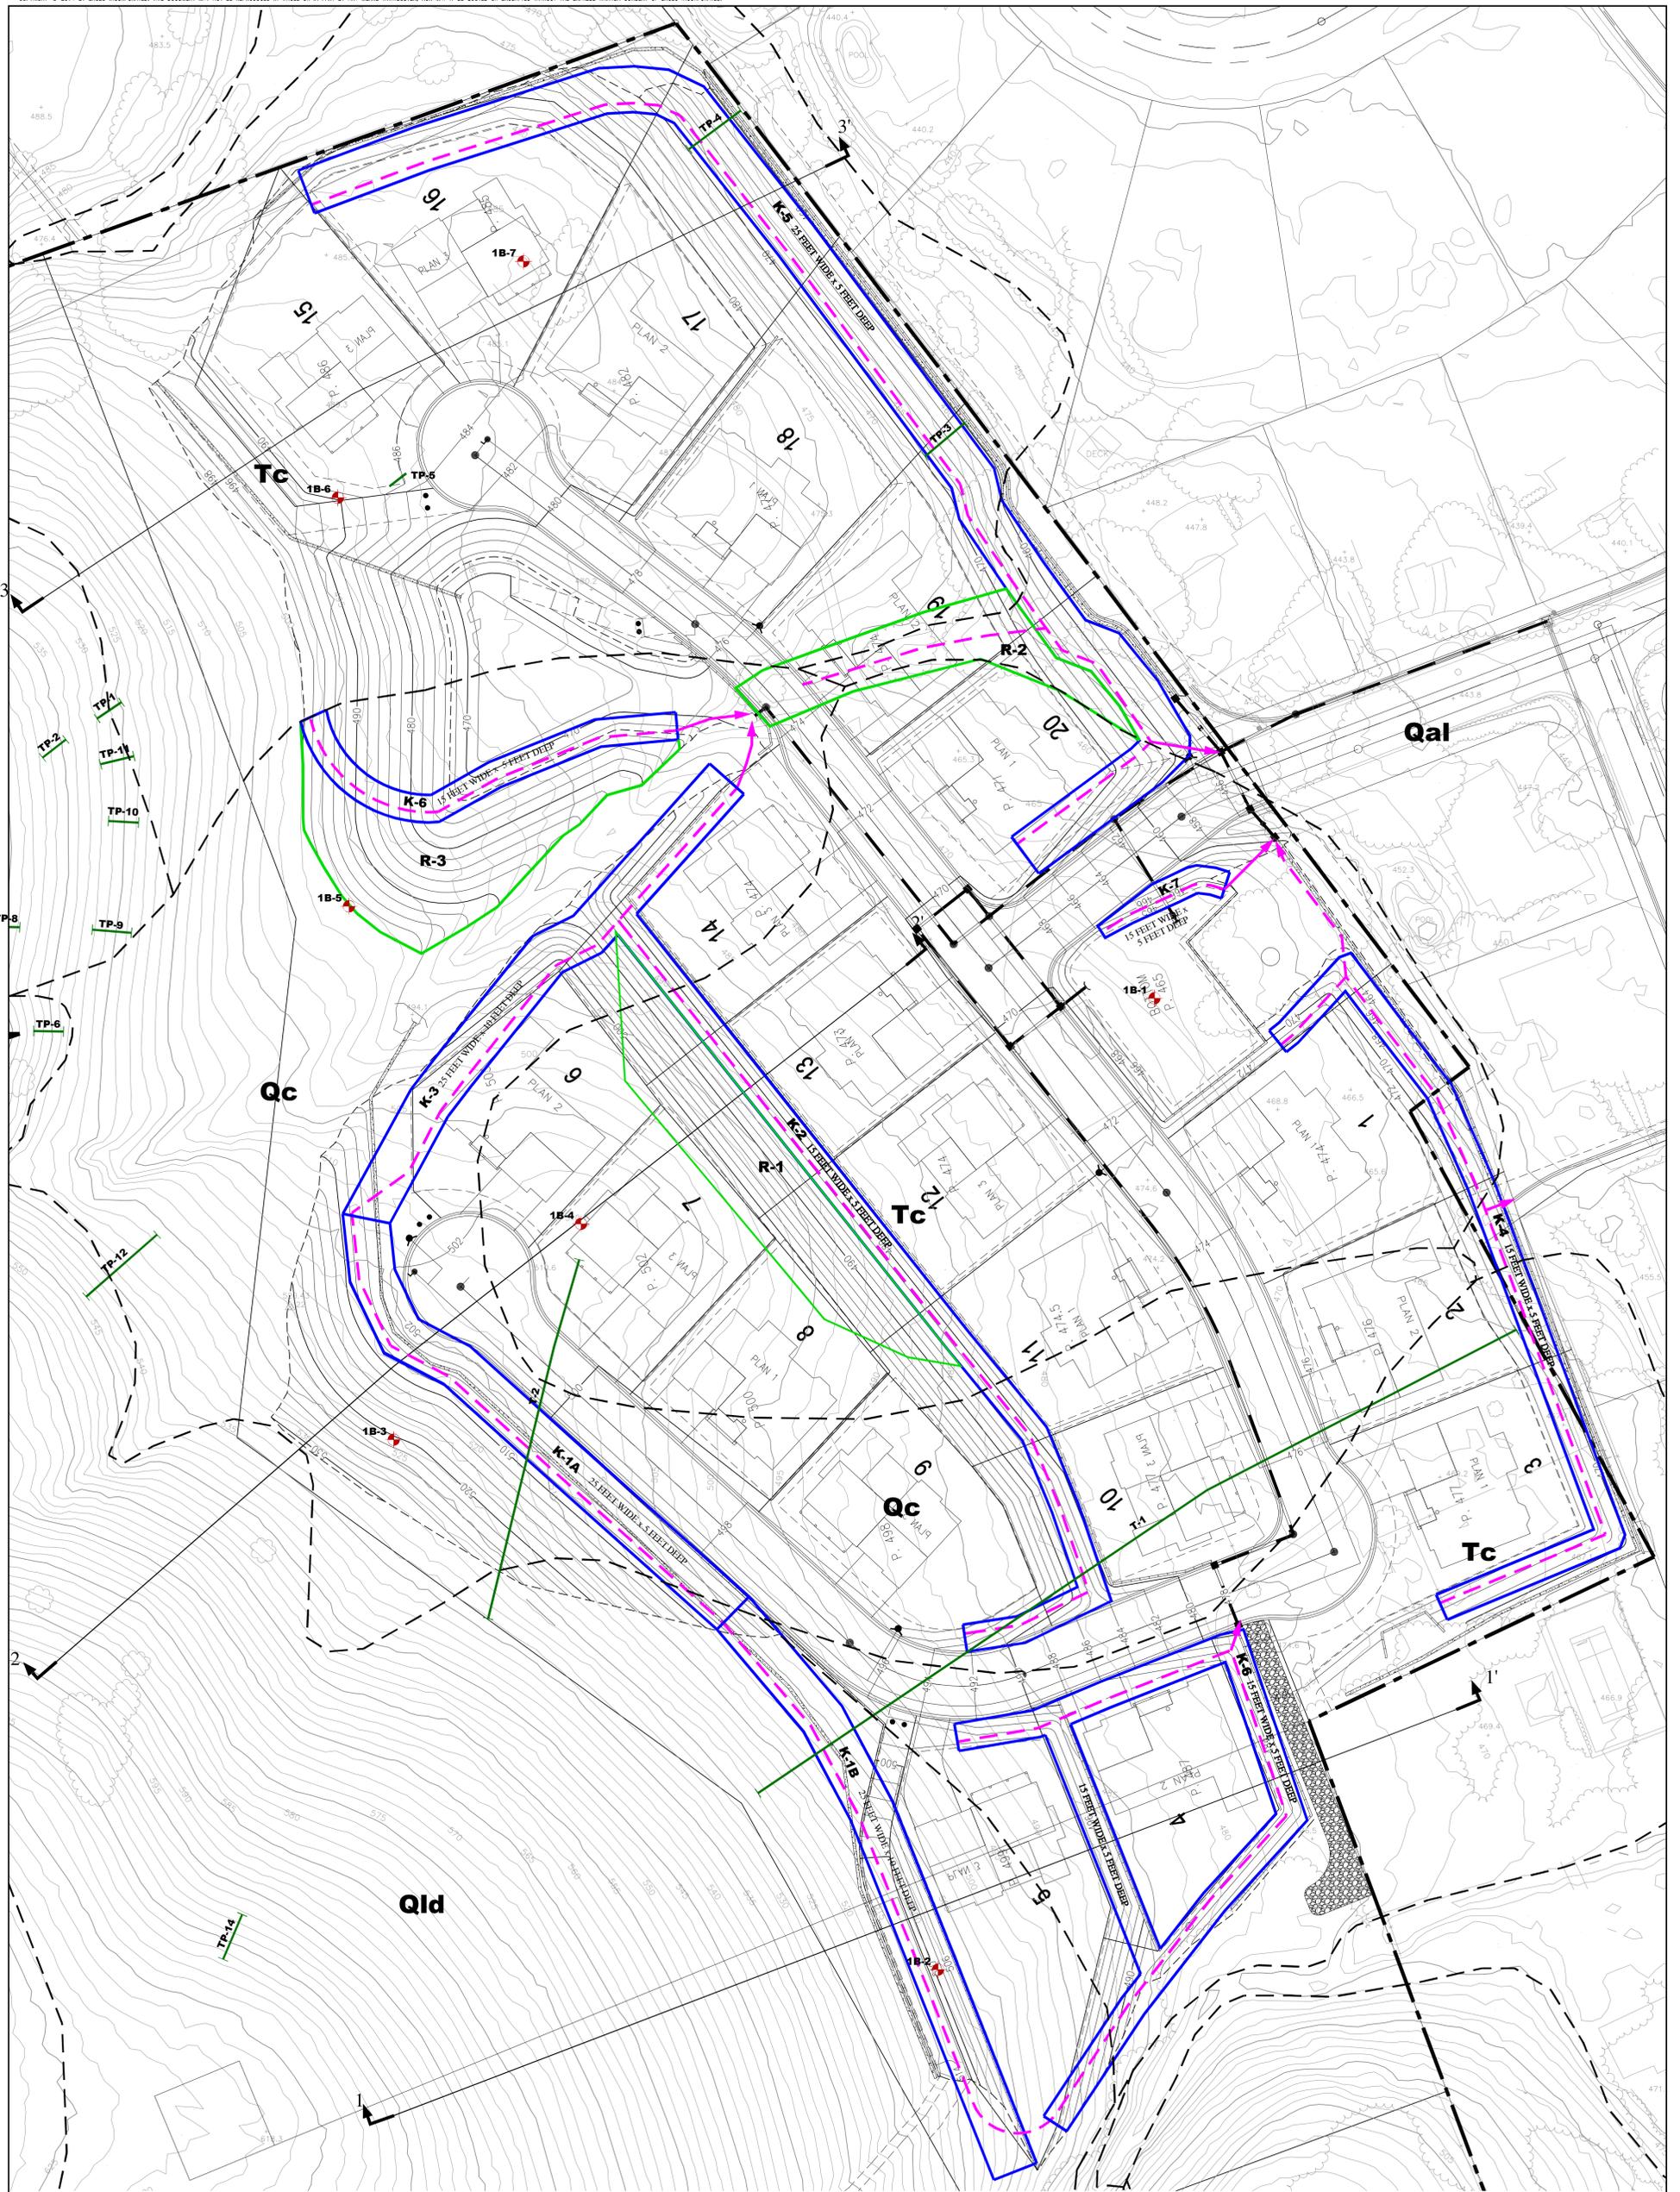
Corrective Grading Plan

**EXPLANATION**  
ALL LOCATIONS ARE APPROXIMATE

- Qal** ALLUVIUM
- Qc** COLLUVIUM
- Tsp** SAN PABLO GROUP / UNDIFFERENTIATED
- Tc** CIERBO SANDSTONE
- Tbr** BRIONES FORMATION
- Tm** MONTEREY GROUP
- Qld** LANDSLIDE DEBRIS FAN DEPOSIT
